HISTORICAL STUDY FOR
KENNEBEC ARSENAL,
AUGUSTA MENTAL HEALTH INSTITUTE
AUGUSTA, MAINE

24 June 2003

TURK TRACEY & LARRY ARCHITECTS, LLC

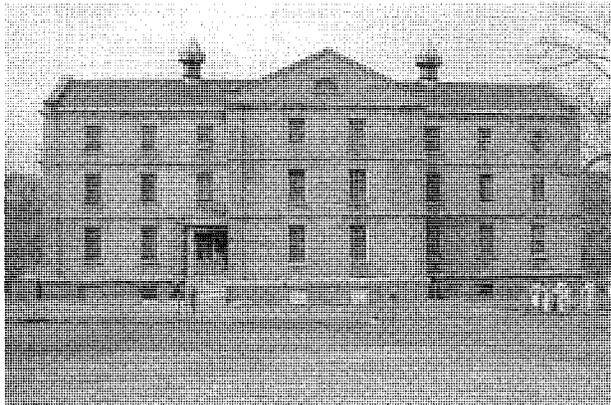
Figure 1. View looking west at principal façade of arsenal building.

The arsenal building was the principal structure of the arsenal for the storage of armaments and is prominently situated near the bank of the river and close to the wharf. The building merits conservation and reuse. Overall, the condition of the building is fair. The building maintains

many of its architectural features associated with Federal Period architecture including the massing, corner pilasters, splayed cornice (Figure 1) and lunette windows in the gable ends. All of the features are in fair to good condition. The roof was replaced within the past ten years and is in good condition. It was not until 1905 when the building was transferred to the State of Maine and used for the Maine Insane Hospital that the structure underwent major alterations. Work included the addition of the gable end pavilion along the east elevation to match the west elevation, roof ventilators, and a one-story full-width verandah (which is in fair to poor condition) along the west elevation (Figure 2). These later alterations have become character-defining elements of the building and should be conserved.

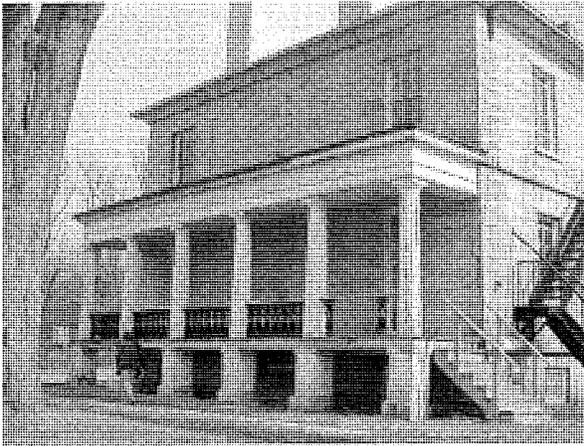
Like the arsenal building, the commandant's house maintains many of its Federal Period features including the symmetrical mass, the hipped roof, and paired interior end-wall chimneys. The building also exhibits Greek Revival attributes added during the 1830s that include the gable portico over the main entrance and veranda, and cast iron balustrade along the west side (Figure 3). Overall, the commandant's house is in good condition and merits conservation and reuse. The double-hung wood sash windows, although several have been replaced by 4/4 double hung sash, are in good condition. The principal entry door is a non-historic staggered three-light flush door. The opening is highlighted by three-light sidelights, which are in fair condition (Figure 4).

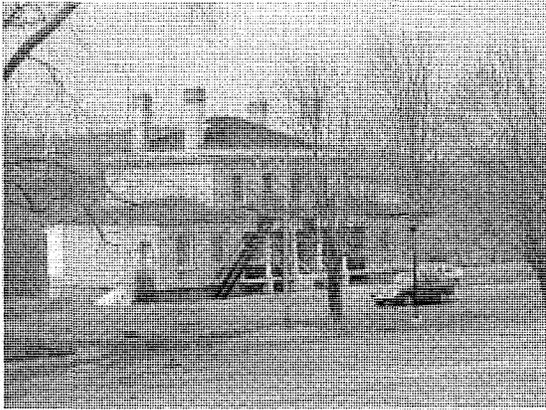
Figure 5. View looking northwest at principal façade of quarters number two.

Officer's quarters number two merits conservation and reuse. Overall, the condition of the building is fair. The building maintains many of its architectural features associated with Federal Period architecture including the symmetrical mass, the hipped roof, and paired interior end-wall chimneys (Figure 5) as well as the Greek Revival attributes adding during the 1830s that include the one-story wings linked by the porch and cast iron balustrade on the east elevation. The full-width veranda along the west elevation was removed in the 1970s with the addition of an obtrusive one-story wing constructed on a raised concrete block foundation (Figure 6). Consideration should be given to removing the addition and restoring the veranda.

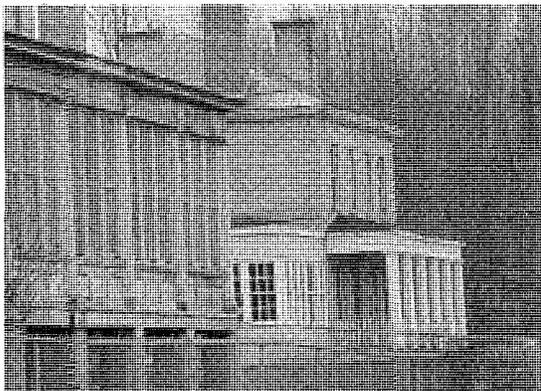
Figure 7. View looking southeast at quarters number three veranda

Officer's quarters number three merits conservation and reuse. Overall, the condition of the building is fair and maintains more significant exterior architectural features than quarter's number two including the full-width veranda along the west elevation (Figure 7). The columns of the veranda, however, are metal replacements. Quarters three exhibits the symmetrical mass, the hipped roof, and paired interior end-wall chimneys (Figure 8) typical of its Federal Period detailing, as well as the Greek Revival attributes added during the 1830s that include the one-story wings linked by the porch and cast iron balustrade on the east and west elevation. A non-historic one-story wood frame wing was added to the north wing in the 1970s. Consideration should be given to removing the addition and restoring the wing.

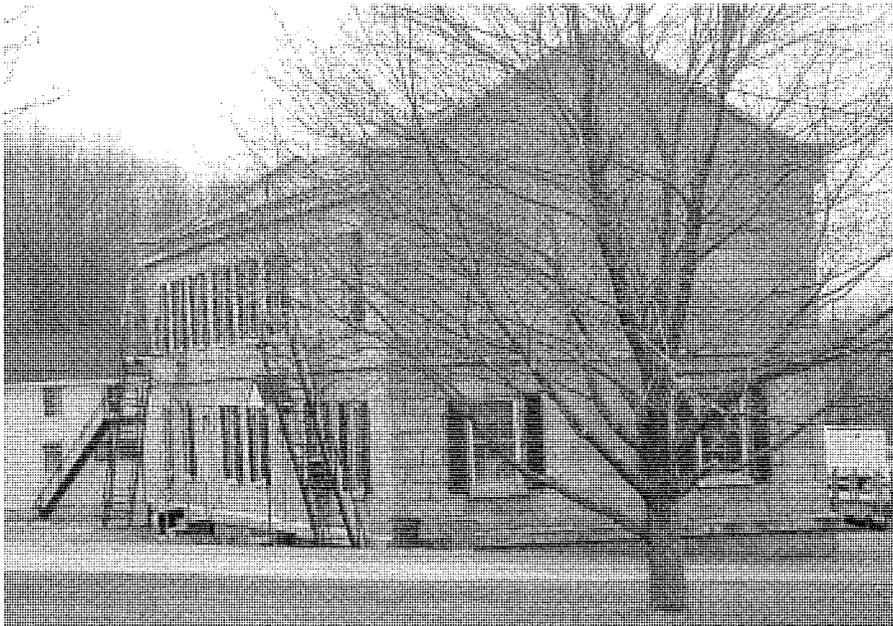
Figure 9. View looking southwest at barracks.

The barracks merits conservation and reuse. The massing, fenestration, and simple unadorned exterior of the building complement the other granite buildings of the arsenal complex (Figure 9). Additionally, the building's historic use as a barracks adds to the historical integrity of the Arsenal. The gable roof porticos over the entrances and fire escapes are later non-historic additions and the interior has been completely altered over the years and exhibits few if any historic finishes or trim work.

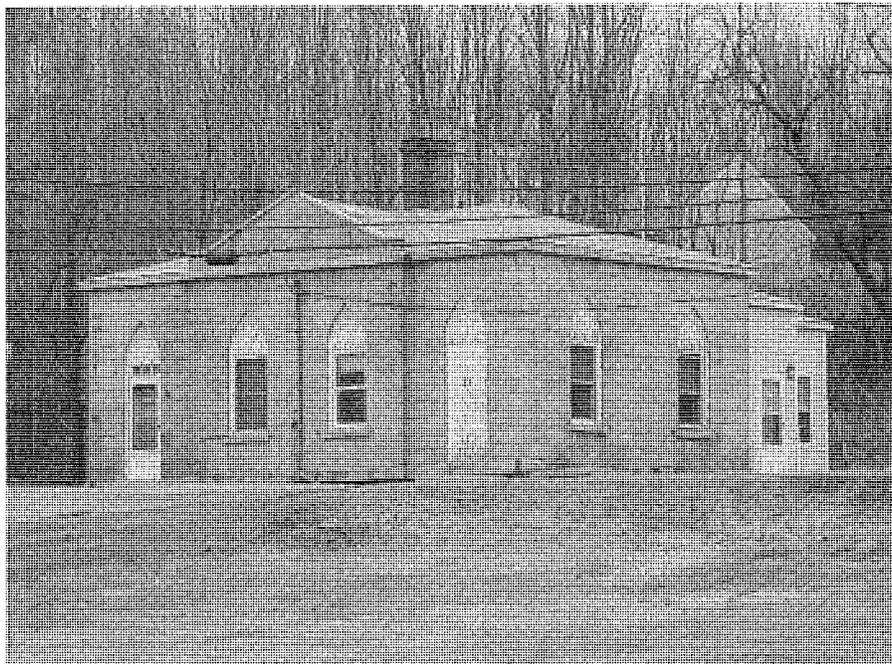
Figure 10. View looking northeast at gatehouse/office.

The gate house/office merits conservation and reuse. While the interior has for the most part been completely gutted over the years, a simple Greek Revival style mantel remains. Additionally, the Gothic Revival stylistics of the building including the lancet arched openings and wood panels with tracery (Figure 10) demonstrate a knowledge of the current architectural trends and the desire to update or “modernize” the arsenal. Several historic photos of the building on file at the Maine Historic Preservation Commission provide views of the original porch and lancet arched shutters that originally adorned the exterior of the gatehouse.

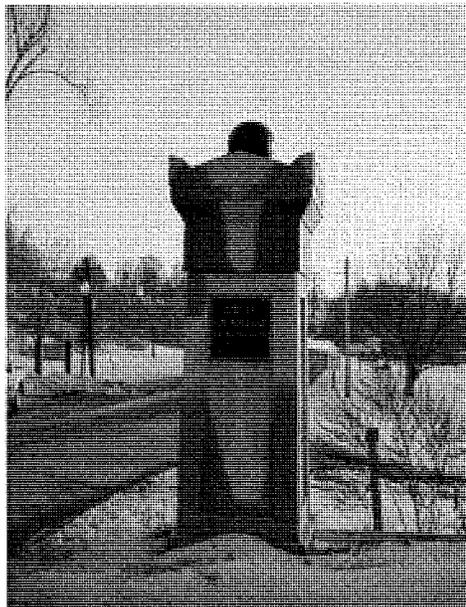
Figure 13. View looking south at entrance gatepost.

The entry gate is located at the north end of Arsenal Street and features two eight-foot granite posts consisting of a plinth, a paneled shaft and a capital; a cannonball is featured on top of the south post (Figure 13). Granite base stones extend to the east and west. The posts are generally in good condition; however, there are several corners that are deteriorated and portions of the post are stained. Additionally, there is some corrosion at the gate latch of both posts that could lead to rust jacking and cracking of the granite. The latches should be cleaned and the rust fully removed. They should then be treated with a rust-inhibitive primer and coated with a modern polymeric coating that adheres well and prevents rust. The missing cannonball (Figure 14) is reported to be stored in a coal bin in the boiler room of the Burleigh Building and should be reinstalled or replicated.

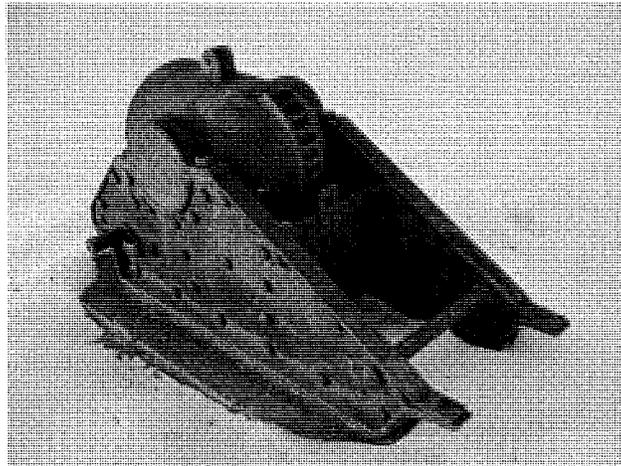
Figure 15. Siege mortar.

The siege mortar is a simple form of ordnance that was used during the Civil War to lob heavy projectiles a short distance at a high elevation and was therefore often referred to as plunging fire. The siege mortar located east of the Arsenal and west of Arsenal Street is in good condition. There are small areas of visible rust, especially at the connection joints between the sections and along the base that should be treated. Once rusting starts, it continues unless measures are taken to remove the rust and a coating of paint is provided to prevent future corrosion. If left untreated rust jacking of the canon could lead to splitting of the concrete base and ultimately deterioration of the canon (Figure 15). While the siege mortar no longer has a functional use it is an integral component of the arsenal campus and should be conserved. The siege mortar should be securely mounted on a historically appropriate and designed base.
