Maine Forestry Best Management Practices Use and Effectiveness 2008

Department of Conservation
Maine Forest Service
22 State House Station
Augusta, Maine 04333
Forest Policy and Management Division

August 2009

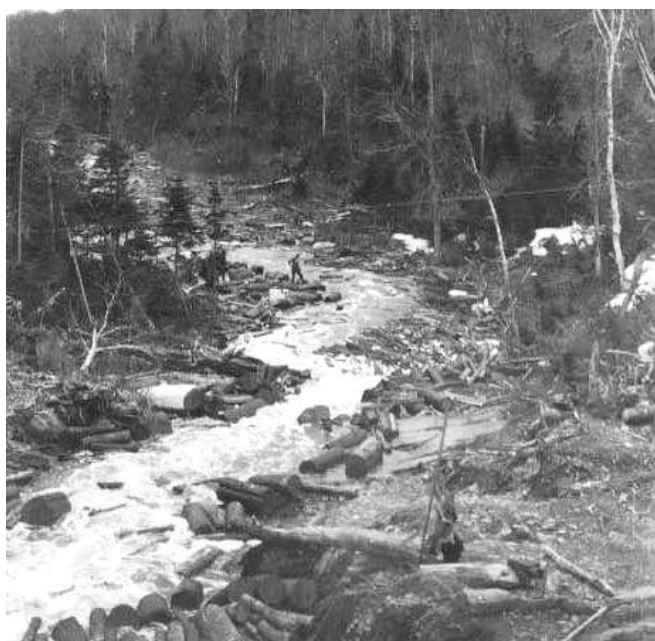
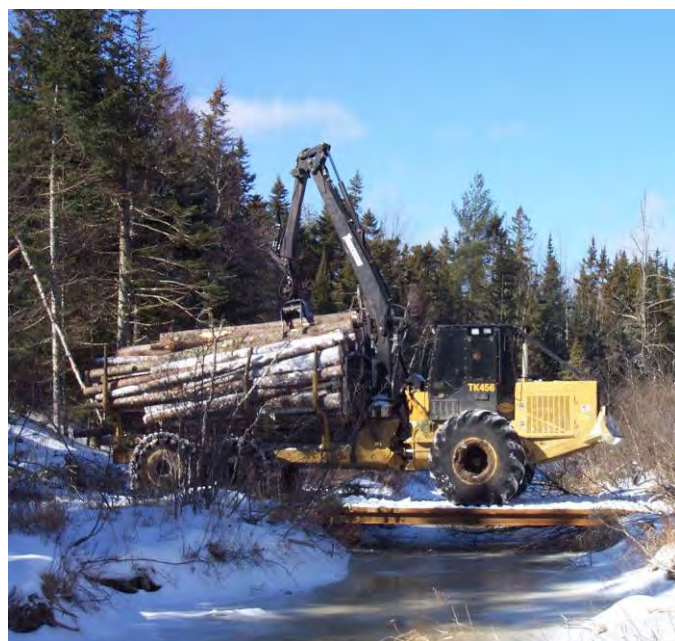
Then and now. As recently as the 1970’s little consideration was given to protecting water quality on timber harvests as the highly eroded banks in the log drive photo on the left illustrates. In contrast, today there is a general acceptance of BMPs by the forestry and logging professions. Sights like forwarders being used to minimize ground disturbance and temporary bridges to protect the integrity of stream channels indicate how far BMPs have come.

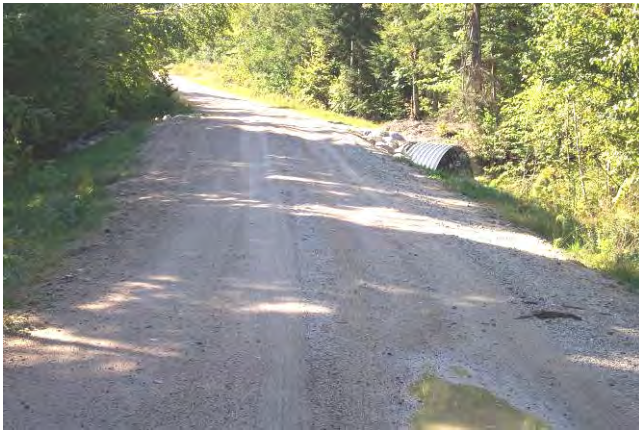
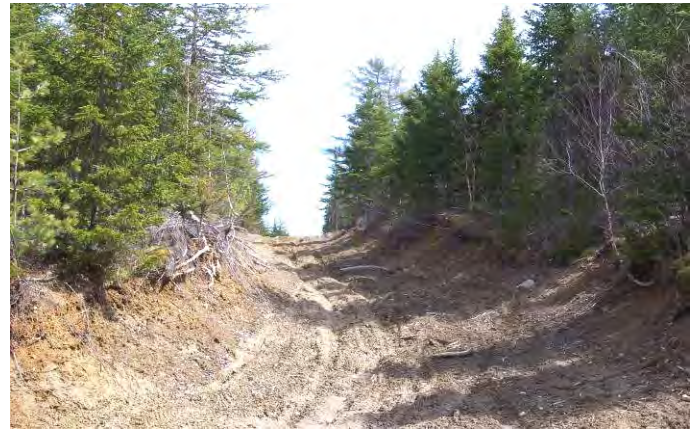
BMPs should extend uphill from the crossing to the point at which a break in the road grade directs water away from the crossing. The road on the left has well designed approaches that direct water into a vegetated filter strip before it reaches the stream. In contrast the road on the right has no place for the water to go before reaching the waterbody. Grading to maintain the road crown, ditch turnouts and vegetated filter strips are some of the BMPs used on approaches.

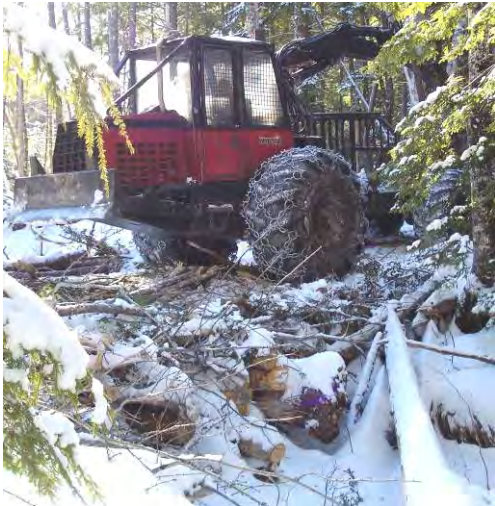
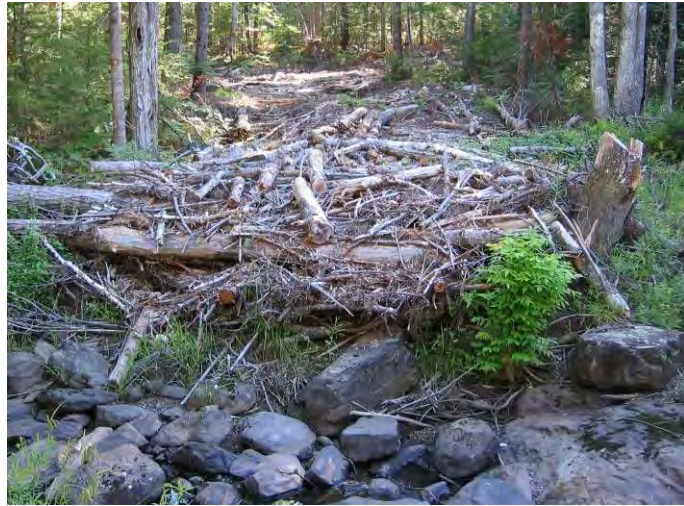
Well designed temporary crossings can be very cost effective and minimize disturbance to the waterbody. Pictured is the same crossing during use and after removal. Note that slash has been left on the approach to the crossing to stabilize any exposed soil. No sediment was deposited below the bankfull elevation of the channel.

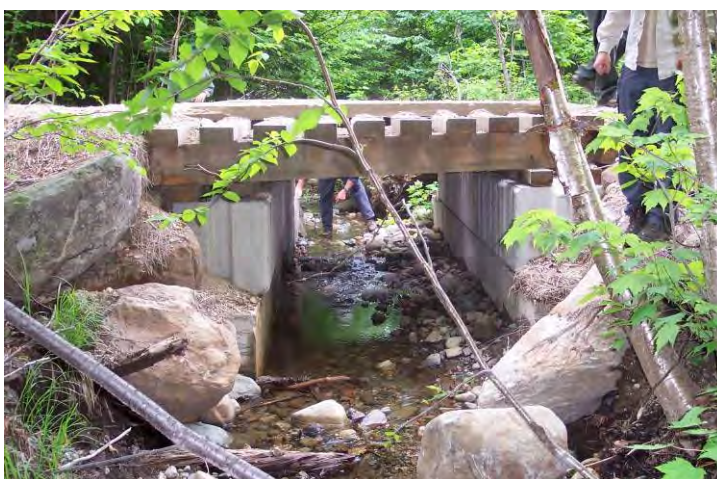
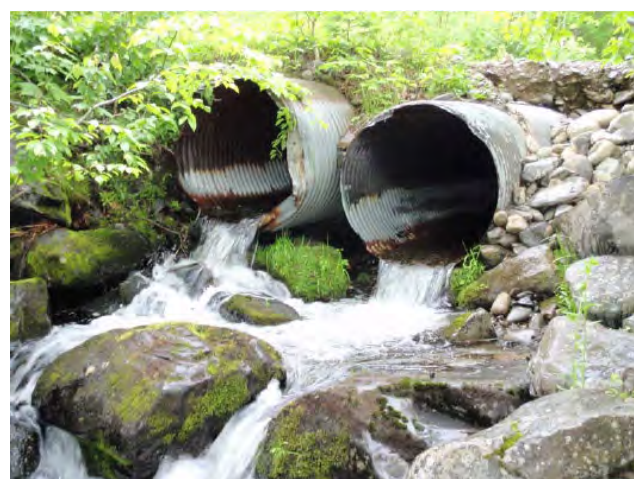
Crossing structures that are open to the natural stream bottom allow for fish passage. Closed bottom structures that do not span the stream channel or are improperly installed can become perched, making it difficult for fish to move upstream.
