Re: Review of Central Maine Power Company's Distribution System  
and Distribution Practices and Procedures

*Submitted to:*

*Maine Public Utilities Commission*

*February 26, 2007*

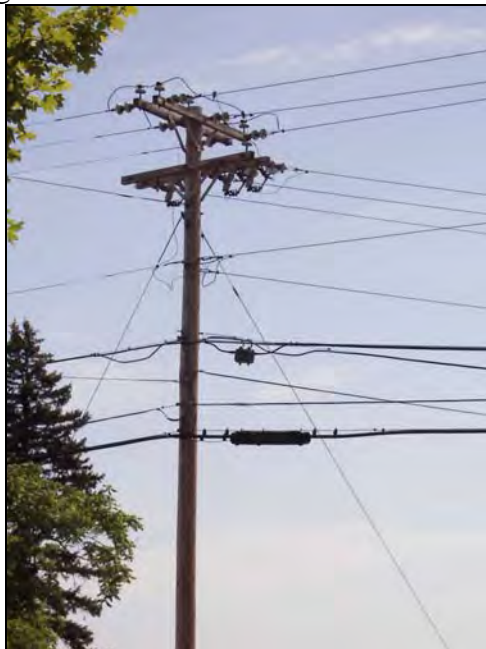
Typical 3-phase pole

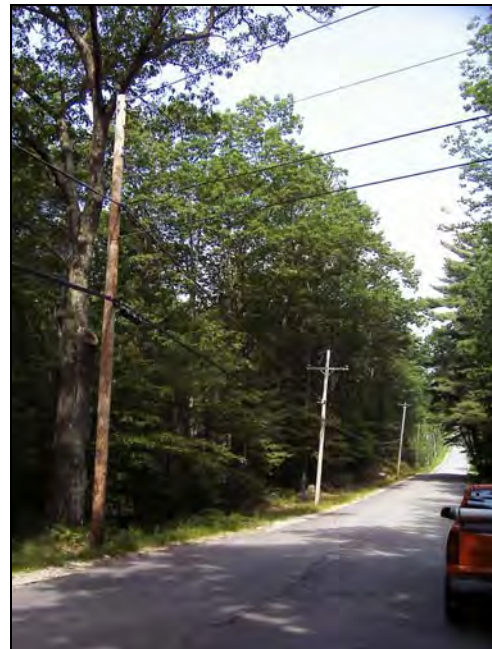
Typical 1-phase circuit

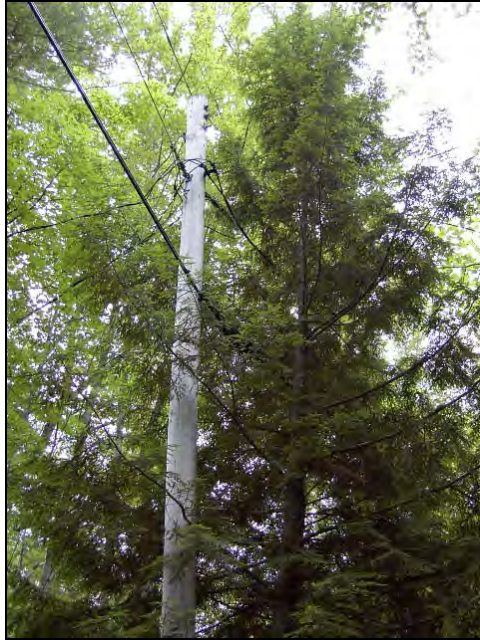
Heavy vegetation in contact with 1-phase circuit

Based on our physical inspection, before and after adjustment, between 12.7% and 19% of the circuits have vegetation in direct contact with the conductor posing an immediate risk of outages, potential fires, hazard to the general public, momentary interruptions, flickering lights, damage to customers' equipment, and increased recloser operations. This latter event would require CMP to inspect and/or replace reclosers more frequently. Another 15.8% to 23.8% of the circuits

- Modify the current reactive vegetation management program and provide sufficient budget funding to implement a proactive tree trim cycle of 4 to 5 years. In order to accomplish this, CMP should develop a formal estimate of annual costs to maintain a 4-5 year trim cycle as well as the additional up-front expenditures required to reach a 4-5 year cycle within a reasonable time frame. Environmental Consultants, Inc. offered similar recommendations in a 1988 report entitled “Distribution Line Clearance Program”, and Barakat & Chamberlin, Inc. in a 1990 report entitled “Assessment of Environmental and Other Impacts of Central Maine Power’s Line Clearance Program”. To maintain a 5-year trim cycle, CMP should increase its vegetation management budget to accommodate trimming 102,000 segments annually (CMP currently trims about 60,000 segments annually). CMP estimates that this will require an annual trim budget in the range of \$15 million (at current pricing), excluding storm budget. This is an increase of \$6 million over current spending. This spending level is based on today’s pricing as set forth in the current Lucas Tree contract and does not reflect any adjustments for contract price increases. Further, CMP should undertake to remediate clearances immediately where vegetation is in direct contact with conductor and within one year where it is within 3 feet of the conductor. As a more general observation, it is likely that what is important to customers is the performance of the system rather than any particular level of expenditures. This suggests that, should the Commission conclude that some metric for performance is warranted here, an outcome based measure (such as a SAIFI or CAIDI) rather than an expenditure target, should be preferred.

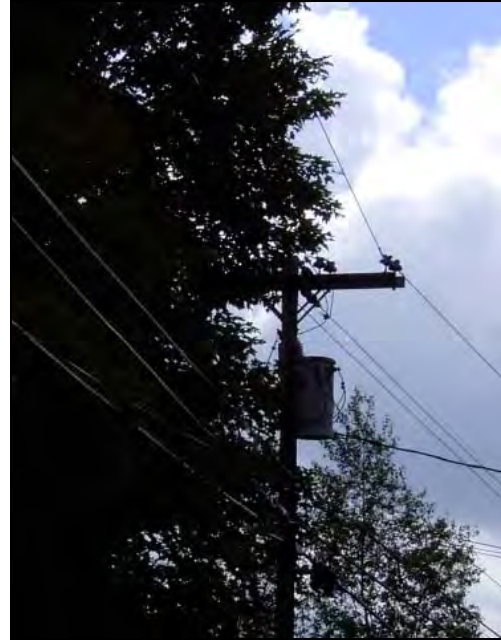
Heavy vegetation in contact with 3-phase circuit
