**1989 ANNUAL REPORT**

**OFFICE OF NUCLEAR SAFETY**

**State Nuclear Safety Inspector  
Department of Human Services  
Division of Health Engineering**

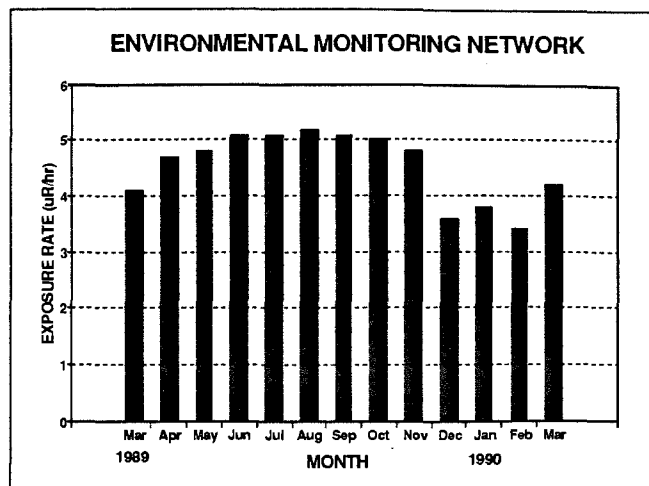
**Figure 2** Monthly average exposure rate for all 17 environmental monitors.

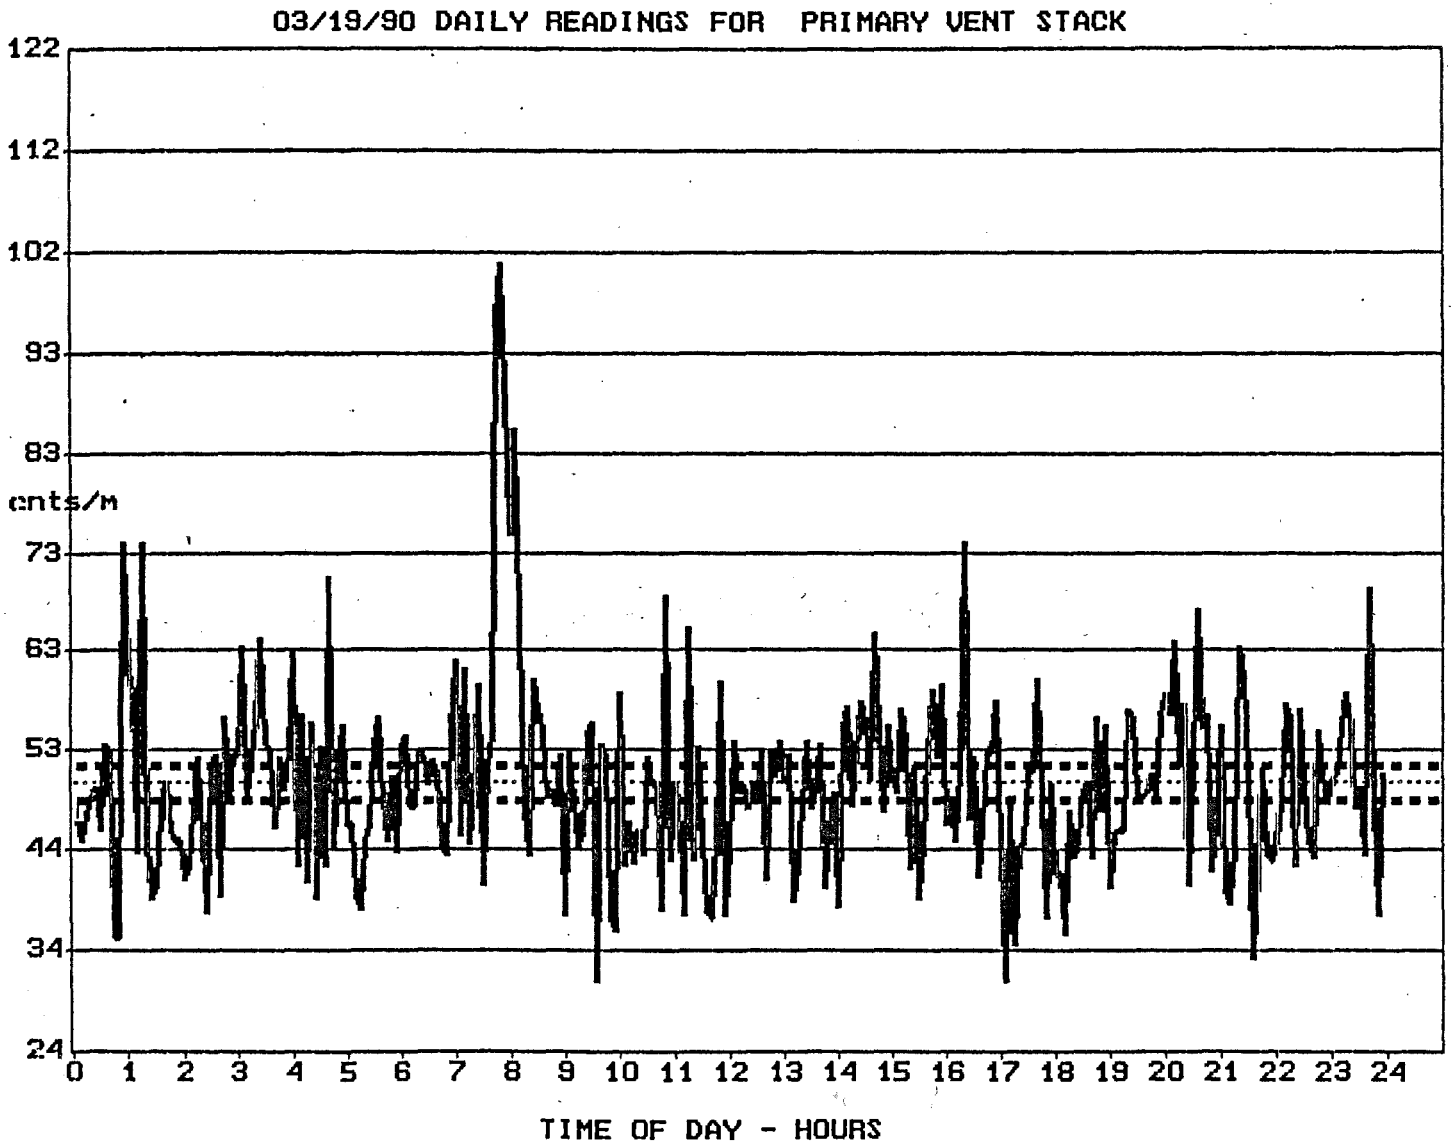
FIGURE 4

longer than allowed and observed the containment purge during the last RCP seal shutdown. Figure 4 illustrates a typical daily spectrum on the primary vent stack (PVS) with a reactor coolant sample being taken at about 8:00 A.M. At the present, based on preliminary evaluations, we cannot see any affect from the PVS effluents on the State's environmental monitors.
