MAINE STATE HOUSE & GROUNDS

Multi-Year Plan For Maintenance & Improvements 2013 Revision

Prepared by:
Richard Burt, AIA
Leo A. Daly
Minneapolis, MN.

March 2013

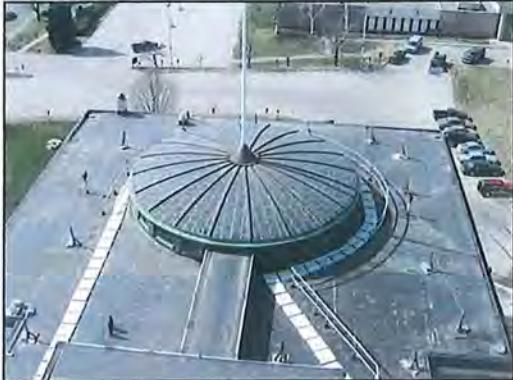
Annual
A.1

Due to a variety of roof forms, the State House is protected by two types of roofing, i.e., copper at the high and two low domes and east/west sloped roofs, and EPDM at the north/south low pitched roofs. The existing roofing on the entire west wing and east porch roofs was removed, and copper roofing was installed in 2004 and 2005.

This project involves the regular review and maintenance of all roofing systems. A yearly review of all roofing areas will be completed by a qualified independent roofing consultant. Areas requiring maintenance will be identified and assessments made whether required repairs are covered under roofing warranties. Repairs will be completed by a roofing subcontractor.

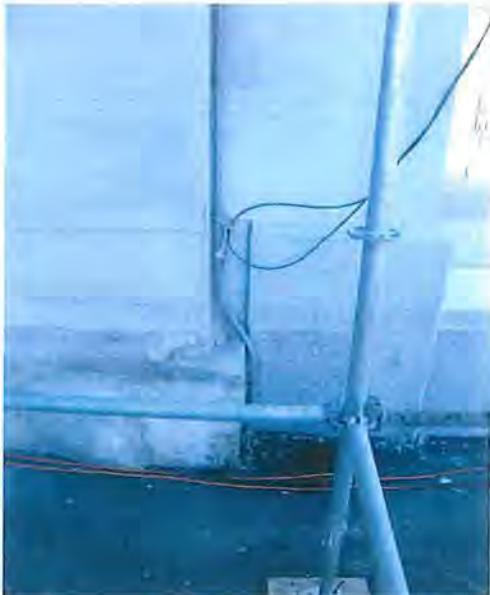
The summer of 2004 marked the end of a three year phased restoration of the State House exterior granite walls. This was the first full scale granite inspection, restoration, and repointing campaign undertaken in over 50 years. The project scope included selected stone repairs and/or replacement and the repointing (existing mortar removal and replacement) of every mortar joint on the building.

While the exterior walls of the State House appear robust and fully capable of standing the test of time, the original Hallowell granite is actually relatively soft and is subject to weathering deterioration. The mortar used at the joints between stones is likewise subject to weathering failure once the mortar has aged and cracked.

This project will provide for the first annual inspection of the exterior granite walls and the repair of any stone damage or loose/cracked mortar. Work will be inspected by ground observation and repairs made via on site crane access.

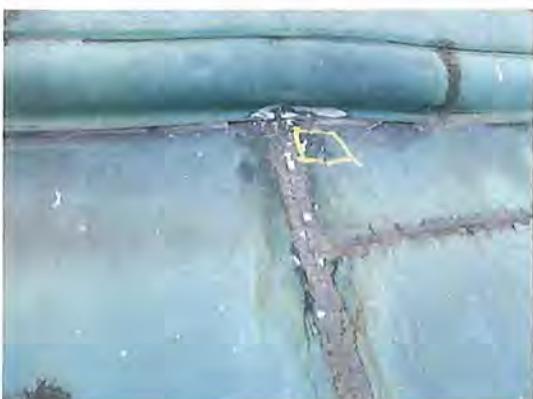
Open Holes at Copper At Upper Dome

In 1907 the Legislature voted to renovate and expand the then 75 year old State House, a structure that had served the people of Maine as its capitol since its original construction in 1832. A singular landmark element of this expansion was the new 180 foot high dome. Conceived as the symbol of the new State House and visible for miles around, the dome was sheathed in long lasting copper both for its durability and its historic reputation as a material of integrity and significance. Today, the copper on the dome is over 100 years old and has exceeded its 75 year life expectancy assisted by an ongoing inspection and maintenance program first initiated in 2002. To date, this program has successfully and continually repaired seams, replaced rivets, and addressed selected minor panel replacement. Despite these efforts, continuous weathering has steadily worn and reduced the thickness of the copper itself to the point where holes ranging from pinholes to the size of dimes are rapidly appearing in open panel areas. In short, the overall integrity of the copper is increasingly compromised with the result that the waterproof integrity of the dome is no longer possible to maintain through mechanical repairs alone.

Today, the copper on the dome is over 100 years old and has exceeded its 75 year life expectancy. Since 2002 an inspection and maintenance program has successfully and continually repaired seams, replaced rivets, and addressed selected minor panel replacement. However, continuous weathering has steadily worn and reduced the thickness of the copper itself to the point where holes ranging from pinholes to the size of dimes are rapidly appearing in open panel areas. As a result, the overall integrity of the copper is increasingly compromised and the waterproof integrity of the dome is no longer possible to maintain through mechanical repairs alone.

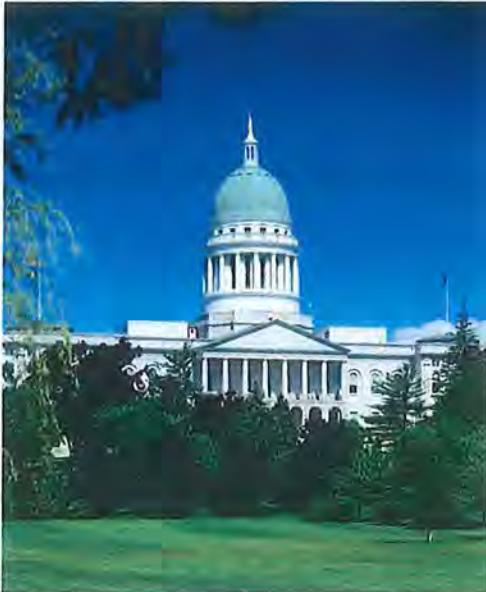
The low rooftop mounted rectangular structures visible immediately north and south of the main dome are mechanical equipment penthouses housing much of the major mechanical equipment serving the State House. A major goal of the 1998-2001 State House wide renovation was the improvement of ventilation and air conditioning systems serving the building. At that time, ventilation was insufficient to adequately serve major portions of the building and air conditioning was non-existent. Because the space demands required to install a new state of the art mechanical system could not itself be fully accommodated within the historic building structure, the majority of the major equipment was located in these rooftop penthouses.

Over the last number of years, substantial leaking has developed around the penthouses, resulting in damage to portions of the State House fourth floor. Numerous water tests and maintenance efforts have been attempted. The source of the leaks has been confirmed as metal panel related, but only short-term corrections have been possible. This project will replace the existing metal panels with metal panels of improved quality to assure no further water infiltration will take place at these highly exposed locations. As a benefit of this necessary panel replacement project, a design study will be completed to determine if the number of equipment access doors can be reduced and if a better panel color match to the building granite can be provided, thus further minimizing the visual appearance of these features when viewed against the sky alongside the State House dome.
