# Maine's Beaches and Dunes and their Changes through Time

Presentation to the Maine Legislature

Joint Standing Committee on

March 25, 2003

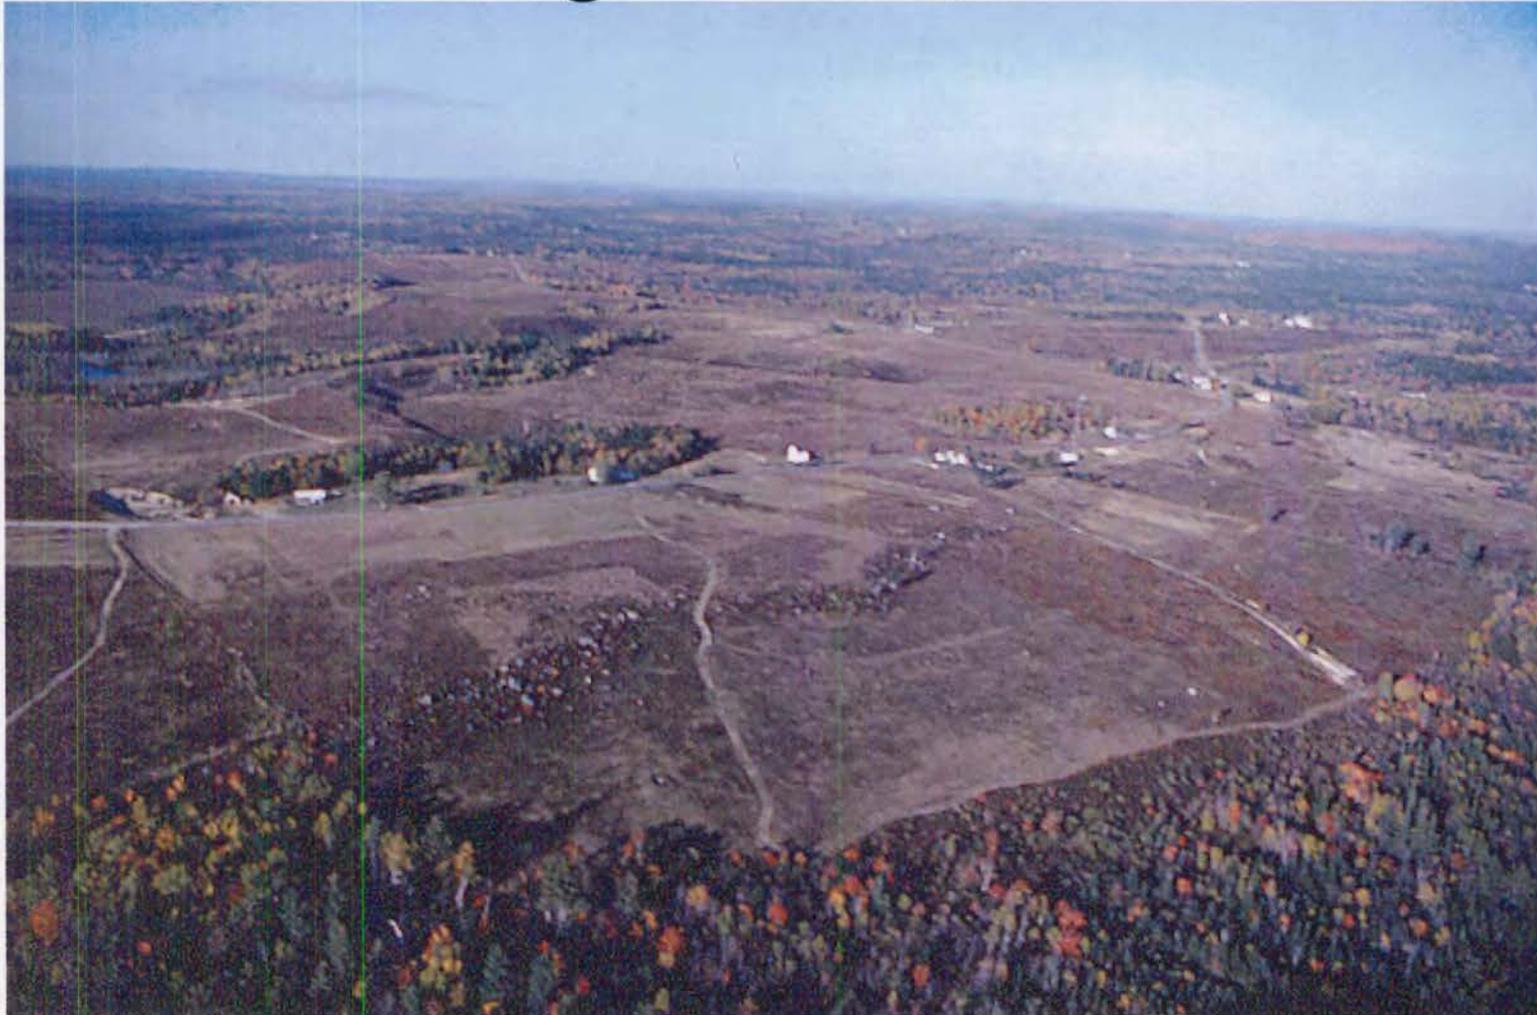
# Pineo Ridge Delta, Columbia

Aerial view of a sand and gravel delta in Washington County. The delta formed in the the ocean at a high stand of sea level as glaciers left Maine. MGS File Photo.

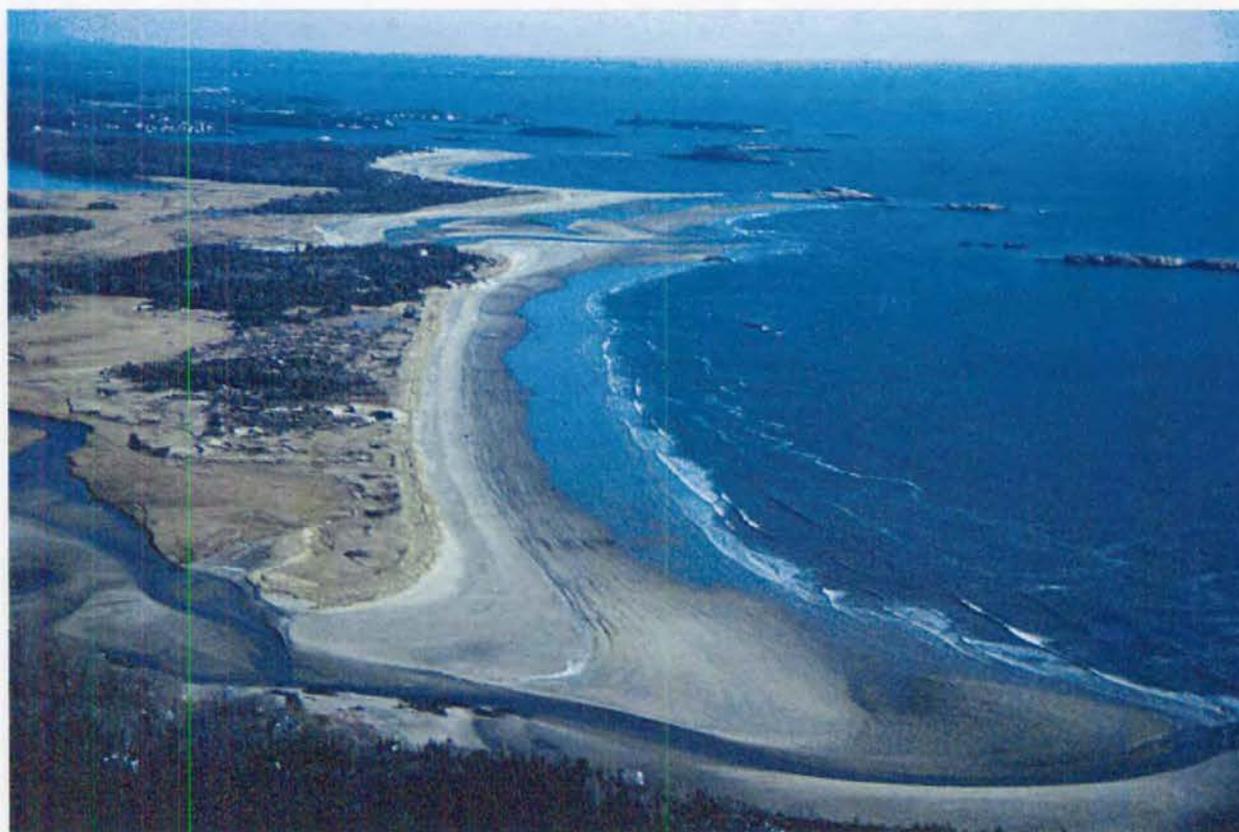
# Maine's Coastal Sand Dune System

Coastal sand dunes are variable in size along the coast. The frontal dune is generally 125 to 150 feet in width (shore perpendicular) while back dune width varies. MGS has mapped about 2000 acres of large dune systems along about 30 miles of the Maine coast. About 1/3 of the dune acreage is frontal dune; 2/3 is back dunes. MGS File Photo of Seawall Beach by S. M. Dickson, 2002.

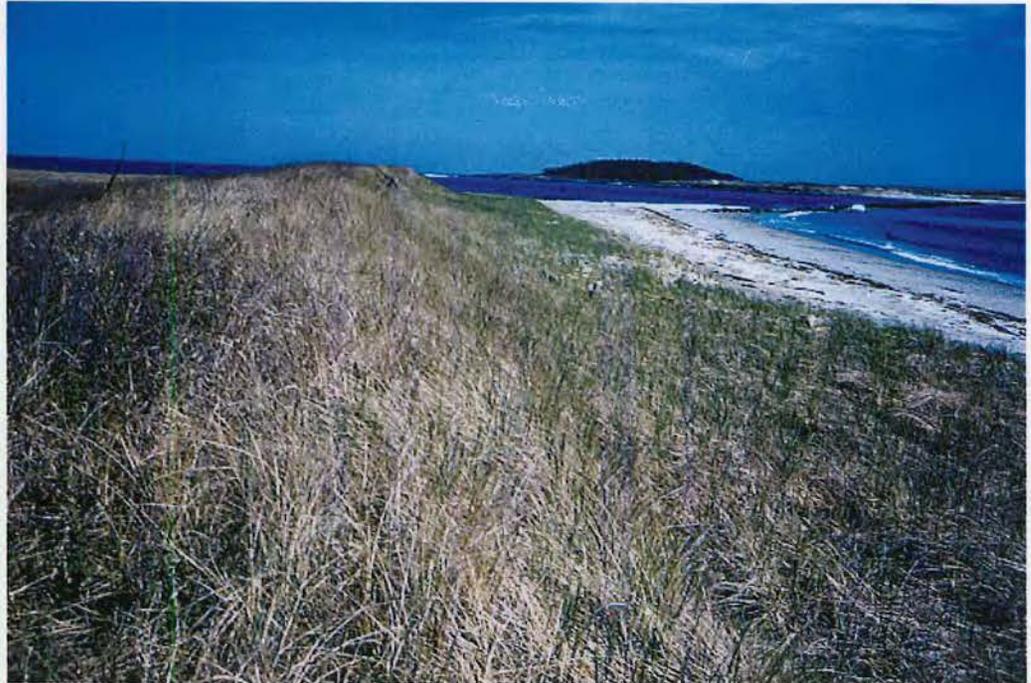
# Frontal Dune Processes

Frontal dune ridge in Cape Elizabeth. About half of the ridge was eroded and subsequently rebuilt with American beach grass and sand. MGS File Photo by S. M. Dickson, 1986.

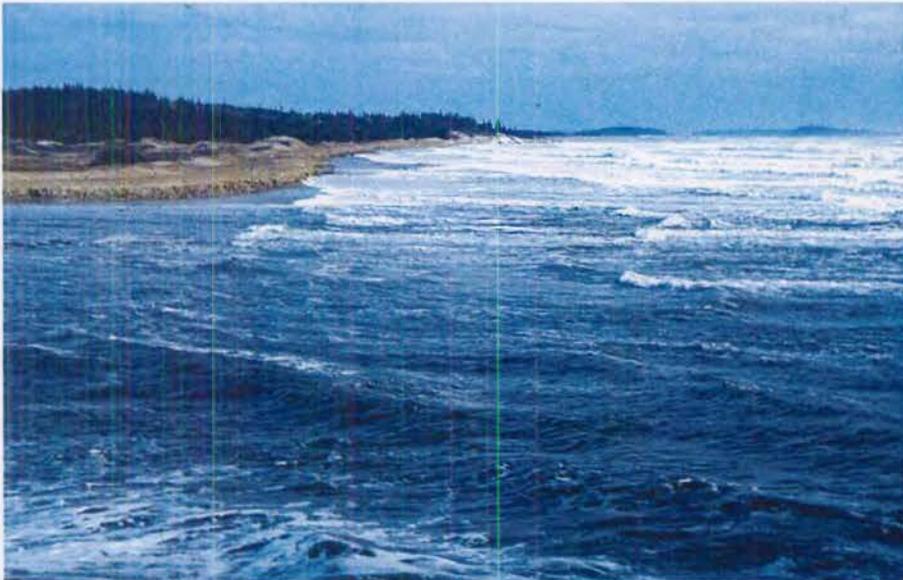
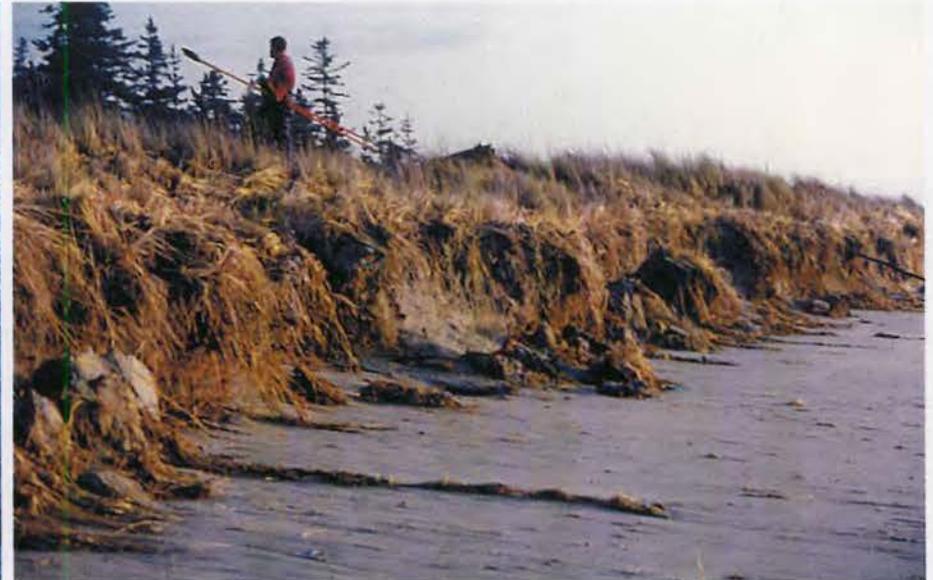
# Dune Scarp Formation

A 4-day northeaster in December 1992 resulted in a coastal storm surge (left) of less than 2 feet produced an erosional cut in the dunes. Northeasters commonly produce frontal dune erosion and scarp formation (right). Dune scarps from major storms can take years to return to the pre-storm condition. MGS File Photo by S. M. Dickson, 12/13/1992 (left) and 1/24/1992 (right)

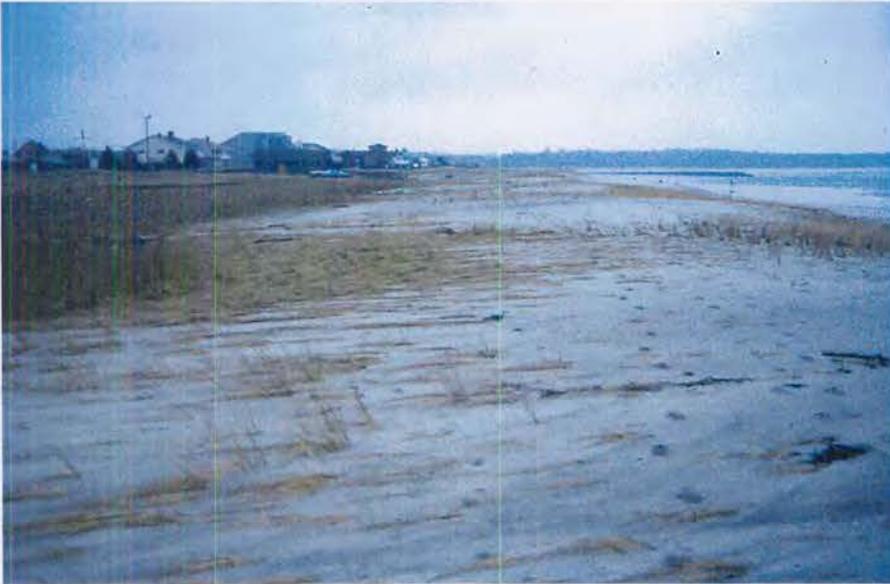
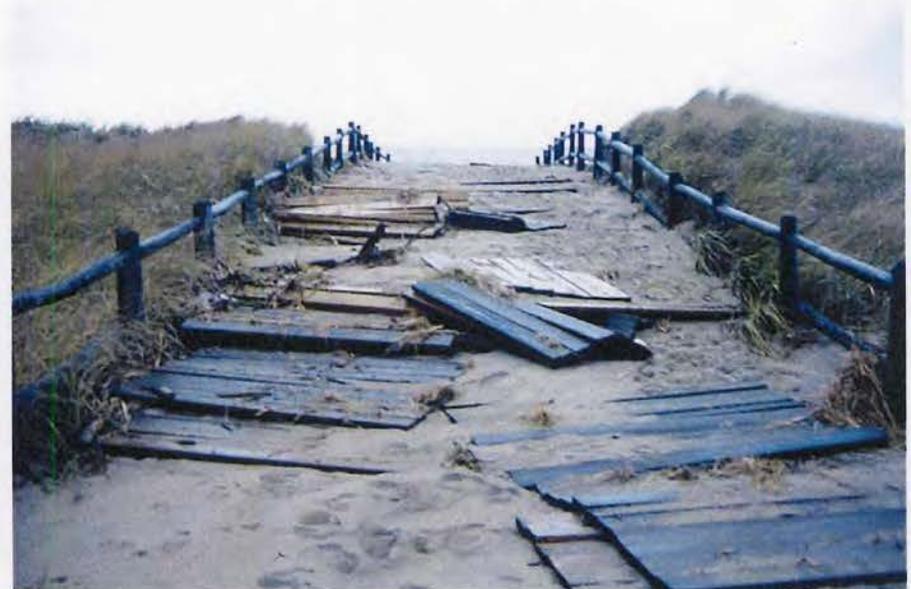
# Frontal Dune Overwash

The frontal dune ridge is built primarily from wave action. In storms, waves deposit sand on the crest of the dune ridge. Most frontal dune ridges are built by the process of overwash to the elevation of active wave run-up and sand transport in a 100-year storm. Lesser storms add sand to low dune areas where wind and foot traffic have lowered the ground elevation. American beach grass grows through the new sand and helps hold it in place. MGS File Photos of Pine Point in Scarborough (left) and Ferry Beach State Park, Saco (right) by S. M. Dickson, 1991.

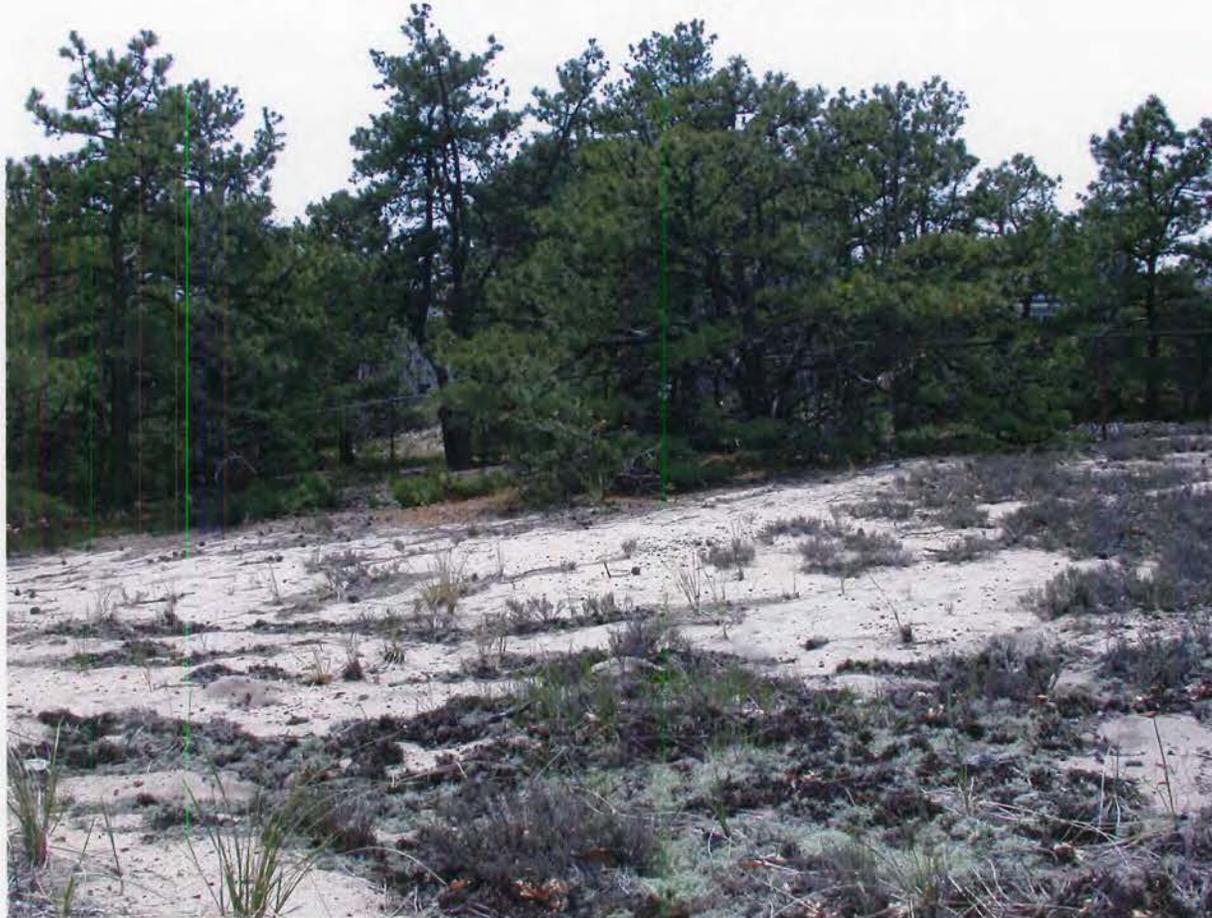
# Back Dune, Saco

The back dune environment has low-relief dunes with patchy vegetation and wind-blown sand. Some back dunes have a pitch pine forest. About one-third of the back dunes are in the 100-year floodplain. MGS File Photo by S. M. Dickson, 2002.

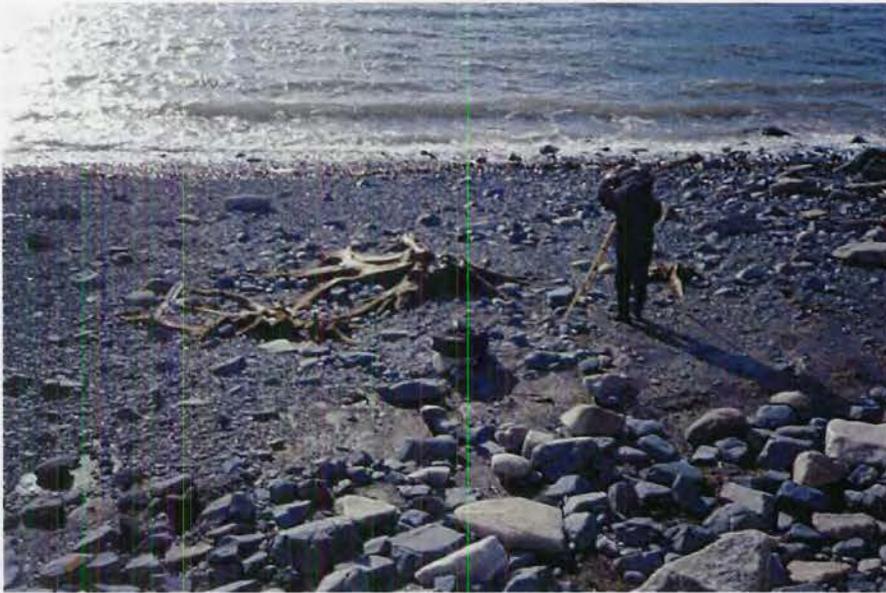
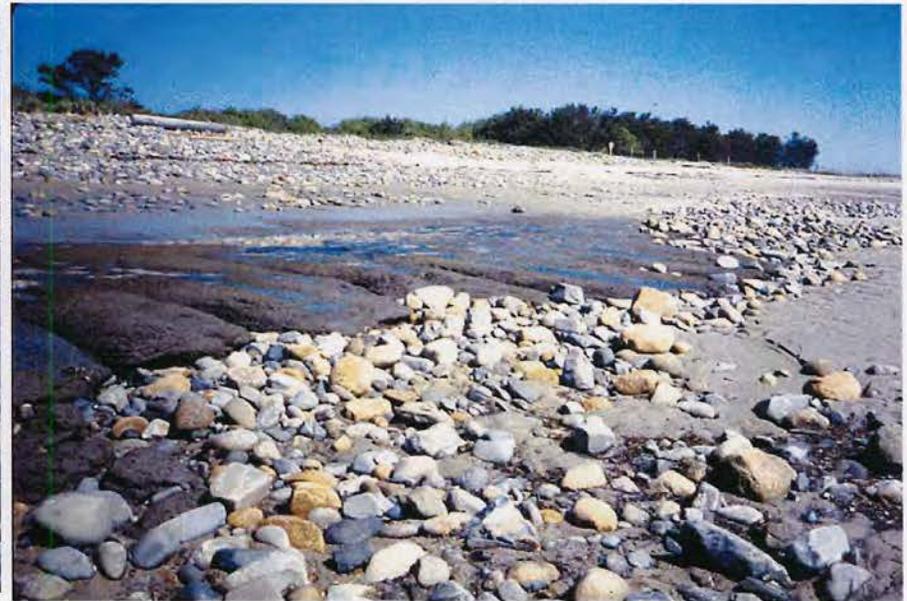
# Signs of Dune Migration

Tree stumps (in situ) on a beach in Kennebunk were drowned by the rising sea (left). Salt marsh peat from the back barrier marsh is exposed on Laudholm Beach in Wells (right). In both locations, the barrier beach and dunes have migrated inland over forest and marsh environments due to sea-level rise of about 6 feet in the last 3,000 years. MGS File Photos by S. M. Dickson.

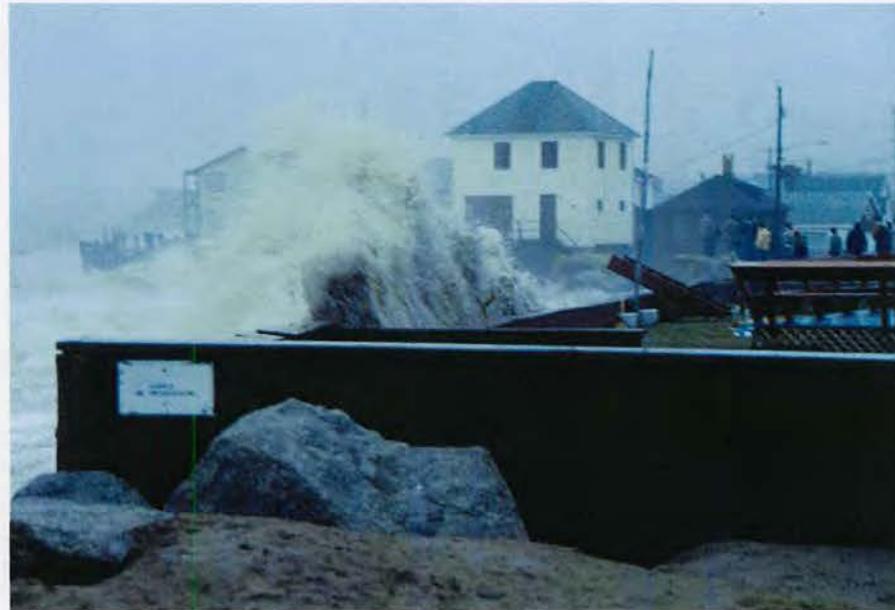
# Seawalls and Wave Reflection

Seawalls result in wave reflection that causes enhanced beach scour in front of the wall. Over time the beach will lower and expose more of the wall. Continued erosion in front of the wall leads to a narrower beach and the need to reinforce or enlarge the wall to increase its resistance to wave action. MGS File Photos (Goose Rocks Beach, Kennebunk, 1990 (left) and Saco, 1986) by S. M. Dickson.

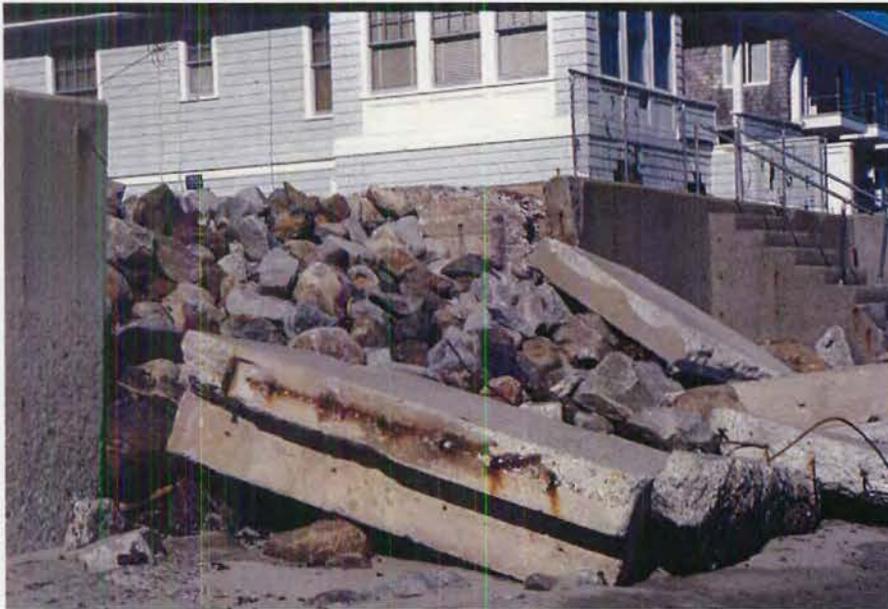
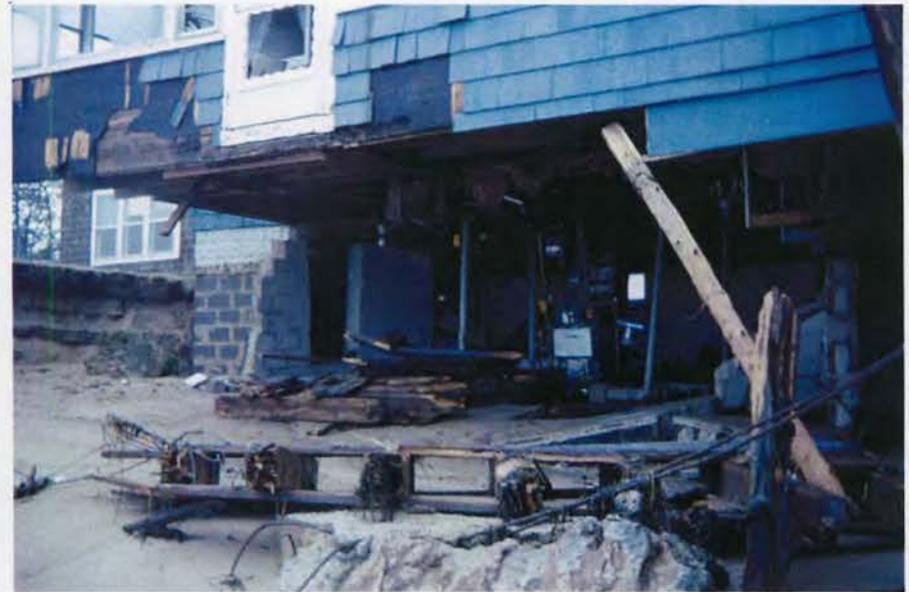
# Seawall Damage

Seawall failure results in rapid release of dune sand and fill from behind the wall. Foundations can be undermined before a storm ends and result in structural damage behind seawalls. MGS File Photos (Wells, 1987 and Saco, 1991) by S. M. Dickson.

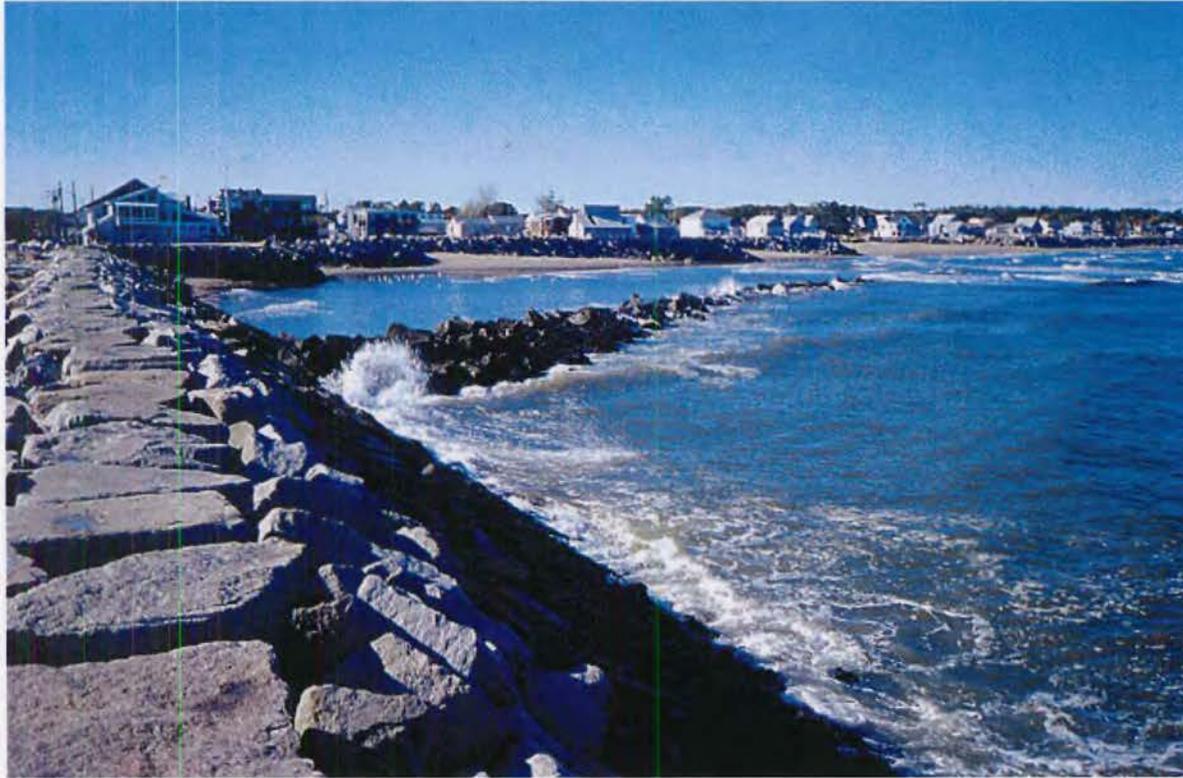
# North Jetty and Breakwater, Saco

Coastal engineering at tidal inlets alter the natural movement of sand. In Saco, the jetty prevents Saco River sand from reaching the beach and wave reflection causes accelerated beach erosion and longshore drift. There are other federal jetties in Wells, Kennebunk, and Scarborough adjacent to beaches. MGS File Photo by S. M. Dickson, 2002.

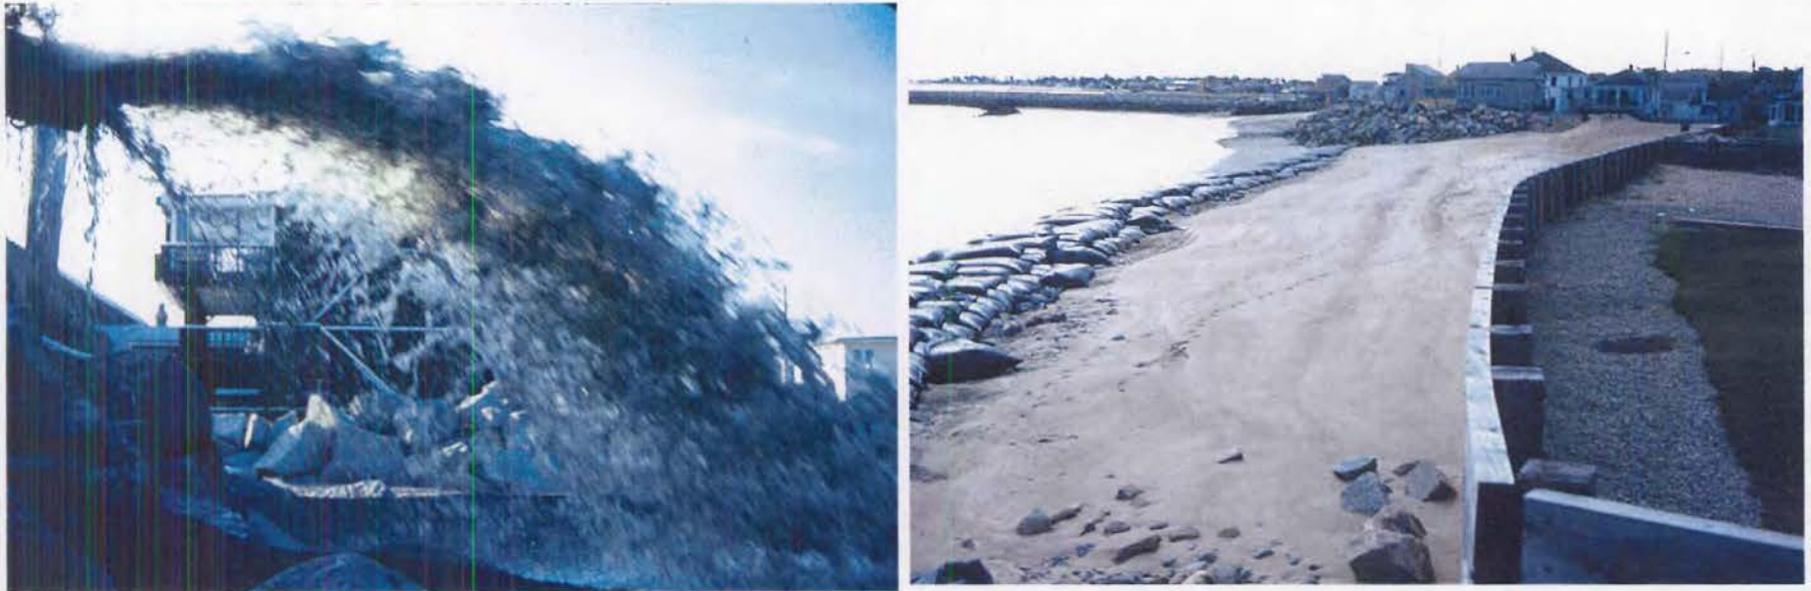
# Beach Nourishment and Sand Bags

Sand pumped onto the beach and placed in bags on the beach

Beach nourishment places additional sand on the beach profile to reduce the sand deficit. Sand bags were placed on the beach to attempt to slow the erosion rate in Saco. MGS File Photos by S. M. Dickson, 1992 left and J. T. Kelley, 1992, right.

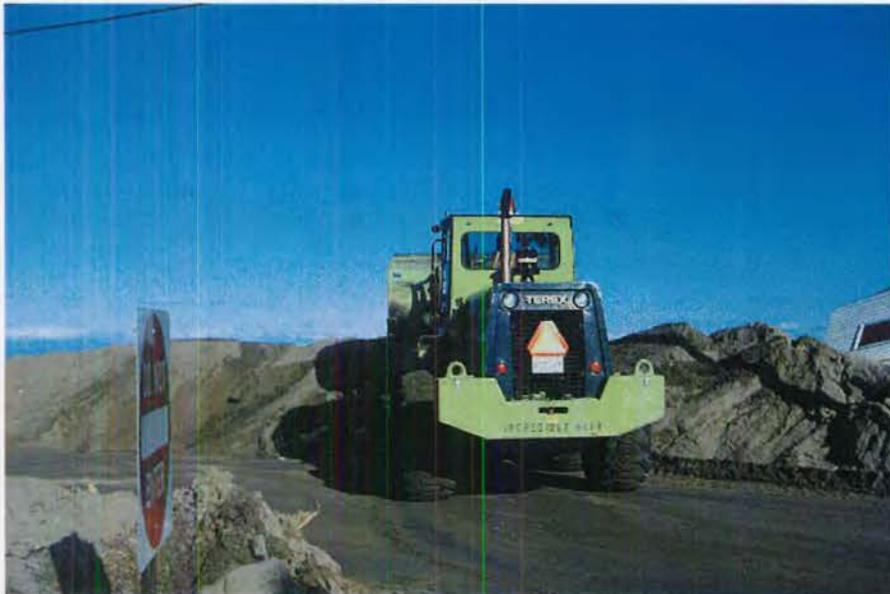
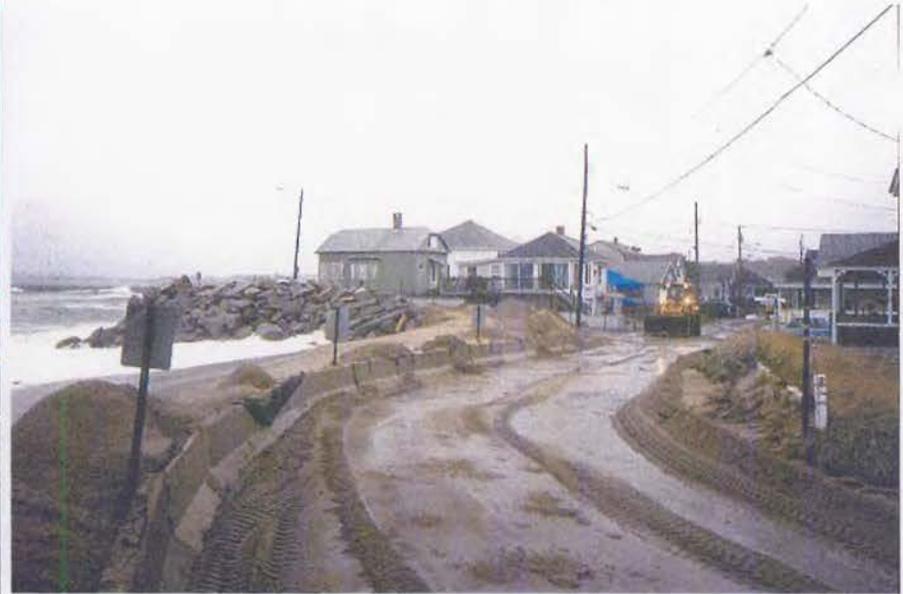
# Sand Movement

Overwash sand replaced on the beach by Saco Public Works

Storms repeatedly wash sand from the beach into the dune (road) at the intersection of North and Main Streets in Saco. The City of Saco regularly returns the sand to the beach. MGS File Photos by S. M. Dickson, 1990 left and P. A. Slovinsky, 2002, right.

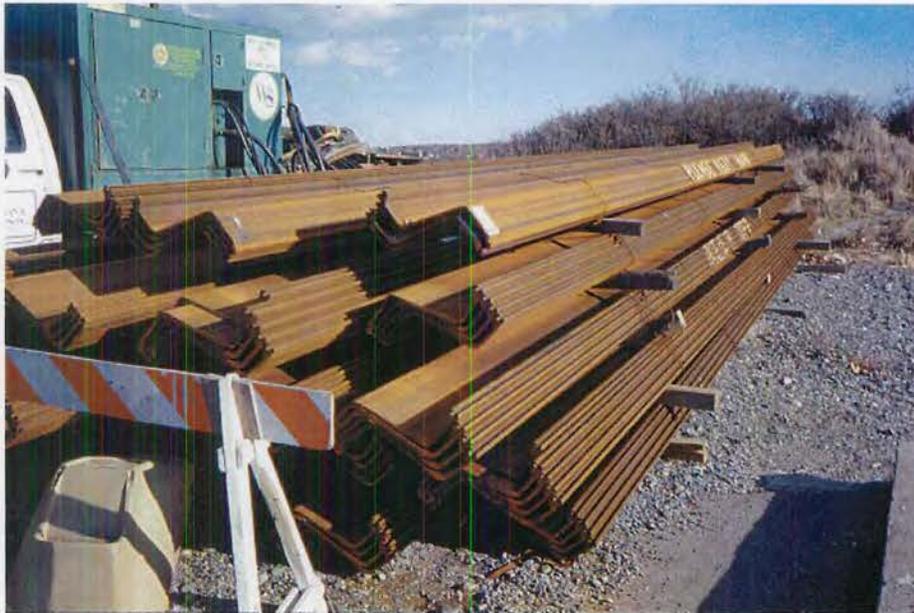
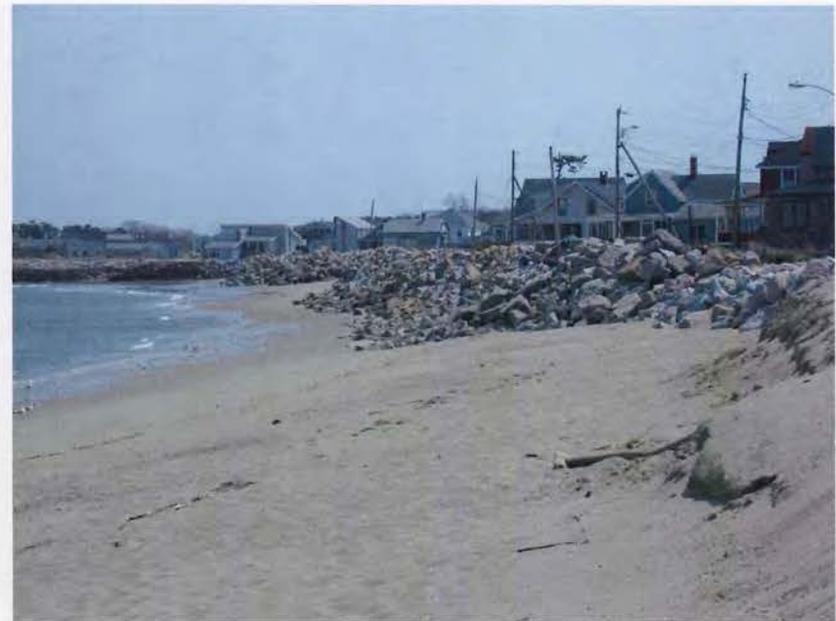
# Fortification of Seawalls

## Seawall reinforcement and expansion

Sheet pile for reinforcement of seawalls along Beach Avenue in Kennebunk. Riprap in Saco slumps on the beach over the upper part of the beach profile. MGS File Photos by S. M. Dickson, 1999, left and 2002, right.

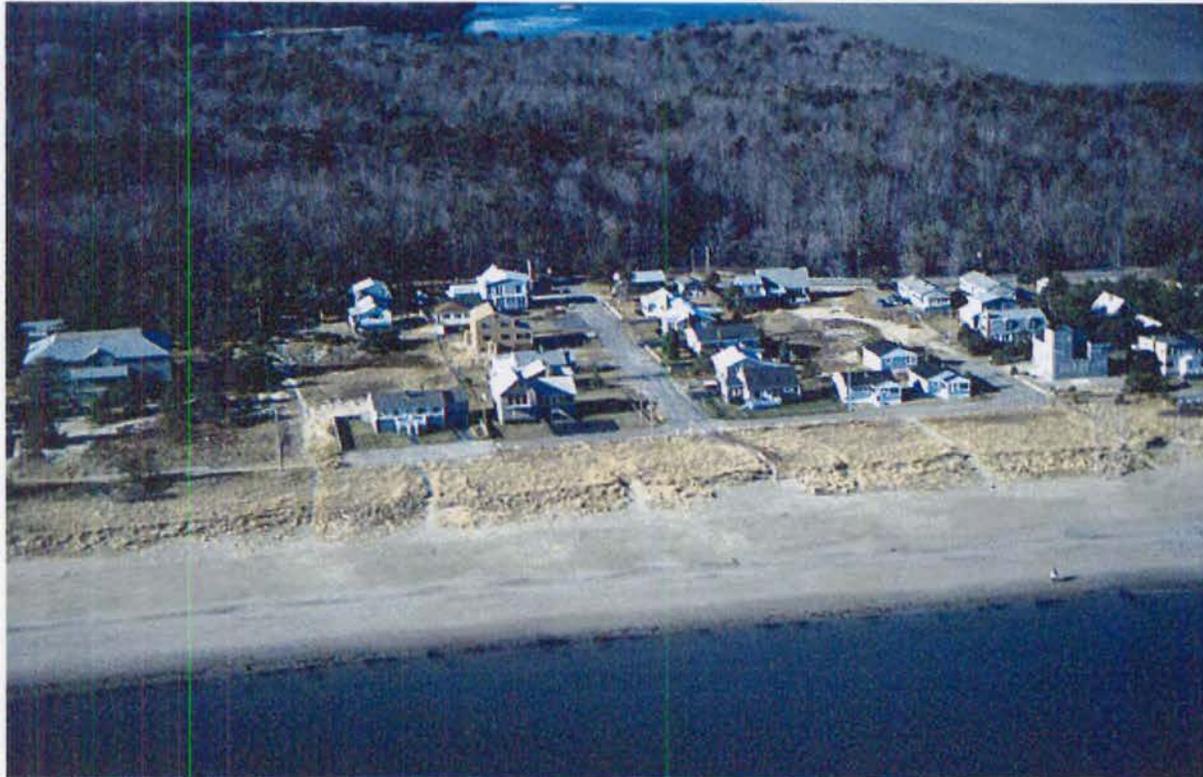
# Old Orchard Beach

Development located landward of a natural frontal dune ridge

Ideal dune development is in the back dunes behind a wide frontal dune ridge.  
MGS File Photo by S. M. Dickson, 1986.

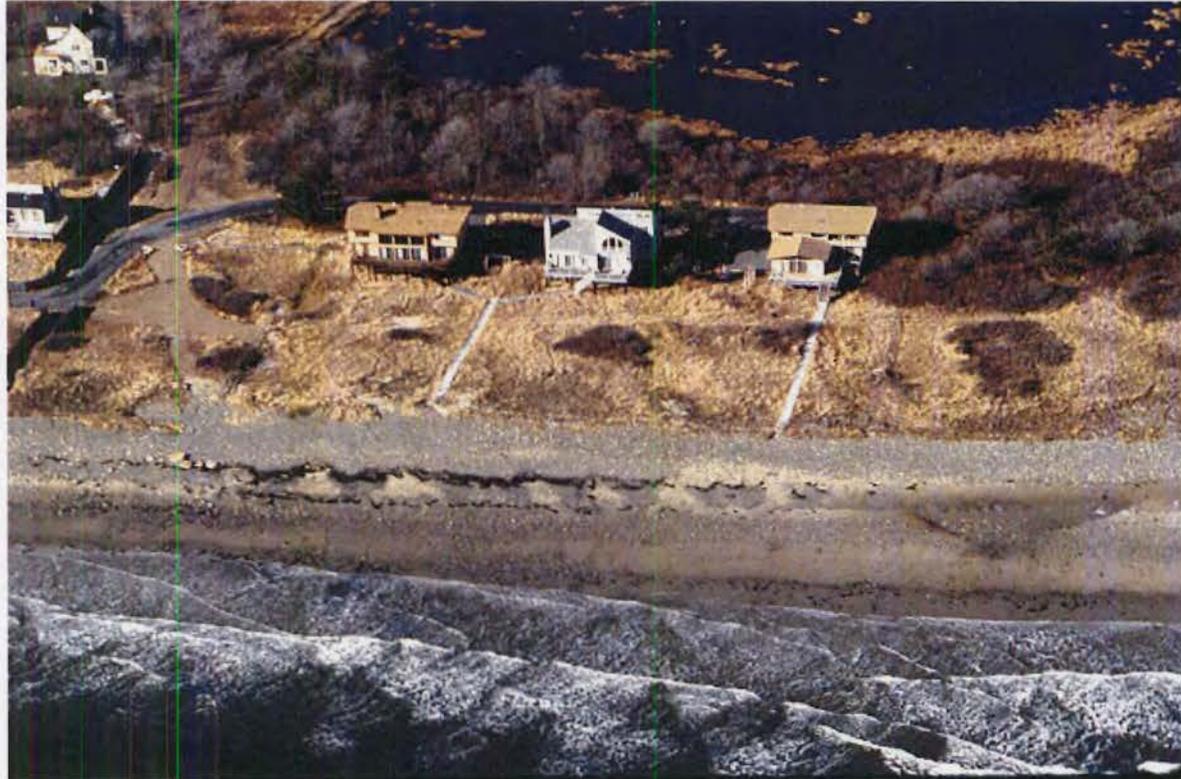
# Laudholm Beach, Wells

Development located landward of a natural frontal dune ridge

Back dune development behind a wide frontal dune ridge and elevated on posts in Wells. MGS File Photo by S. M. Dickson, 1986.

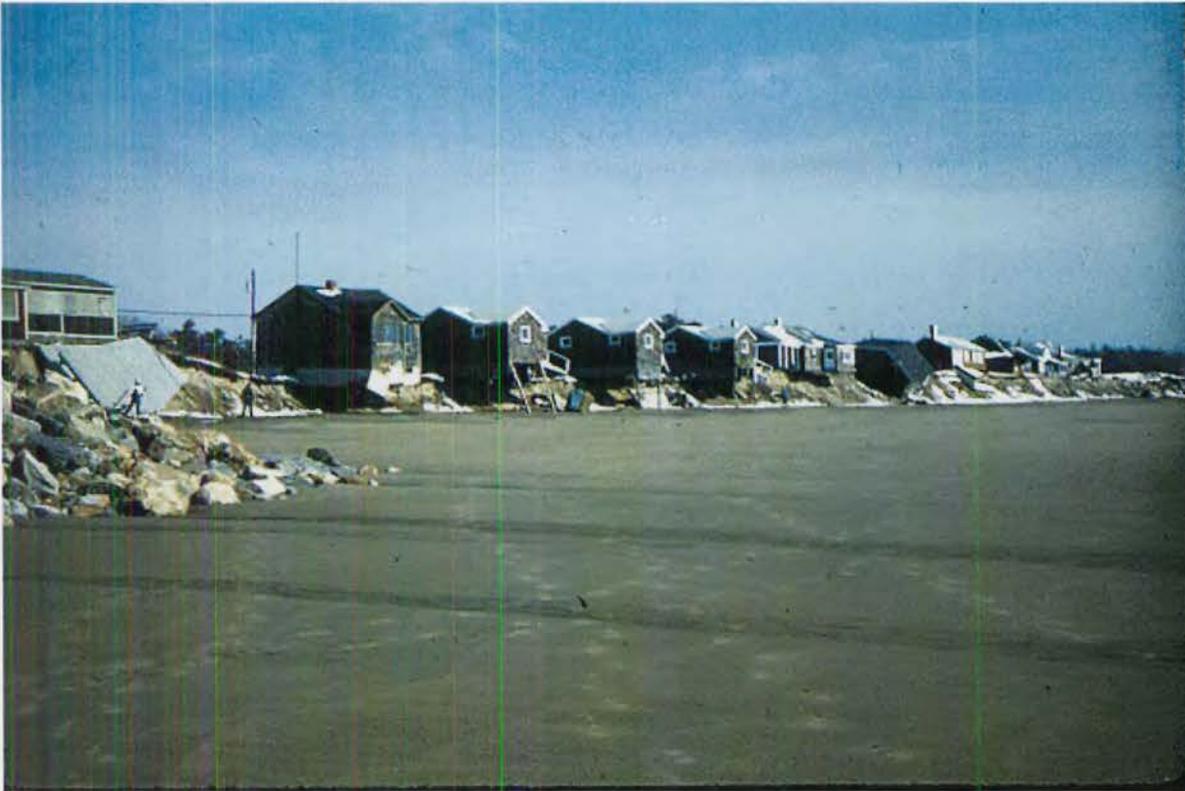
# Popham Beach Property Damage

Erosion undermines homes at Hunnewell Beach, Phippsburg

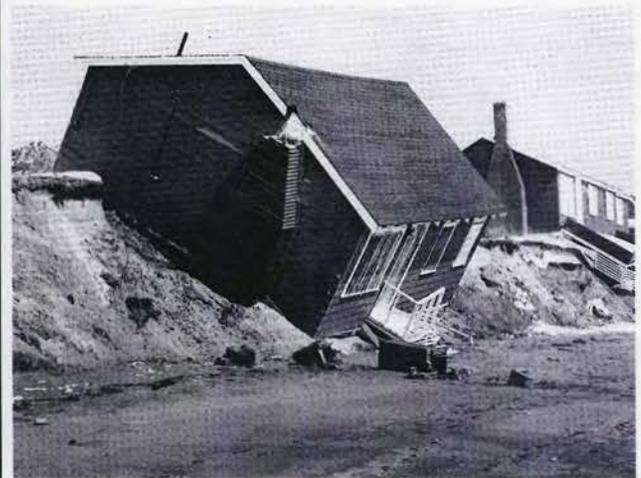
1976 beach erosion at  
Hunnewell Beach,  
Phippsubrg

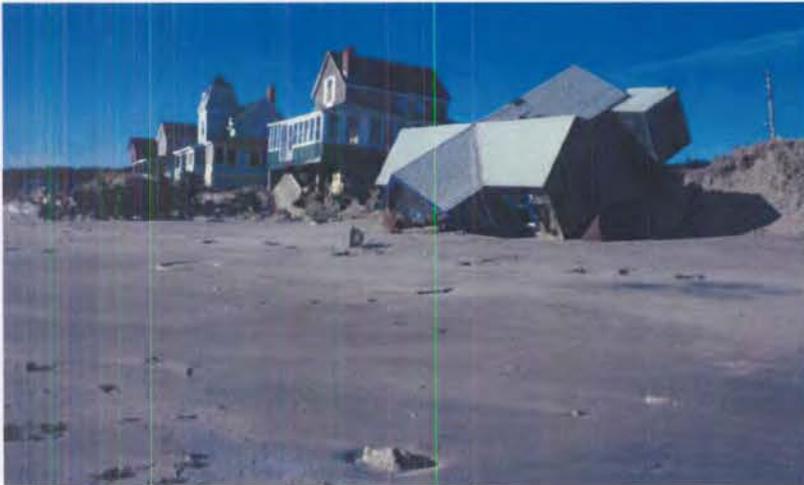
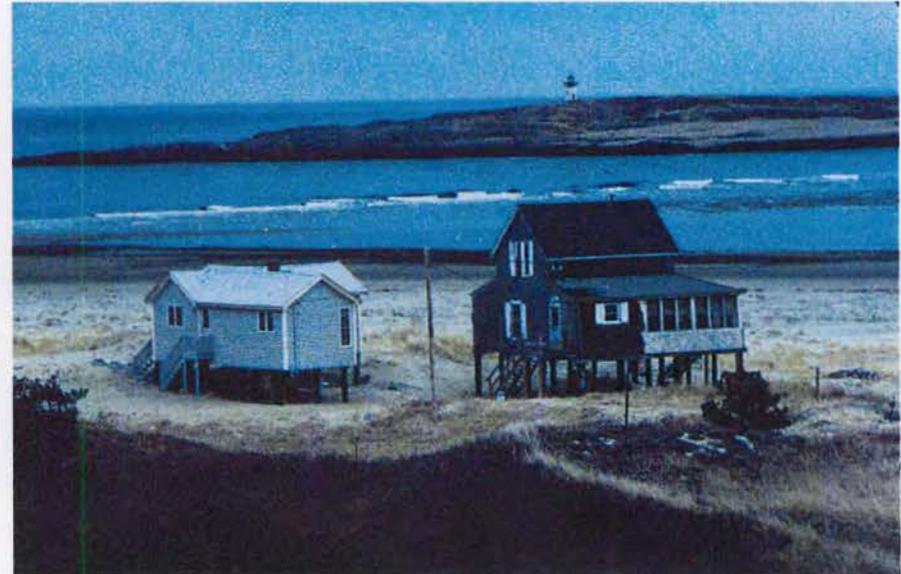
# Popham Beach, Phippsburg

Undermined and threatened by erosion, 2 homes retreat and elevate

A damaged home at Hunnewell Beach in Phippsburg (left) and the neighboring home were moved landward and raised on posts after erosion in 1983. MGS File Photos by J. T. Kelley, left, 1983 and by S. M. Dickson, right, 1989.

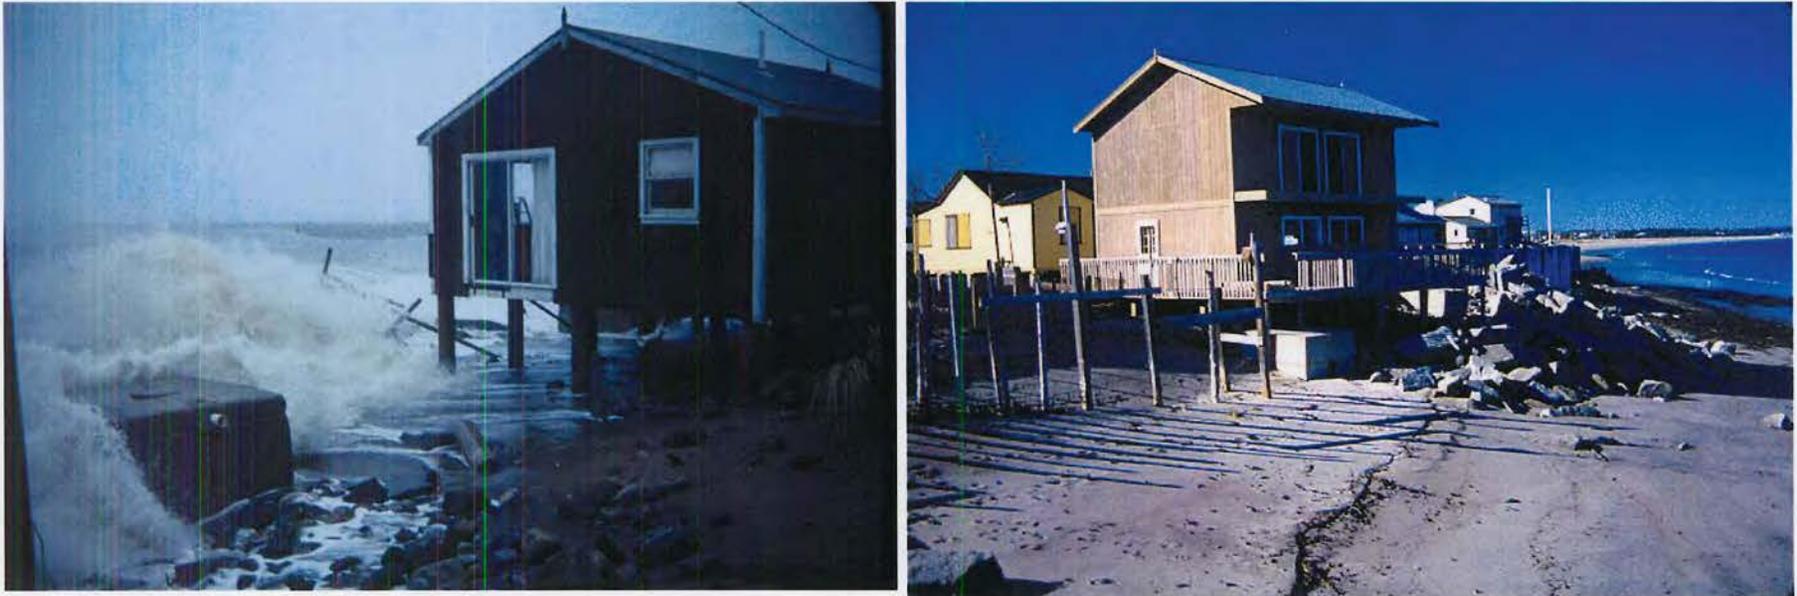
# Camp Ellis, Saco

Erosion undermines a home at Camp Ellis Beach prior to collapse

Despite the threat of imminent collapse and a long-term erosion rate of 2 to 3 feet per year, this Saco property was enlarged prior to being destroyed in 1991. MGS File Photos by S. M. Dickson, left 1986 and right, 1990.

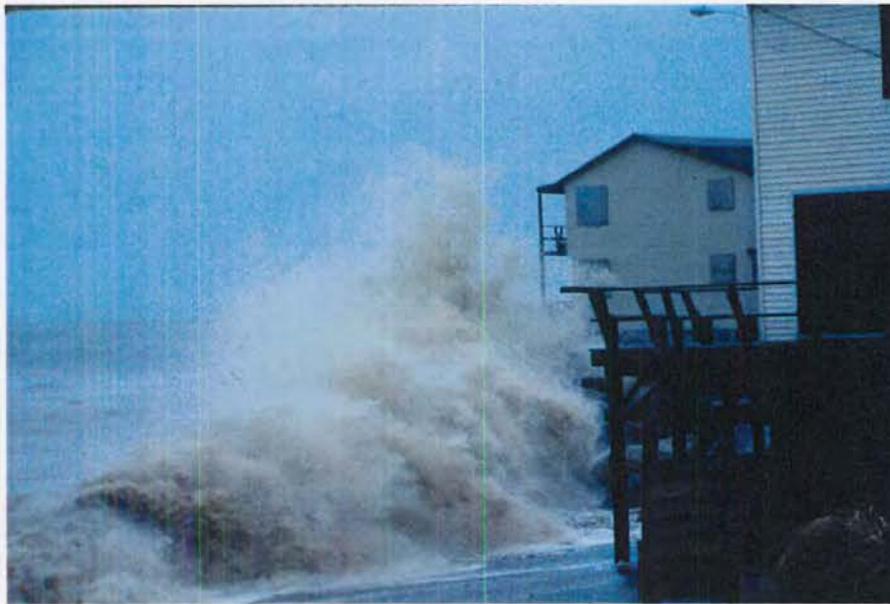
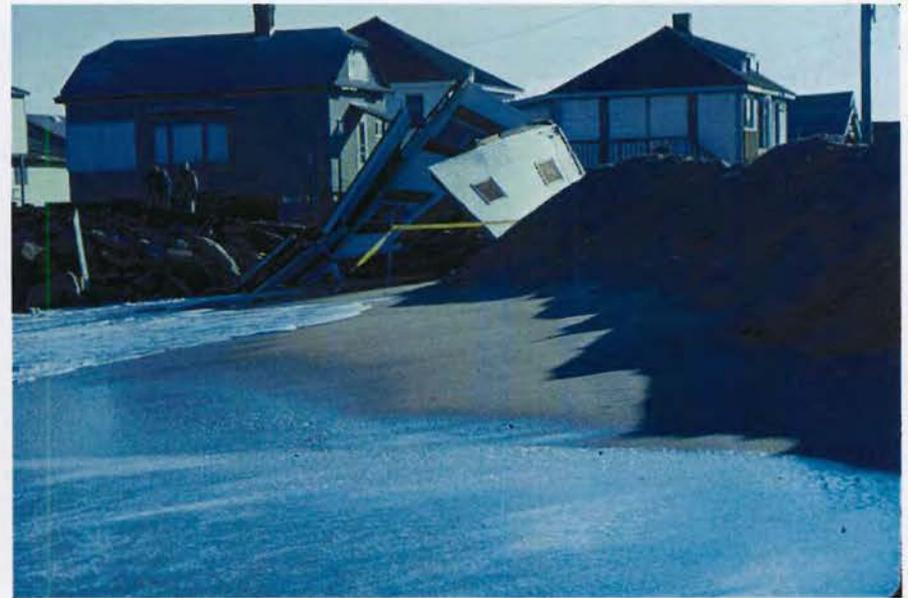
# Camp Ellis Property Damage

Erosion undermines homes at Camp Ellis Beach in Saco

Surf and chronic erosion threaten the Camp Ellis neighborhood. The two homes in the left photo were destroyed by different storms. The house on the left was behind a seawall; the one on the right was not. MGS File Photos by S. M. Dickson, left 1986 and right 1990.

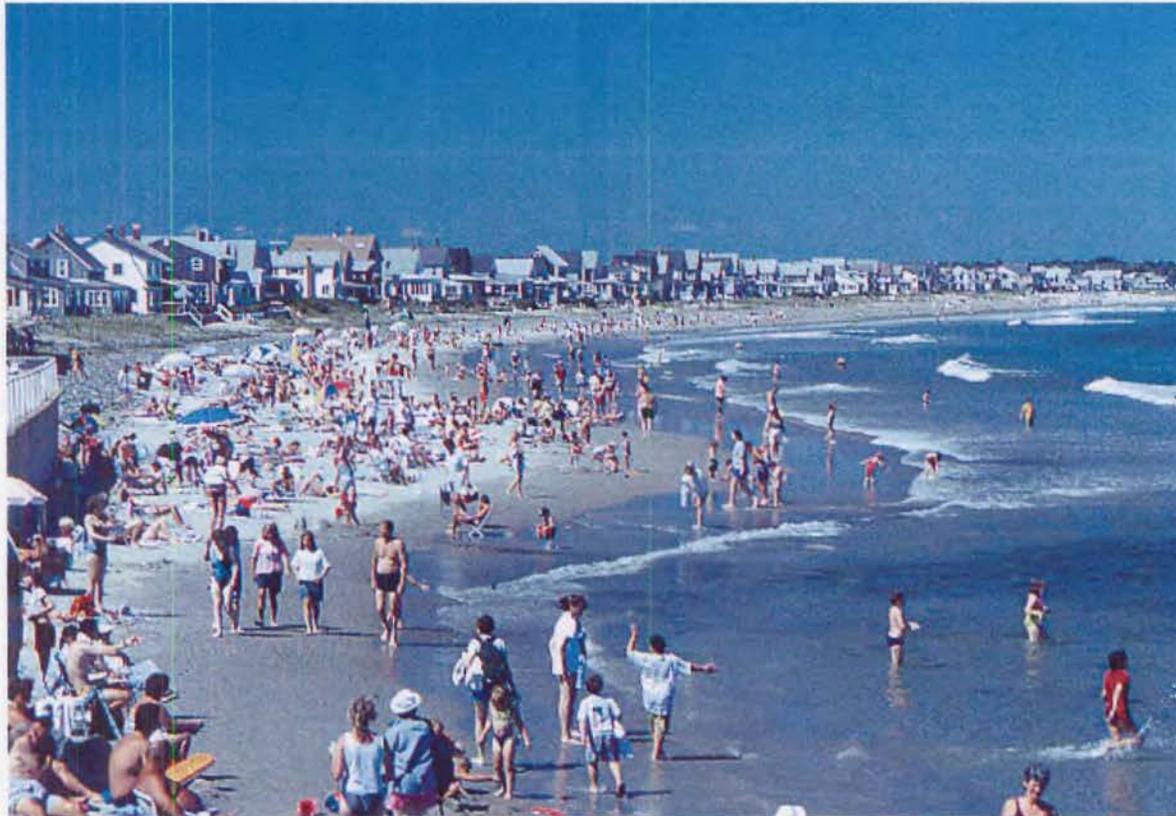
# Beach Erosion and Recreation

Continued beach erosion reduces the recreational beach width when dunes are fixed in place beneath frontal dune homes and do not migrate inland. Erosion in Wells (above) has limited the optimal time for recreation to about half of the tidal cycle. MGS File Photo by S. M. Dickson, 1990.
