Sears Island Dry Cargo Terminal • Searsport, Maine

Distribution of Eelgrass in Penobscot Bay, Maine

# **Distribution of Eelgrass in Penobscot Bay, Maine**

**Frederick T. Short**

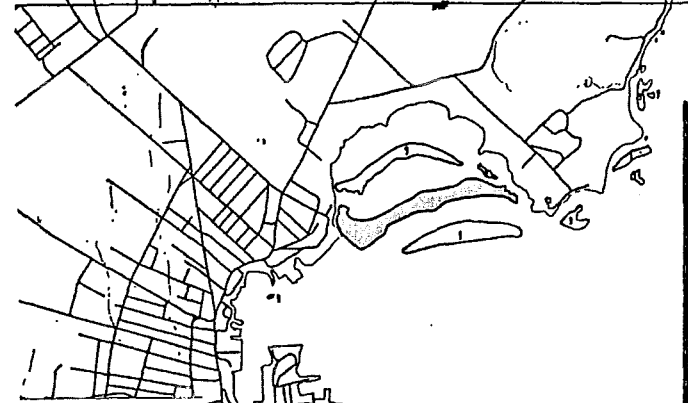
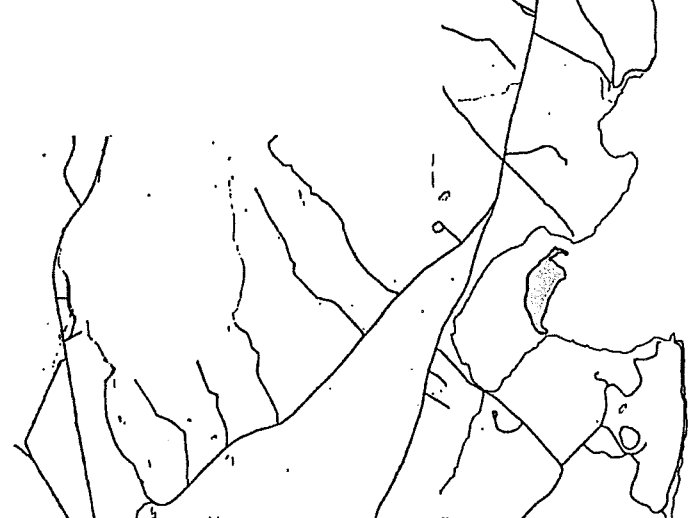
Scale: 1" = 44,000"      Map no. **PB 5**

**PENOBSCOT BAY, MAINE  
EELGRASS DISTRIBUTION MAP**

**Rockland**

POSSIBLE EELGRASS AREA  
(field verification required)

The remainder of the western shore (Maps PB3-PB5) has some fairly large eelgrass beds, primarily associated with protected harbor areas, particularly Duck Harbor and Rockland Harbor. Eelgrass is found extensively along the coast of Islesboro (Maps B2-B4; Maps C2 and C3), the largest beds located at the southern end of the island chain, where eelgrass is often found in protected coves and harbors.
