FINAL DRAFT REPORT

MAINE STATE
CULTURAL BUILDING
December 15, 2006

State of Maine Cultural Center An Opportunity of Historic Proportion

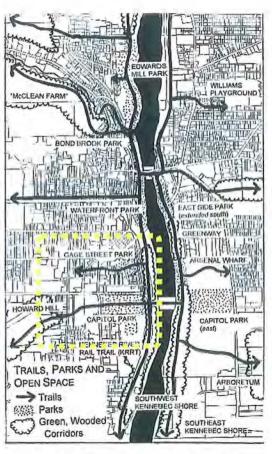
CAPITAL RIVERFRONT IMPROVEMENT DISTRICT MASTER PLAN
TRAILS, PARKS, AND OPEN SPACE

The CRMP calls for the demolition of the MDOT garage and the reuse of the site for public or private development.

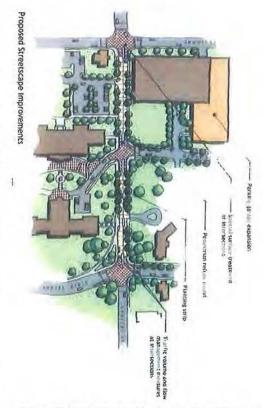
Option 4 - New Parking on MDOT Lot

circulation reconstruction and that utilities serving the existing building could be tied into for the expansion. It is anticipated that Stormwater for the new parking lot would tie into the existing collection line in Capitol Street which ties into the 60" line in Sewall.

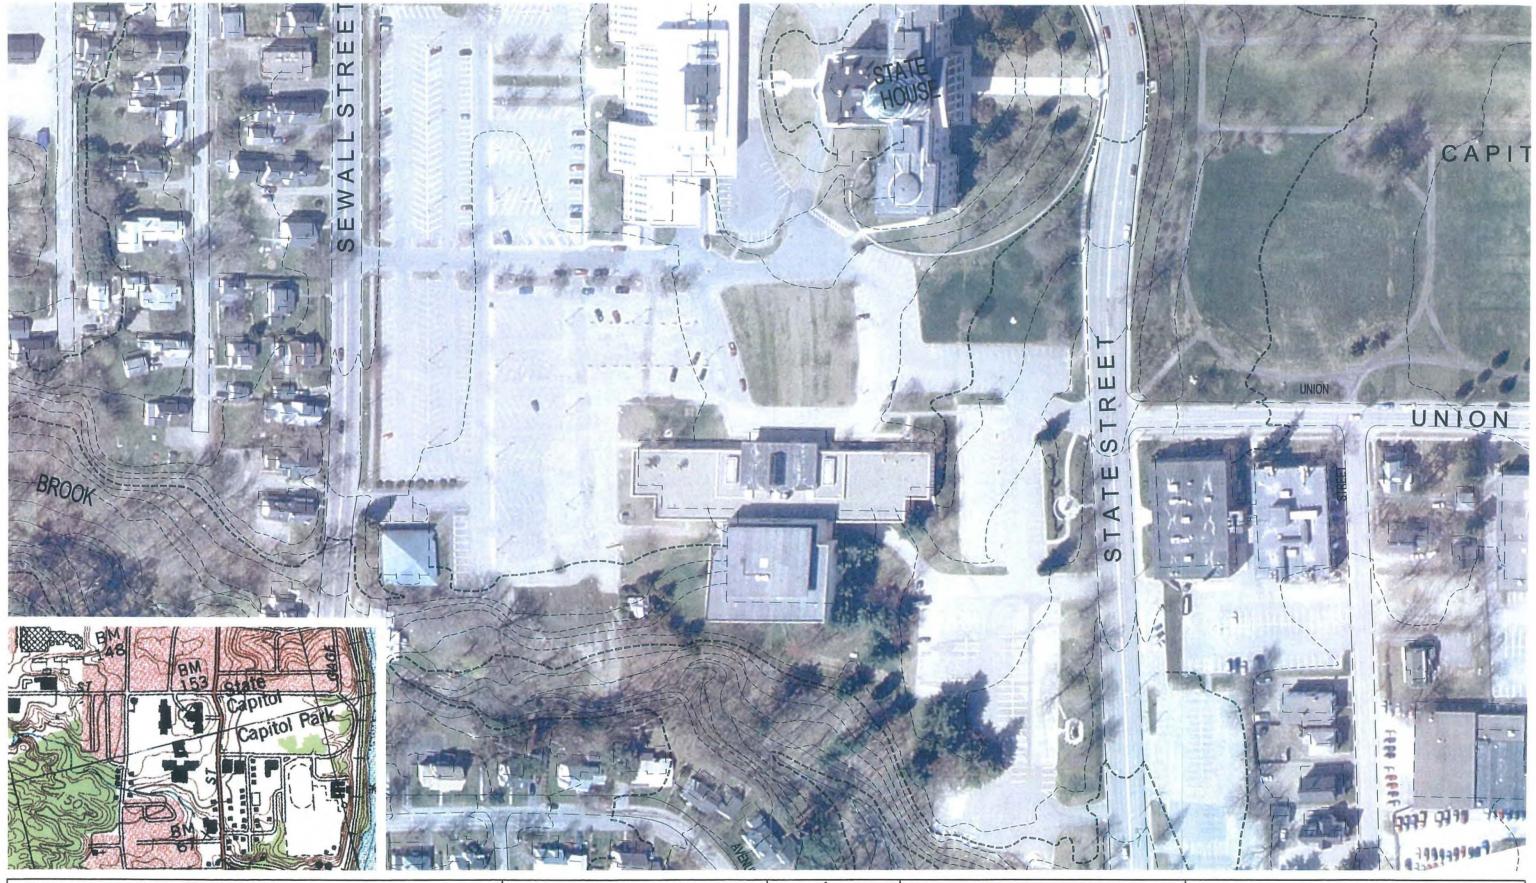
MAINE STATE CULTURAL
BUILDING STUDY
SITE CONCEPT PLAN - OPTION 1

Unlike the other development scenarios, Option 1 ("Do nothing" scheme) has no plan of action. It assumes that the building continues to fail and that at some future date ceases to serve the citizens of Maine.

AIR PHOTO PROVIDED BY MAINE STATE GIS, TAKEN 2004
 TOPOGRAPHY, WETLANDS, & PROPERTY LINE BASED ON PUBLICLY AVAILABLE DATA SOURCES & IS INTENDED TO BE USED FOR PRELIMINARY PLANNING PURPOSES ONLY.

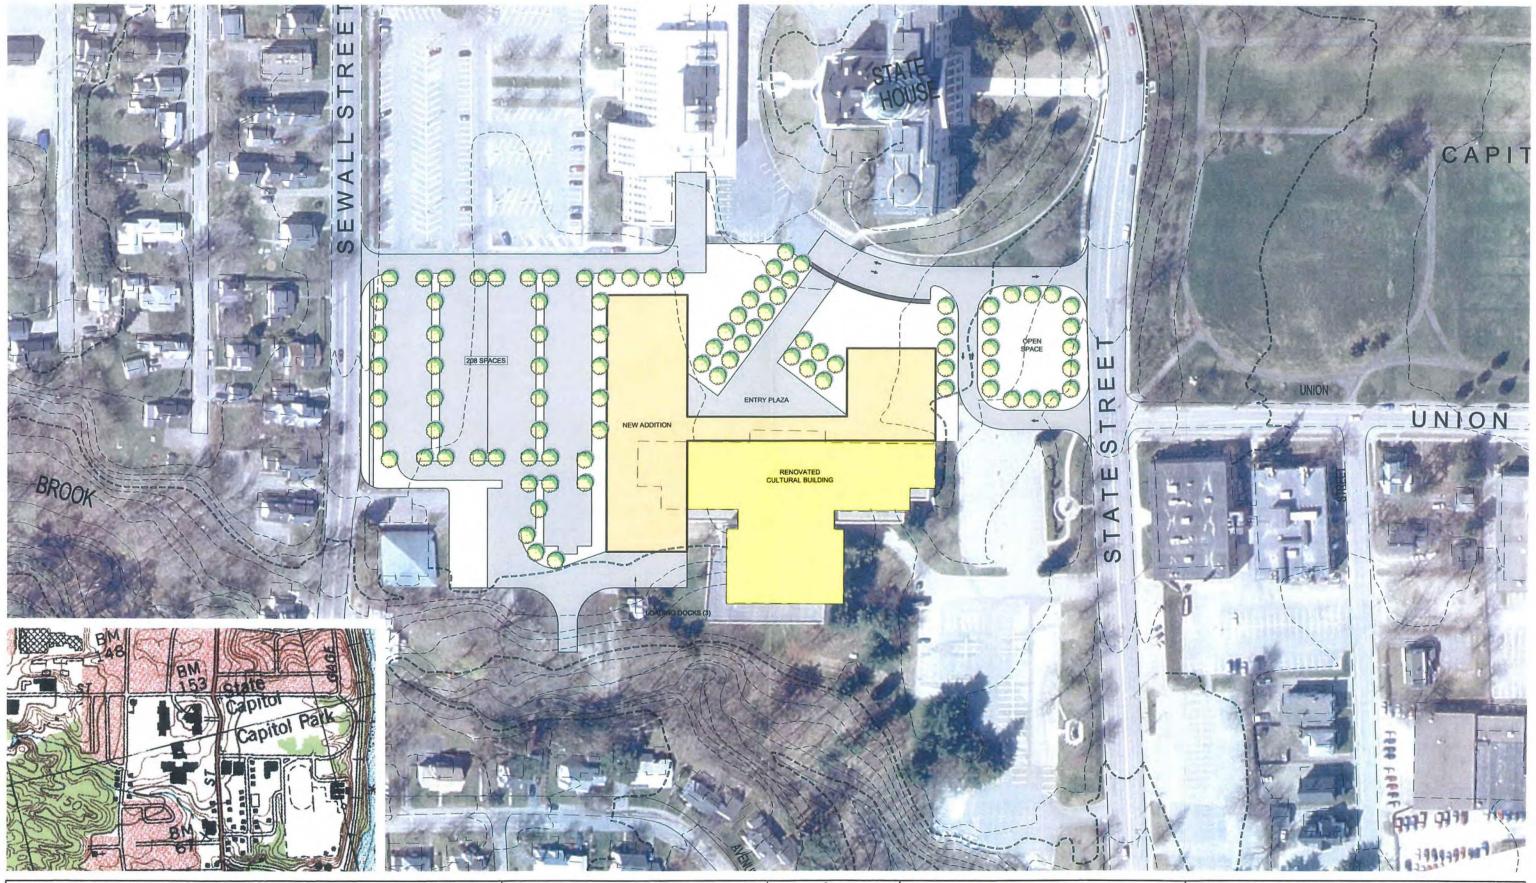
MAINE STATE CULTURAL
BUILDING STUDY
SITE CONCEPT PLAN - OPTION 3
RENOVATE AND EXPAND

1. AIR PHOTO PROVIDED BY MAINE STATE GIS, TAKEN 2004
2. TOPOGRAPHY, WETLANDS, & PROPERTY LINE BASED ON PUBLICLY AVAILABLE DATA SOURCES & IS INTENDED TO BE USED FOR PRELIMINARY PLANNING PURPOSES ONLY.

PARKING COUNTS: NEW SPACES: 708 EXISTING SPACES REMOVED: ±575 NET GAIN/ LOSS OF PARKING: GAIN ±133

Option 3: Expansion/renovation of existing MSCB was essentially the recommendation from the 2001 Harriman/Orcut masterplan.

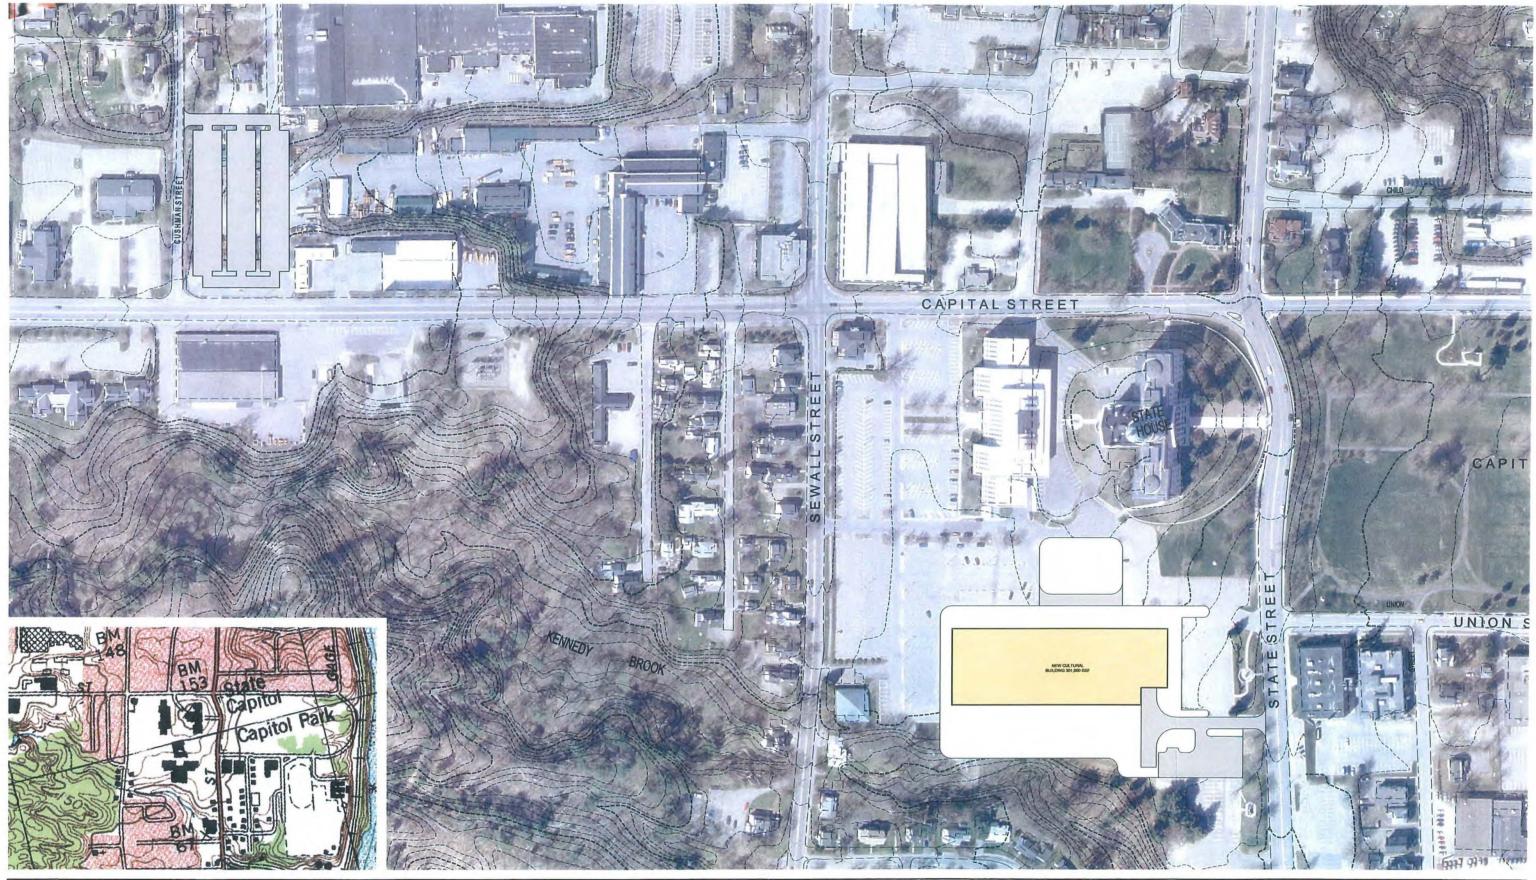
MAINE STATE CULTURAL
BUILDING STUDY
SITE CONCEPT PLAN - OPTION 4
DEMOLISH AND START OVER

- 1. AIR PHOTO PROVIDED BY MAINE STATE GIS, TAKEN 2004
- 2. TOPOGRAPHY, WETLANDS, & PROPERTY LINE BASED ON PUBLICLY AVAILABLE DATA SOURCES & IS INTENDED TO BE USED FOR PRELIMINARY PLANNING PURPOSES ONLY.

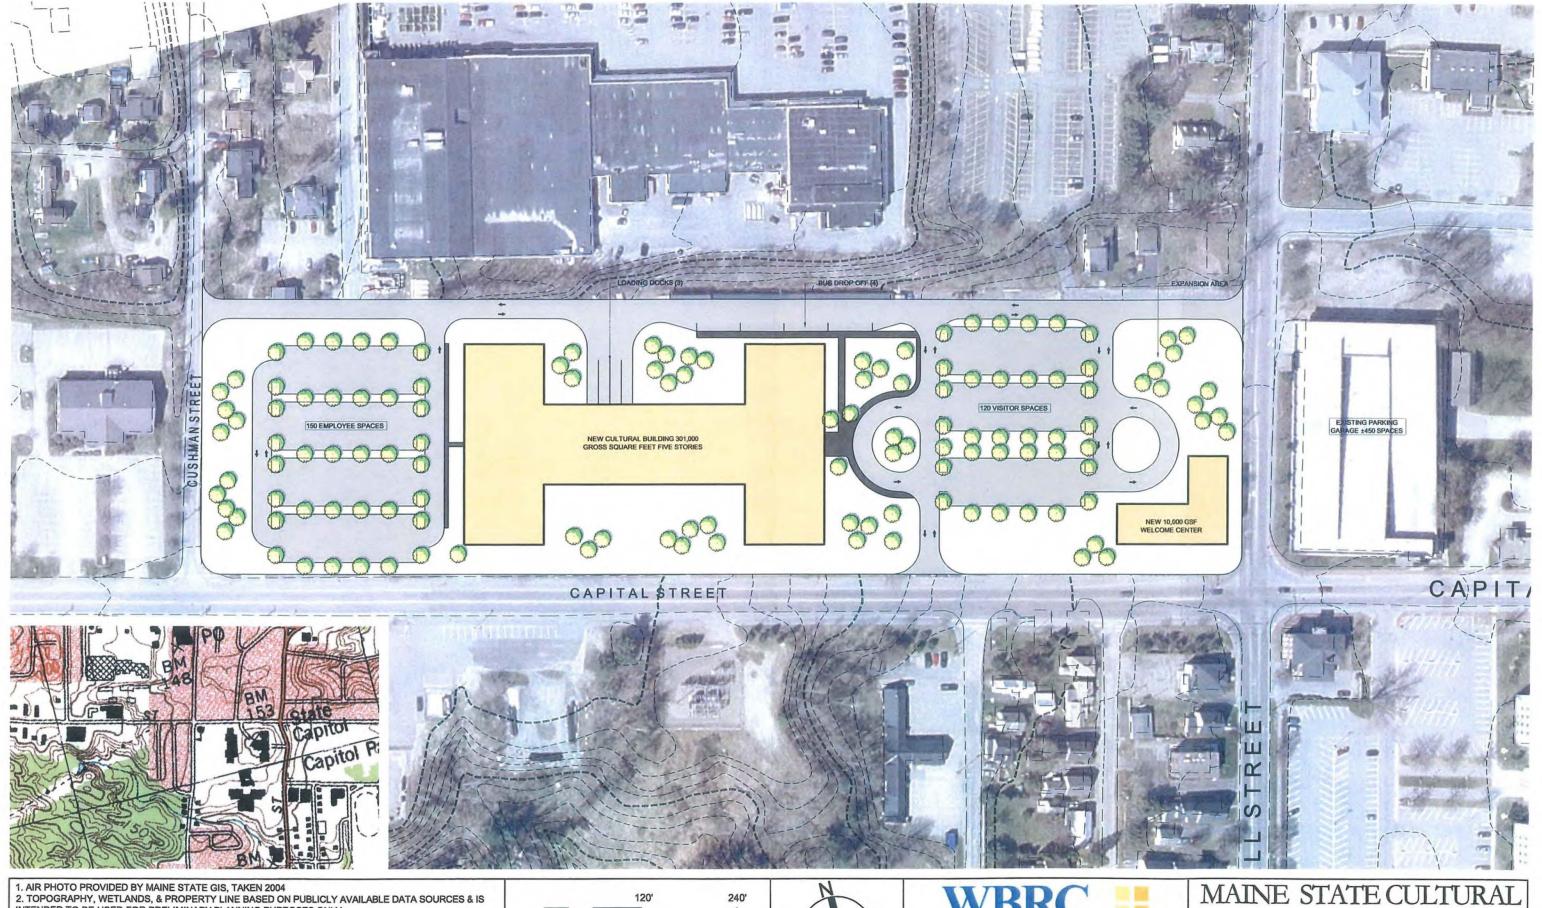
BUILDING STUDY SITE CONCEPT PLAN - OPTION 5 NEW FACIILITY ELSEWHERE

AIR PHOTO PROVIDED BY MAINE STATE GIS, TAKEN 2004
 TOPOGRAPHY, WETLANDS, & PROPERTY LINE BASED ON PUBLICLY AVAILABLE DATA SOURCES & IS INTENDED TO BE USED FOR PRELIMINARY PLANNING PURPOSES ONLY.

PARKING COUNTS: NEW SPACES: 270 **EXISTING SPACES REMOVED: 0** NET GAIN/ LOSS OF PARKING: GAIN 270

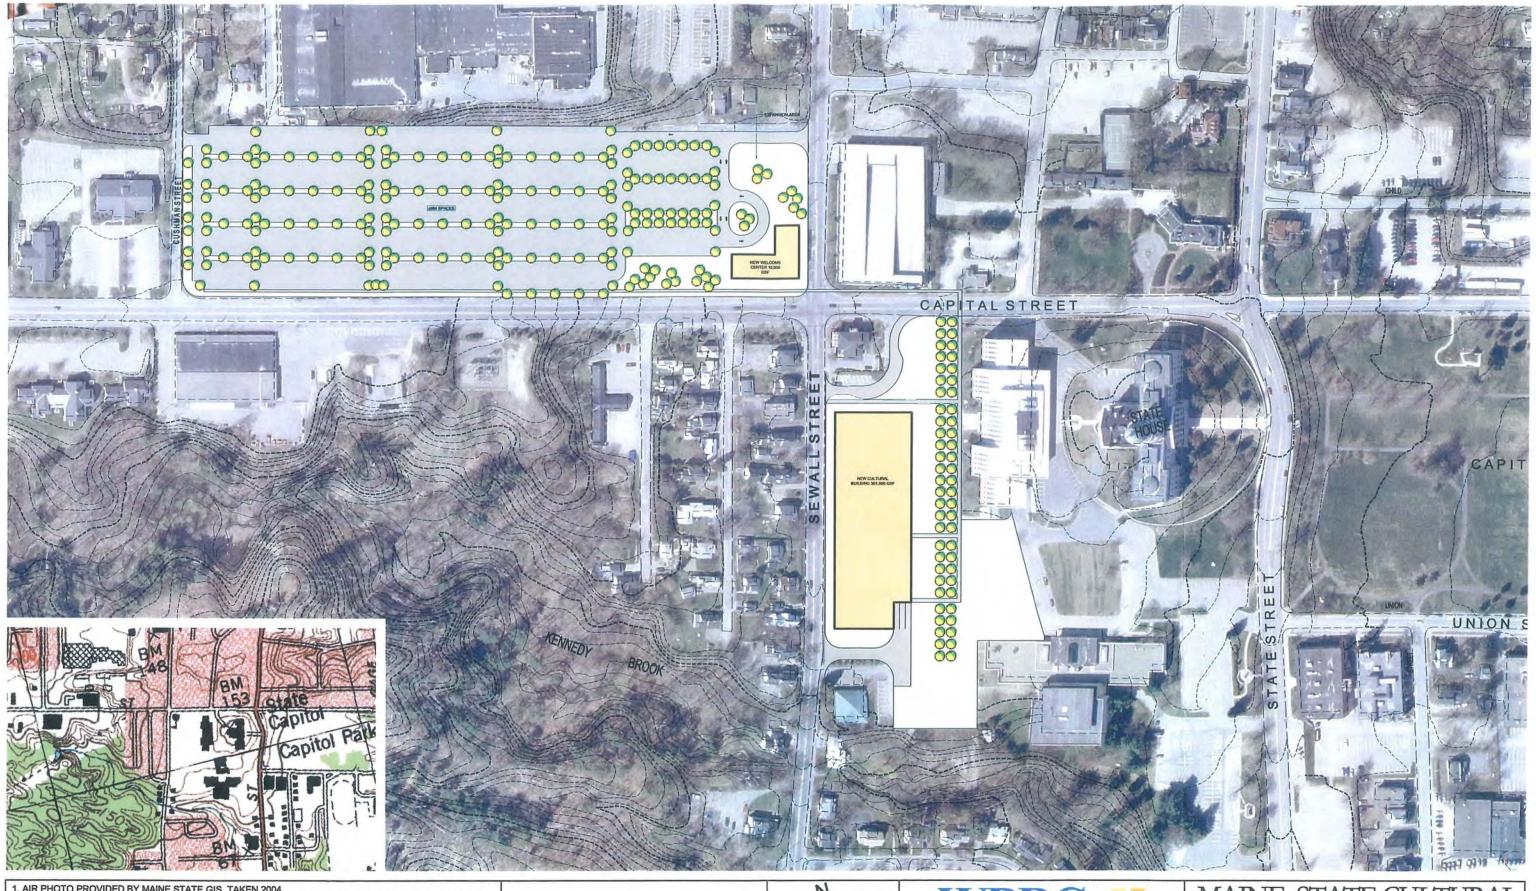
SITE CONCEPT PLAN OPTION 6 SATELLITE PARKING - BUILDING ON SEWALL LOT

AIR PHOTO PROVIDED BY MAINE STATE GIS, TAKEN 2004
 TOPOGRAPHY, WETLANDS, & PROPERTY LINE BASED ON PUBLICLY AVAILABLE DATA SOURCES & IS INTENDED TO BE USED FOR PRELIMINARY PLANNING PURPOSES ONLY.

PARKING COUNTS:
NEW SPACES: 964
EXISTING SPACES REMOVED: ±491*
NET GAIN/ LOSS OF PARKING: GAIN ±473
*DOES NOT INCLUDE MDOT LOT REMOVALS
