**Maine Forestry Best Management Practices  
Use and Effectiveness  
2006 - 2007**

Department of Conservation  
Maine Forest Service  
22 State House Station  
Augusta, Maine 04333  
Forest Policy and Management Division

**October 2008**

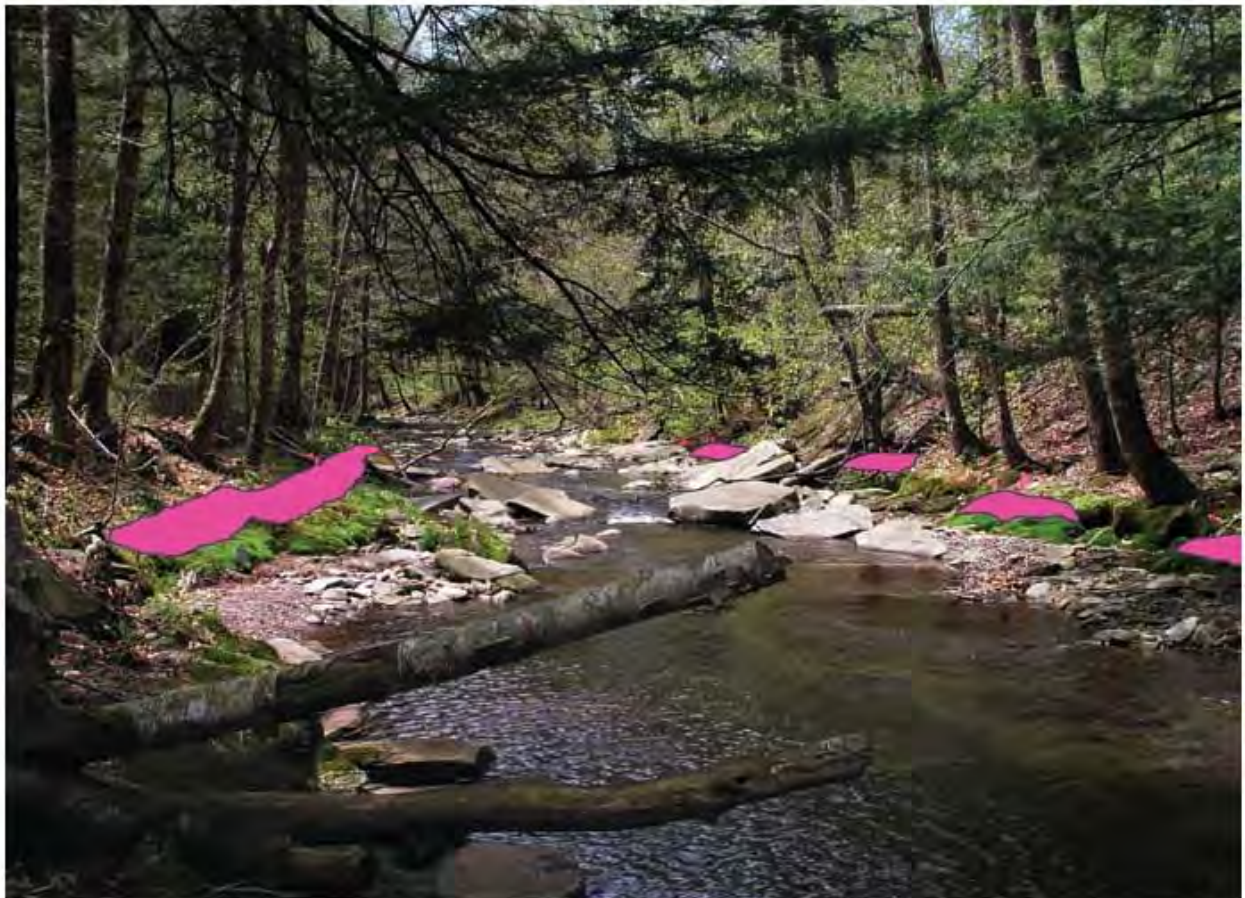
Bankfull elevation may be defined as the point of demarcation between the stream channel and the floodplain. The bankfull elevation is at the elevation of the lowest depositional flat immediately above the channel and is often identified by the deposition of fine sediments indicated by the first depositional flat above the channel.

Bankfull width is the channel width from the bankfull elevation on the one side of the channel to the bankfull elevation on the other side of the channel.

**Figure 19** Bankfull indicators visible at low flow. The bankfull elevation is indicated by the first depositional flat above the channel. On very confined channels, the bankfull elevation may only be evident as the discontinuous flat depositional areas shaded on the photo.
