Maine Forestry Best Management Practices Use and Effectiveness 2008

Department of Conservation
Maine Forest Service
22 State House Station
Augusta, Maine 04333
Forest Policy and Management Division

August 2009

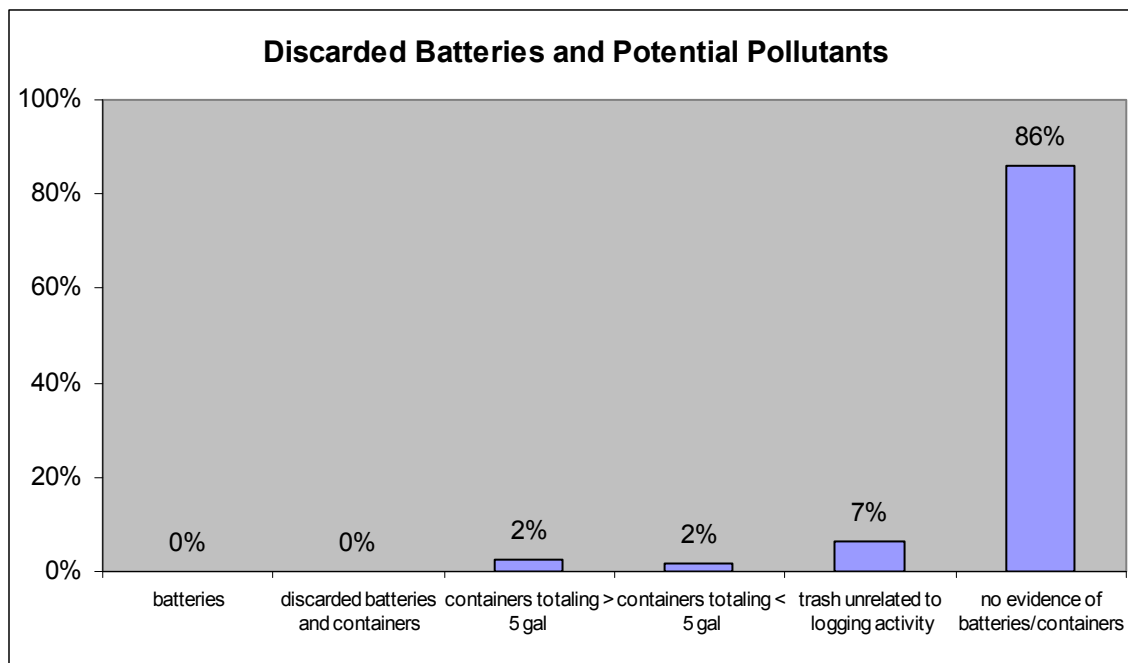
Loggers and foresters generally take seriously the importance of keeping chemical pollutants out of water supplies. Observations of chemical pollutants in sample units were limited to a few cases of minor dripping from machines and occasional empty containers left at woodyards (Figures 17 and 18). There were no cases of chemical pollutants entering the water recorded (data not shown). Although no chemical pollutants made it to the waterbody, contamination remains a concern, particularly in areas where groundwater may serve as private or public drinking water sources.

Figure 18 Discarded batteries and other pollutants. (n=122)
