Re: Review of Central Maine Power Company's Distribution System  
and Distribution Practices and Procedures

*Submitted to:*

*Maine Public Utilities Commission*

*February 26, 2007*

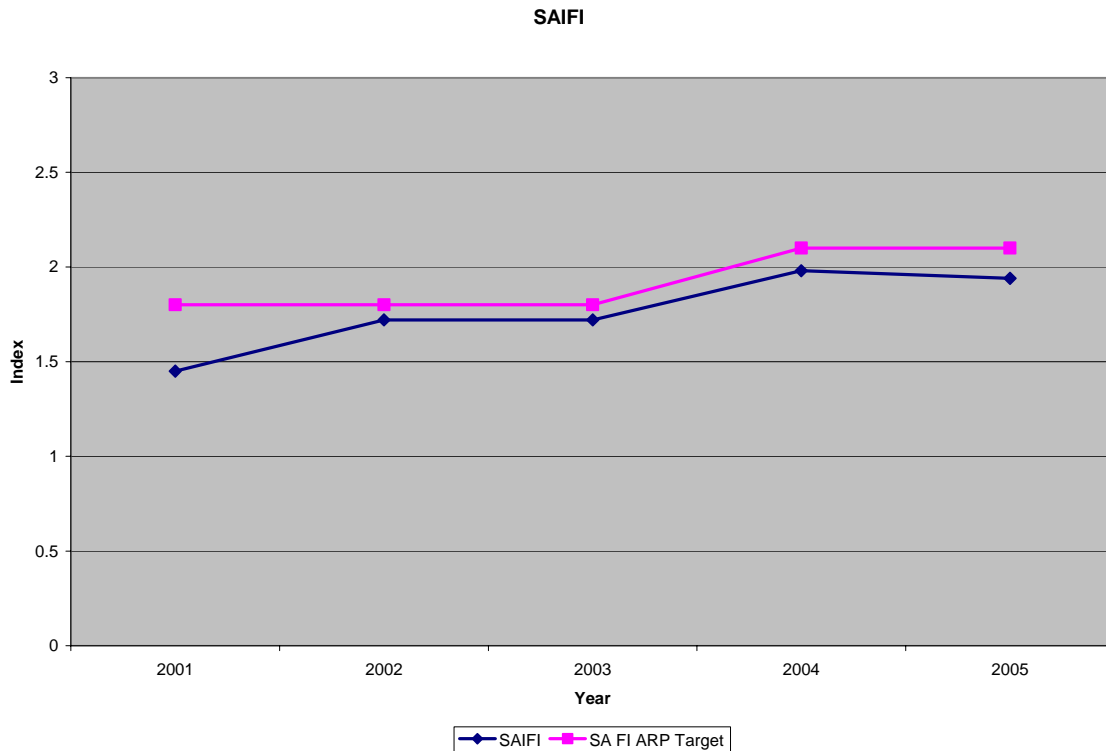
As can be seen from the preceding table, CMP's SAIFI has stayed within the ARP targets, but is trending upward, or getting worse. It is worthy to note that following adjustments to the ARP target in 2004 to 2.1 interruptions, CMP's SAIFI for 2005 appears to be improving. However, a single year's data does not necessarily indicate a trend reversal. It should be noted that there was a change in exclusion criteria that generally worked to change the calculated CAIDI (decreased) and SAIFI (increased) figures. Beginning in 2004, CMP was allowed to exclude only events where 10% or more of CMP's total customers experience outages. Prior to 2004, CMP excluded outages by service area (11 such areas) when the event resulted in 10% or more of CMP's customers in the service area experiencing an outage.

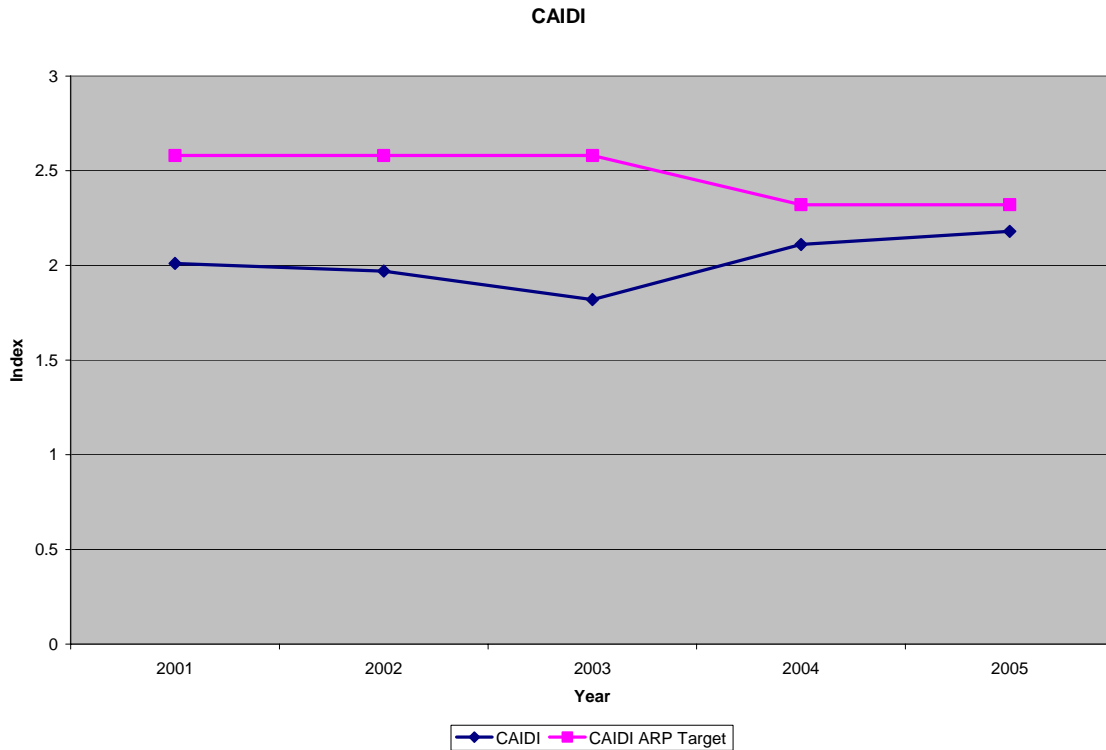
As shown in the preceding table, CMP’s CAIDI reliability performance has worsened (i.e., increased) over the past five years. However, CAIDI performance has been below the ARP target through 2005, even with a reduction (tightening) in the ARP target in 2004.

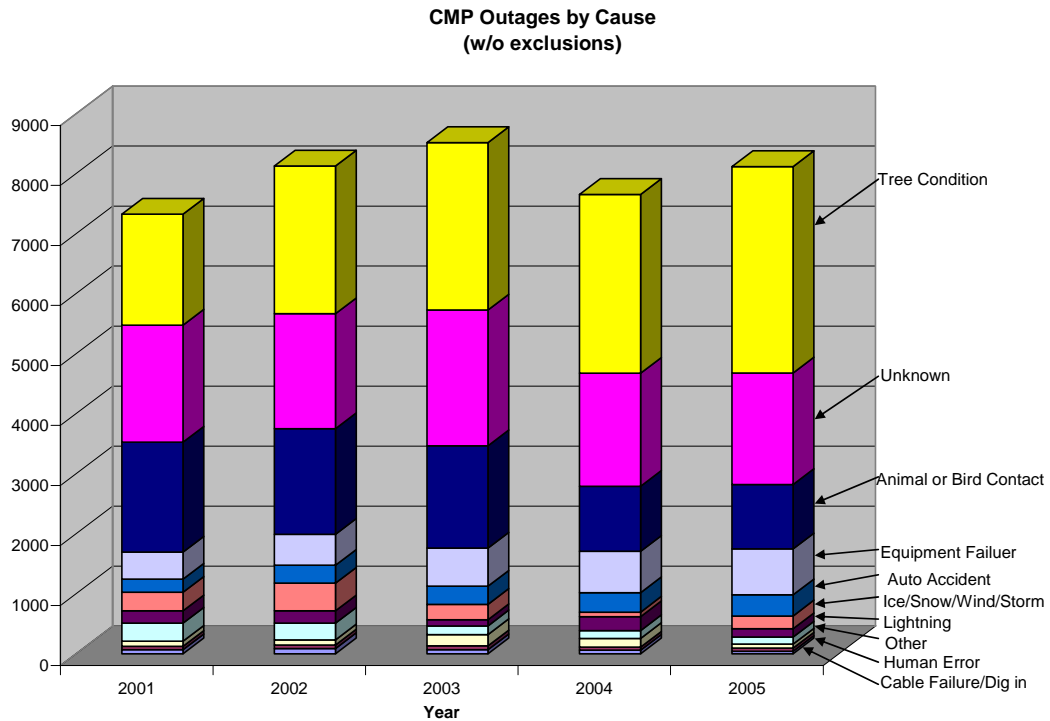
As depicted above, tree-related outages comprise the largest and growing component of overall outages. In fact, for 2005, CMP’s tree-related outages at 42.3% are high in comparison to other utilities and as compared to the 2002 EEI survey average of 21%. Animal related outages at 13% are higher than EEI averages, and OH equipment failures at 9.5% are below EEI survey data at 16%. The following table provides a comparison of the EEI 2002 survey with recent CMP statistics:

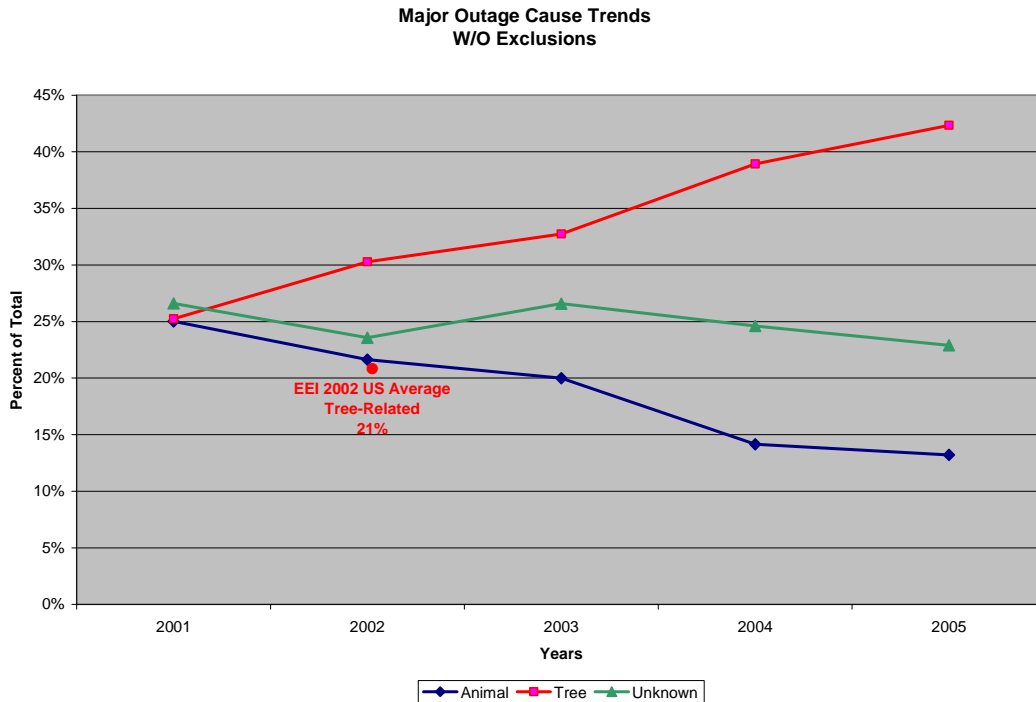
Over the 2001 through 2005 period, tree-related outages as a percent of total outages have increased significantly, while animal-related outages have declined by half as illustrated in the following chart (based on annual ARP filing data):

This suggests that the work that CMP has accomplished over the past several years installing animal (wildlife) guards on distribution pole equipment has had a positive and measurable impact. However, it also suggests that vegetation management and tree trimming programs are not keeping up with tree growth. To further clarify this observation, we have provided the following chart which shows the raw outage counts for the same categories. The pattern of increases in tree-related outages remains consistent.

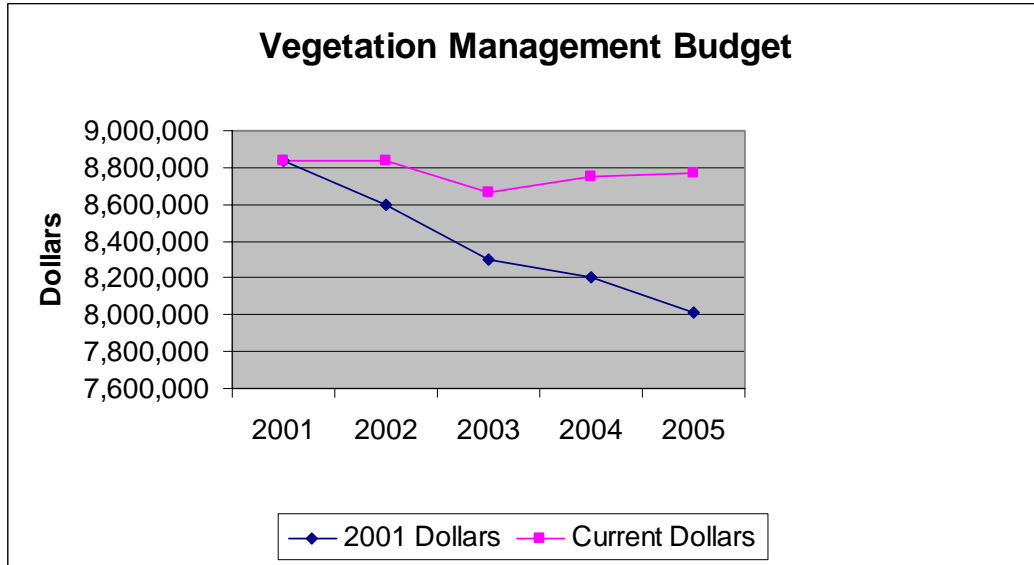
As shown above, the annual distribution vegetation management program budget has been approximately 4% to 5% below expenditure levels accommodated in rates. Actual expenditures have been on average 3% below budget and 7% below rates. Further, the budget has remained relatively flat over the past five years, and in real terms (based on 2001 dollars) the vegetation management budget has declined as shown in the following chart.

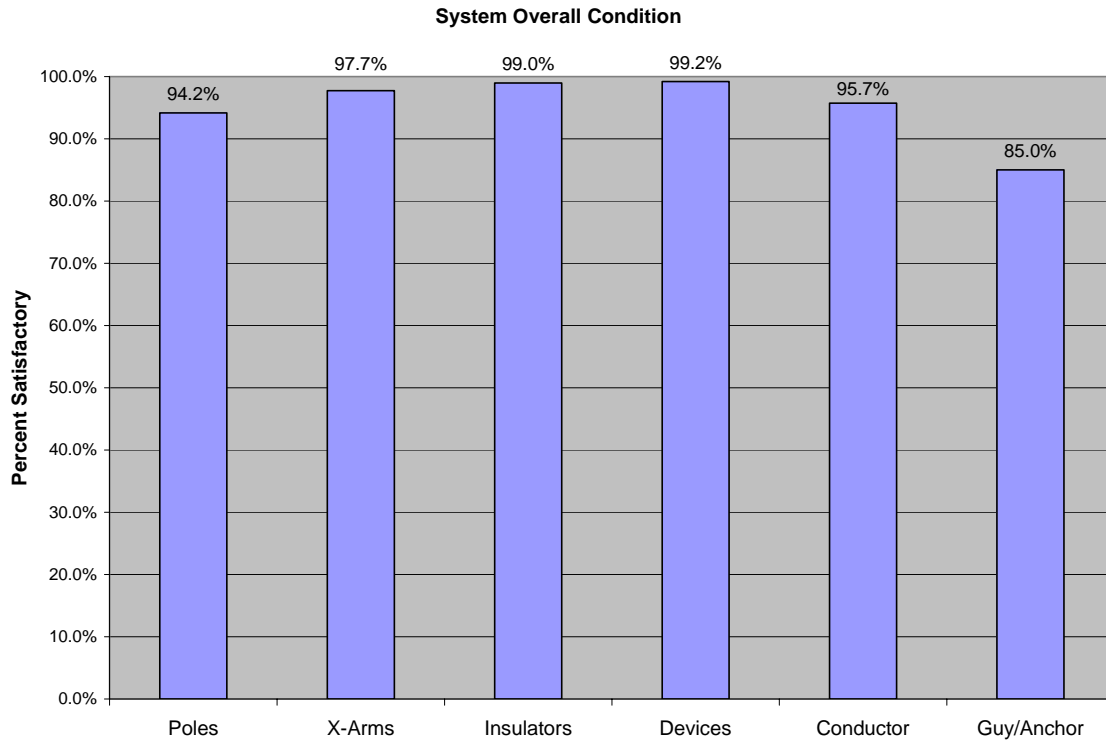
CMP's distribution system appears to be in good condition electrically and mechanically based on the inspection results shown below:

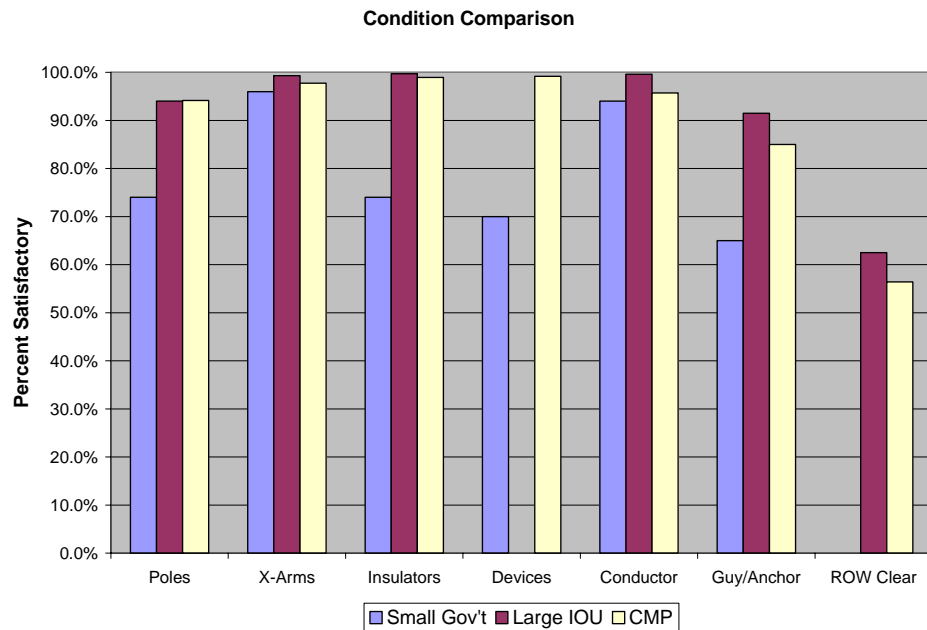
Excluding the status of its vegetation management, CMP's overhead electric distribution system condition compares favorably with several other utilities<sup>12</sup> for which we have conducted condition assessments:

<sup>12</sup> The Large IOU (whose identity is confidential due to agreements signed during that study) did not report condition for devices and the Small Government utility did not report ROW or vegetation condition as their system was primarily devoid of vegetation.

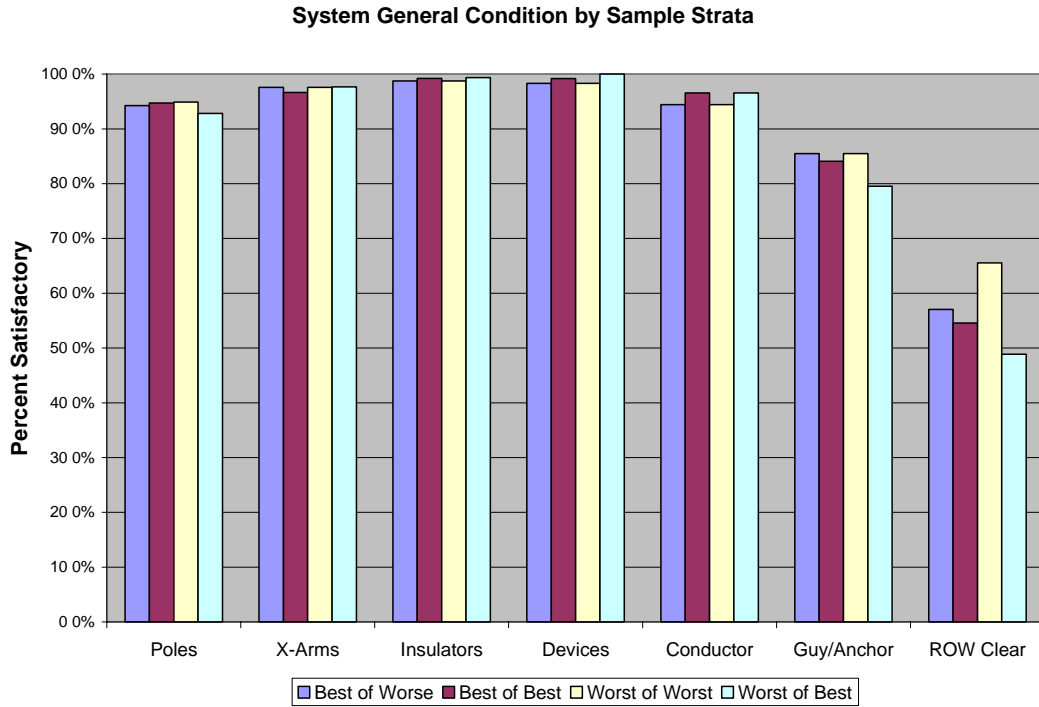
The following charts depict distribution system condition broken out by sample strata and by single-phase and three-phase circuits, which we believe are representative of CMP's service area. Therefore, we conclude that the system mechanical and electrical condition is generally uniform across the service area. The percent of ROW that is clear of vegetation, or where vegetation is more than 8 feet away from the conductor, varies within the sample strata from 49% to 65%.

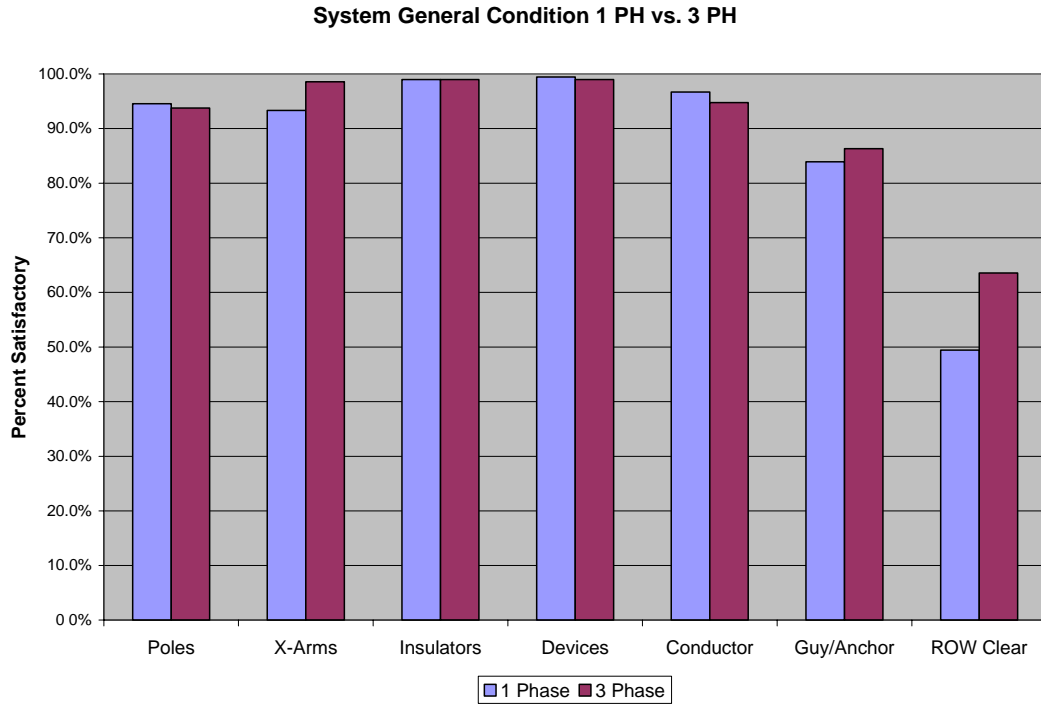
For single-phase vs. three-phase, as shown in the chart below, the three-phase sample circuits at 63.3% clear of vegetation encroachment were significantly better than the single-phase sample circuits at only 49.4% clear. This is in line with our expectations and indicates that more tree-related outages could be expected to occur on single-phase circuits.

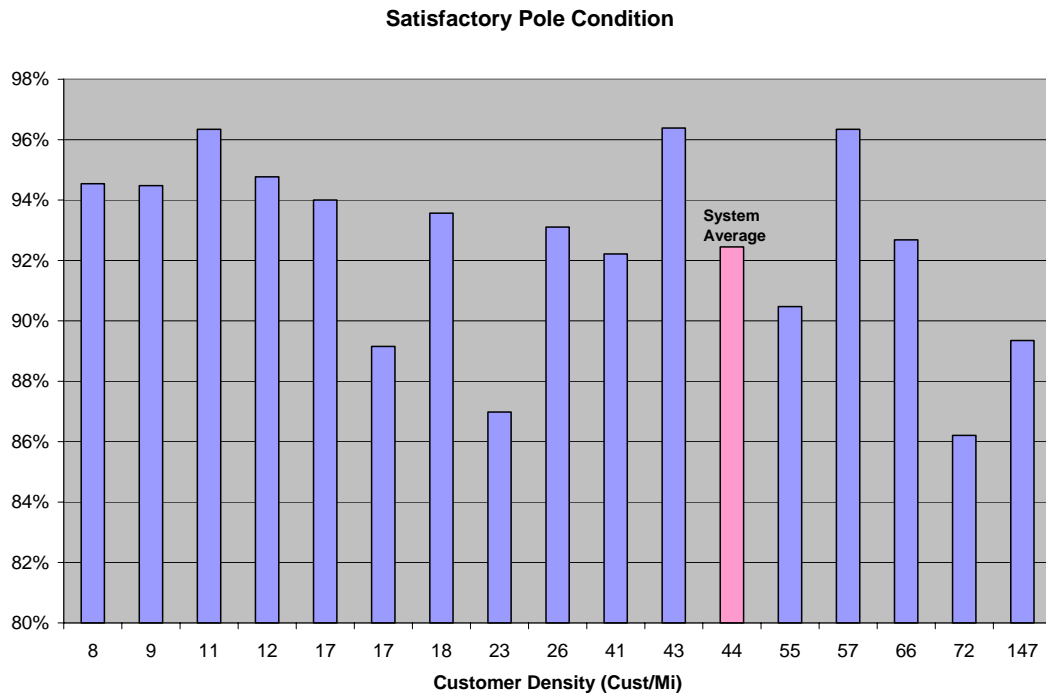
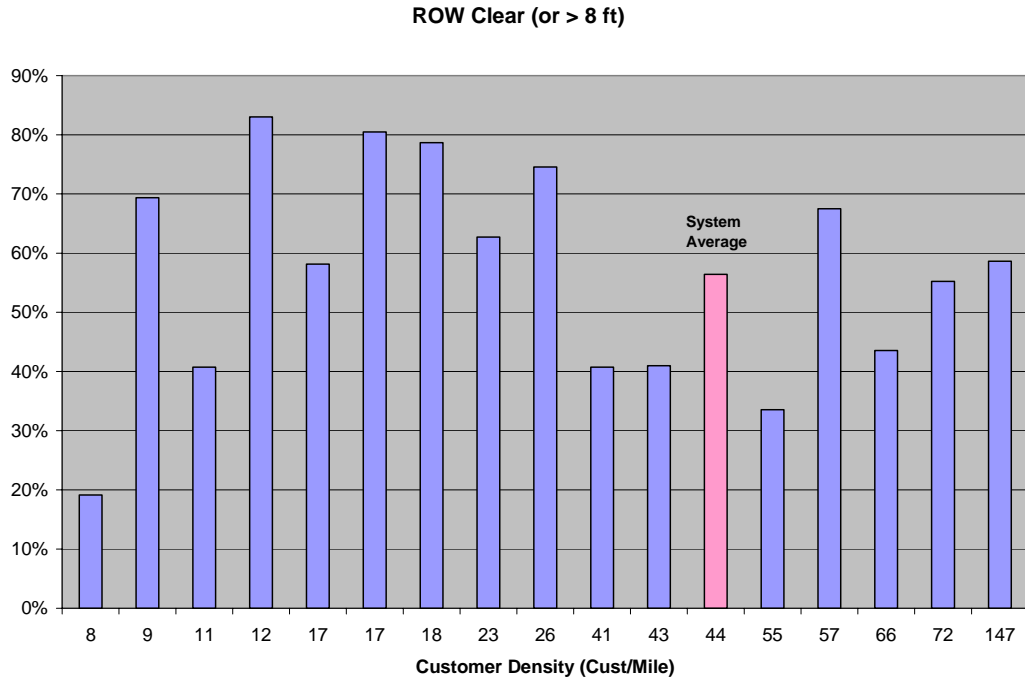
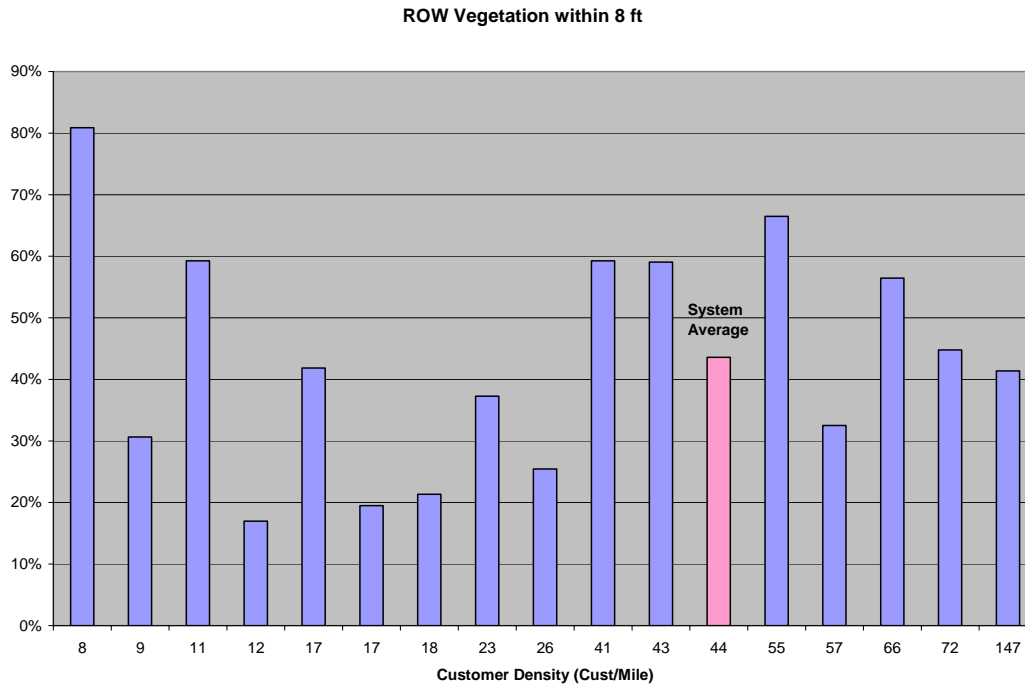
As depicted on the following charts, the results indicate that system condition is fairly uniform across various customer densities. While there are differences in satisfactory pole condition and vegetation clearance (for example), we do not detect any bias toward less dense circuits.
