# MAINE STATE HOUSE & GROUNDS

Years  
2003  
through  
2007

## Multi Year Plan For Maintenance & Improvements

Prepared by  
Richard Burt Architects  
Damariscotta, Maine

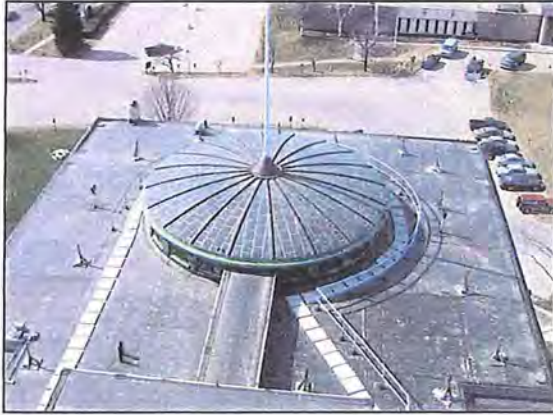
Annual  
A.1

## ANNUAL PROJECT #1

### Roofing — EPDM/Copper Inspection

This project involves the regular review and maintenance of all roofing systems. A yearly review of all roofing areas will be completed by a qualified independent roofing consultant. Areas requiring maintenance will be identified. Repairs will be completed by a roofing subcontractor.

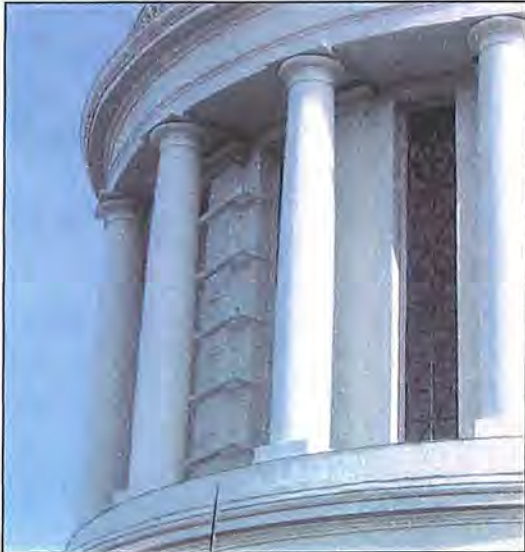
## PROJECT 03.2

### Copper Pilaster Repair at High Dome

At the southwest quadrant of the high dome, an existing ornamental (white-painted) copper-faced pilaster has pulled away from the dome proper. On-site observations have confirmed that water infiltration through fatigued fasteners has rotted a portion of the pilaster's wood-framed structure, resulting in its separation from the main dome. Temporary bracing has been installed in order to stabilize this condition until permanent repairs can be made. This project will complete all necessary repairs to both the structure and copper facing of the pilaster.

Part One will include additional on-site observations of the pilaster and adjacent similar pilasters in an effort to further document the cause of this failure.

Part Two will include the repairs to the pilaster and any adjacent pilasters, as determined by the Part One observations.

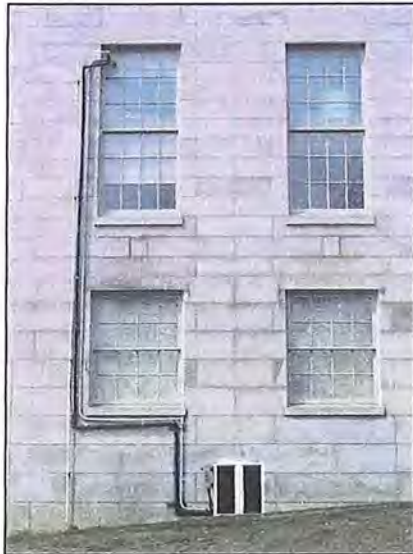
## PROJECT 03.6

### Air Handler Modification at Information Services Mezzanine

In 1998, an exterior pad-mounted condenser was placed at the southeast corner of the State House as a component of a temporary air conditioner system provided for the 2.5 floor south (Information Services) mezzanine. This installation was designed to be temporary in nature until the then-planned renovations of the south wing provided a centralized air conditioning system. This project will augment the recently installed fan coil units at the Information Services mezzanine and provide for the removal of the exterior pad-mounted equipment.

With the provision of the new central air conditioning system changeover, this existing exterior pad-mounted equipment and temporary piping can be removed. Improved energy efficiency will result from use of the central system and the overall State House aesthetic will be improved at this very visible exterior corner of the building.

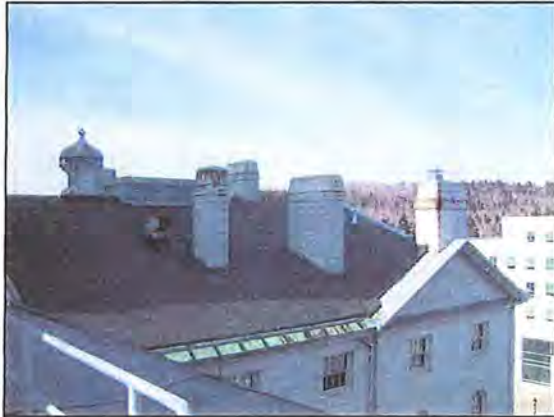
## PROJECT 03.8

### West Wing SBS Roofing Replacement with Standing-Seam Metal, Rain Leader Replacement

This project involves the removal of the in-place SBS roofing and replacement with standing-seam metal at the sloped West Wing roof. Also included will be the replacement of existing rain leaders (downspouts).

In 1994, the in-place SBS roofing was installed as a temporary repair measure only. This project will involve the removal of same, and the prior roof substrate, and replacement with standing-seam metal roofing. Roofing metal consistent with the character of the State House involving either copper, prepatinated copper, or lead-coated (gray) copper shall be employed.

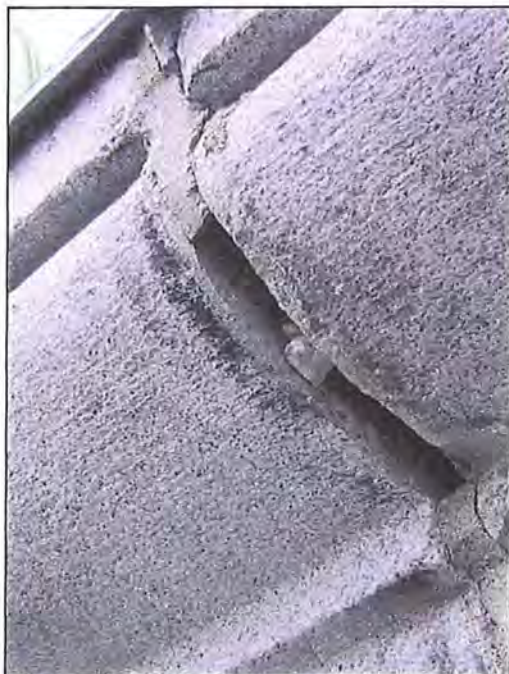
## PHASED PROJECT, WEST WING Exterior Granite: Repointing, Granite Cleaning

The work of with this project includes repointing (new mortar) at selected locations, sealant replacement at granite/trim interface, and cleaning of exterior granite.

Although the building is massive in appearance and structurally impenetrable, it is case that even small amounts of water infiltration into the exterior granite walls of the State House will cause significant long-term damage and structural deterioration.

By observation, there are a numerous locations where existing mortar has cracked or fallen from the walls. In addition, a number of building leaks have occurred due to wind-driven rain infiltration at high granite/roof/cornice intersections.

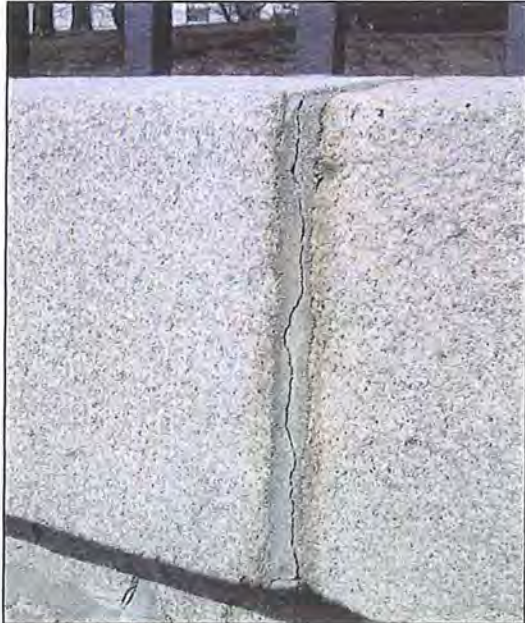
Subsequent field observations have determined that the effort to maintain historically appropriate detailing has resulted in thermal cracking at several capstone joints.

This project will provide for the removal of capstone grout joints and replacement with mortar. Sealant joints will also be replaced as they have reached their useful lifespan.

Replacement of hairline cracked mortar joints is necessary in order to prevent water infiltration into the wall system that can damage the wall. In addition, selected sealant joints on a calculated spacing need to be provided in order to accommodate granite thermal movement. At the completion of this project, overall water repellant integrity will be restored at the granite retaining wall, thus preventing wall deterioration.

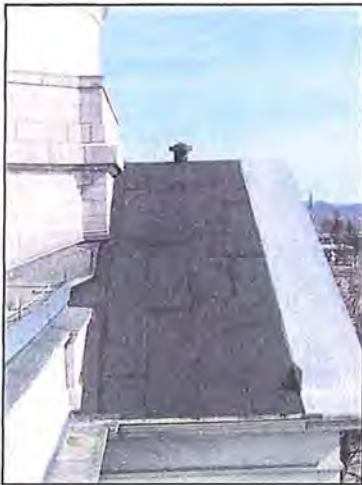
### East Porch SBS Roofing Replacement with Standing-Seam Metal, Rain Leader Replacement

This project involves the removal of the in-place SBS roofing and replacement with standing-seam metal at the sloped East Porch roof. Also included will be the replacement of existing rain leaders (down spouts).

This project will restore the long-term waterproof integrity of the east porch sloped roof. Marginally functional rain leader systems will be restored, thereby controlling rain runoff in a manner that will protect the granite building envelope well into the future. In addition, this very prominent roof will be restored, employing a material consistent with the overall architectural integrity and quality of the State House.
