REPORT ON
INDOOR AIR QUALITY IN STATE FACILITIES

SUBMITTED TO
THE JOINT STANDING COMMITTEE ON
STATE AND LOCAL GOVERNMENT
114TH MAINE LEGISLATURE

SUBMITTED BY
THE DIVISION OF SAFETY AND ENVIRONMENTAL SERVICES
BUREAU OF PUBLIC IMPROVEMENTS
MAINE DEPARTMENT OF ADMINISTRATION

JANUARY 30, 1989

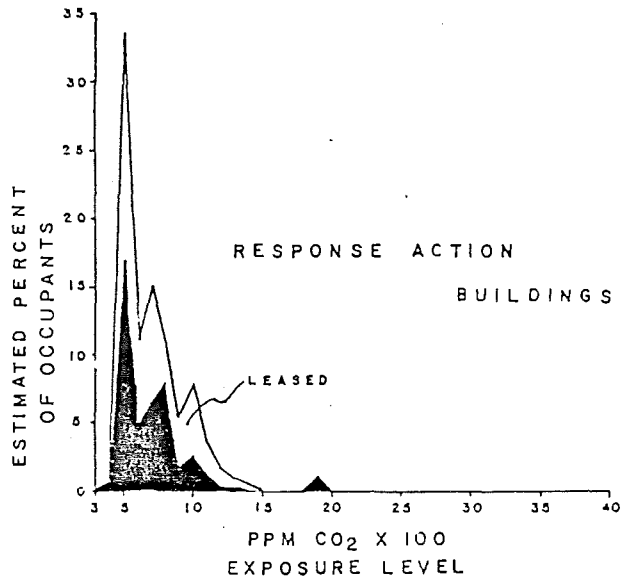
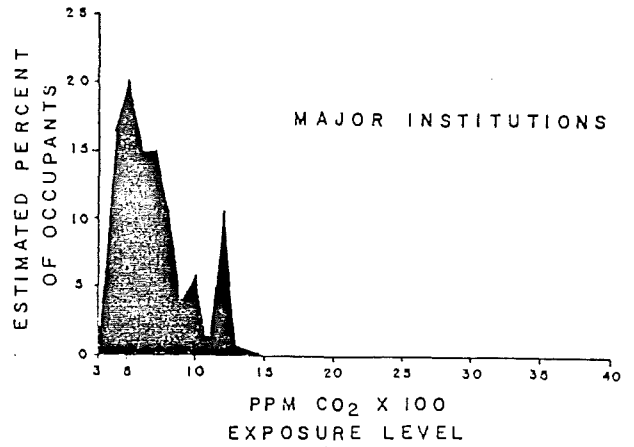
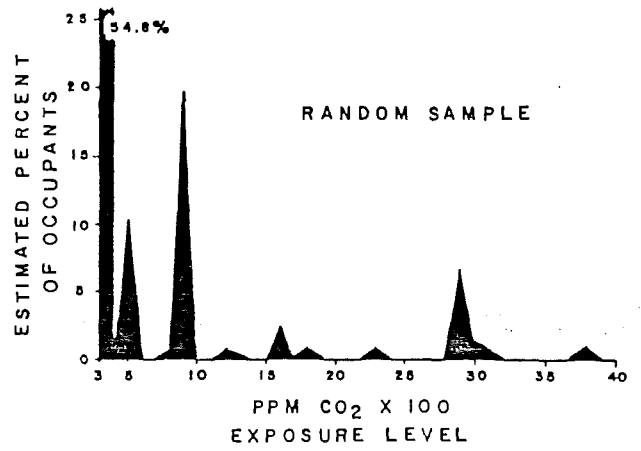
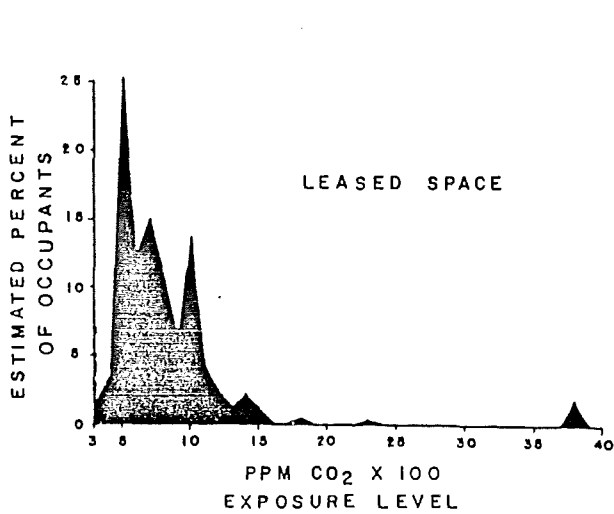
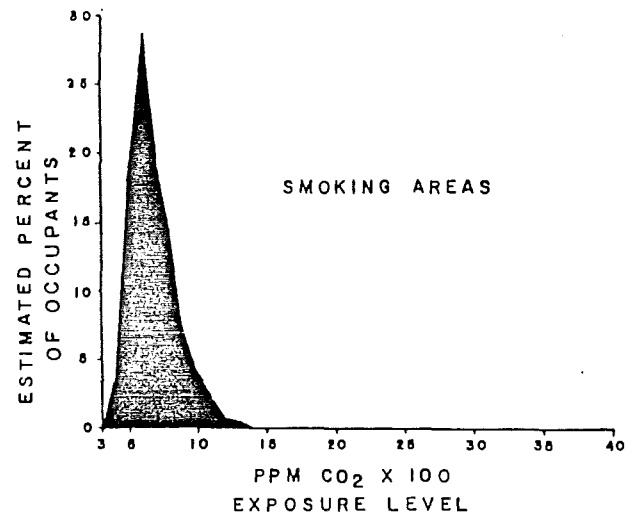
FIGURE 1.

Distribution Curves: Occupant Population vs. CO₂ Concentration

Summary results of this study are presented in Table 1 and Figure 1. Exposure levels in the figures are expressed in terms of estimated percentage of occupants likely to be exposed at a given CO₂ concentration at some time during the course of a working day. "Estimation" was an effort to make comparable the results from differing field methodologies. It may result in slight overestimation of population, but reliability of proportions is improved. CO₂ concentrations are diagrammed in increments of 100 ppm. That is, exposures graphed at 500 ppm are all those greater than 400 but less than or equal to 500 ppm, at 600 ppm those greater than 500 but less than or equal to 600 ppm, and so forth.

Results from this category are graphed in Figure 1. The mode ("peak") of this curve is approximately 550 ppm but maximum levels exceed the 1500 ppm maximum of categories two and three. It is not readily apparent why these levels should cause significantly more complaints than for those other strata. Other factors, particularly temperature control and humidity, may be important as the CO₂ level approaches 1000 ppm. These suspicions cannot be evaluated with current data.

Figure 1 presents these results solely for the major institutions. This is the "cleanest" category, modal exposure occurring near 500 ppm. However, there still exist exposures at up to 1400 ppm, not significantly different in this respect from Strata One and Three. The low mode appears to result from intermittent and/or low occupation of many institutional spaces, rather than any superiority in air exchange. This stratum contains a higher proportion of non-office space than others and the strong secondary peak at 1200 ppm makes this situation clear. Consideration of the state prison mess hall as fully-occupied produced that peak and significantly increases the proportion of exposures above 1000 ppm for the entire category.
