NUCLEAR SAFETY REPORT

submitted to the

115th Maine Legislature, 1991

Department
State Nuclear Safety Advisor

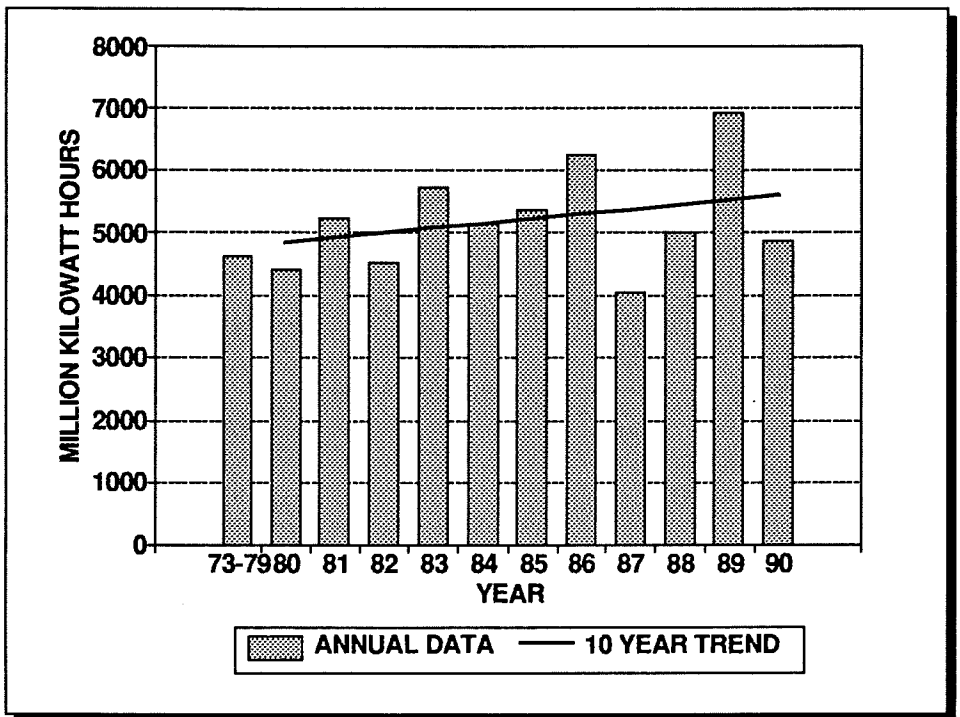
Figure 3 Annual net electrical production for Maine Yankee, and general trend from 1980 through 1990.

In Figure 3, the annual net electrical production for Maine Yankee is displayed. Maine Yankee's annual electrical production peaked in 1989 at 6900 million kilowatt-hours. The record production year was partially due to 1989 being a non-refueling year, increasing the power of the reactor (as approved by the Nuclear Regulatory Commission (NRC), and several plant efficiency improvements. In 1990, Maine Yankee underwent a scheduled refueling outage from April through June, and also experienced several plant shutdowns (discussed in this report). This resulted in a fairly average electrical production year of 4860 million kilowatt-hours. Because there are years when Maine Yankee's electrical production year is shortened due to refueling, it is more valid to look at the plant's performance over several years. Figure 3 also shows the general trend of the plant's net electrical production for the last ten years. The graph shows that the plants performance is gradually improving with regards to electrical production. This is the result of many factors including several equipment improvements for increased efficiency, effective maintenance and plant modernization, and overall plant management.

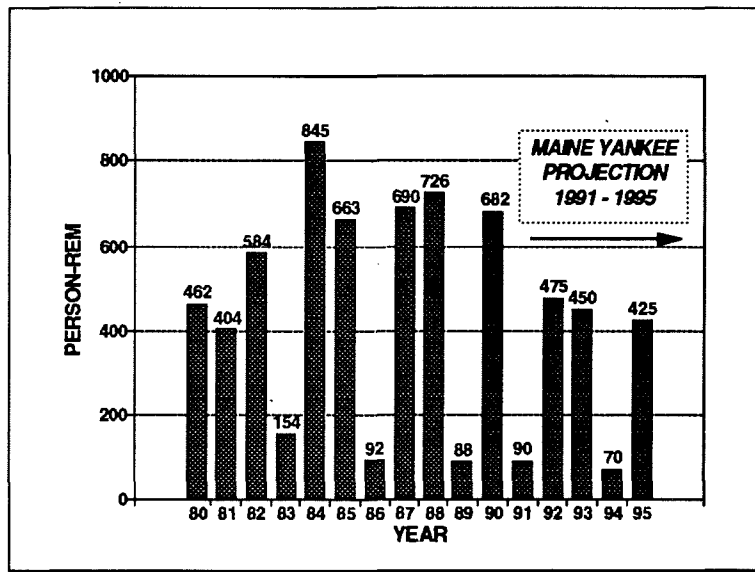
Figure 12 Annual collective radiation dose for Maine Yankee personnel.

In controlling radiation exposure to workers, Maine Yankee met its planned refueling person-rem goal, but unexpected events during and after the refueling outage resulted in additional radiation exposure. The additional exposure increased Maine Yankee's 1990 goal of limiting total worker radiation dose to 500 person-rem. As shown in Figure 12, the annual collective radiation exposure at Maine Yankee for 1990 was 682 person-rem. Radiation exposures for the previous years when Maine Yankee conducted refueling activities are essentially in the same range, thus the 1990 total dose essentially portrays no improvement in reducing worker exposure. (The years in which Maine Yankee was not refueling are evident from the small person-rem recorded, e.g. the years 1983, 1986, 1989).

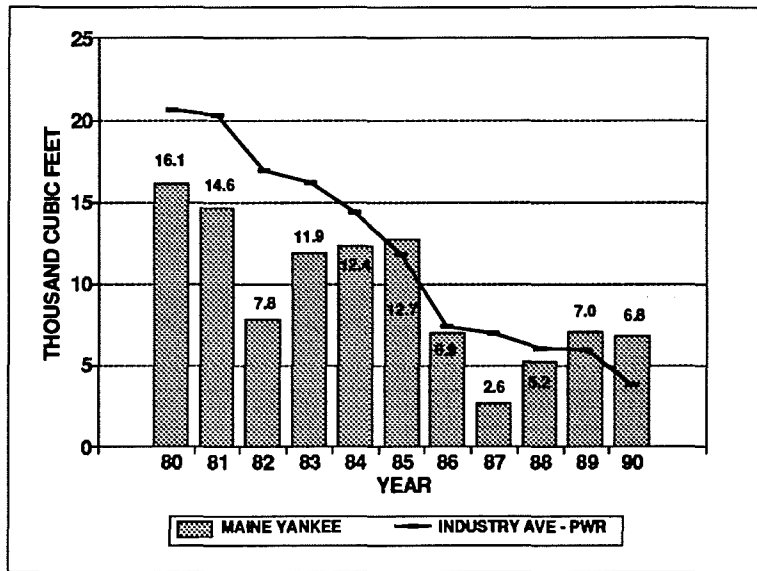
Figure 21 Annual volume of low-level radioactive waste buried from Maine Yankee compared to the U.S. pressurized water reactor (PWR) industry.

Figures 21 and 22 display the Maine Yankee record for Volume and Curies, respectively, of low level radioactive waste shipped since 1980. As shown, Maine Yankee's production of LLRW for 1990 is greater than the industry average, however, Maine Yankee's overall performance in LLRW production is somewhat representative of the declining LLRW waste production that is occurring in the U.S. nuclear power industry.
