Feasibility Study and Concept Design II for the Maine Correctional Center

Maine Department of Corrections
Windham, Maine

Joint Study Report – Appendices Volume 3

Maine Project #14MCC015

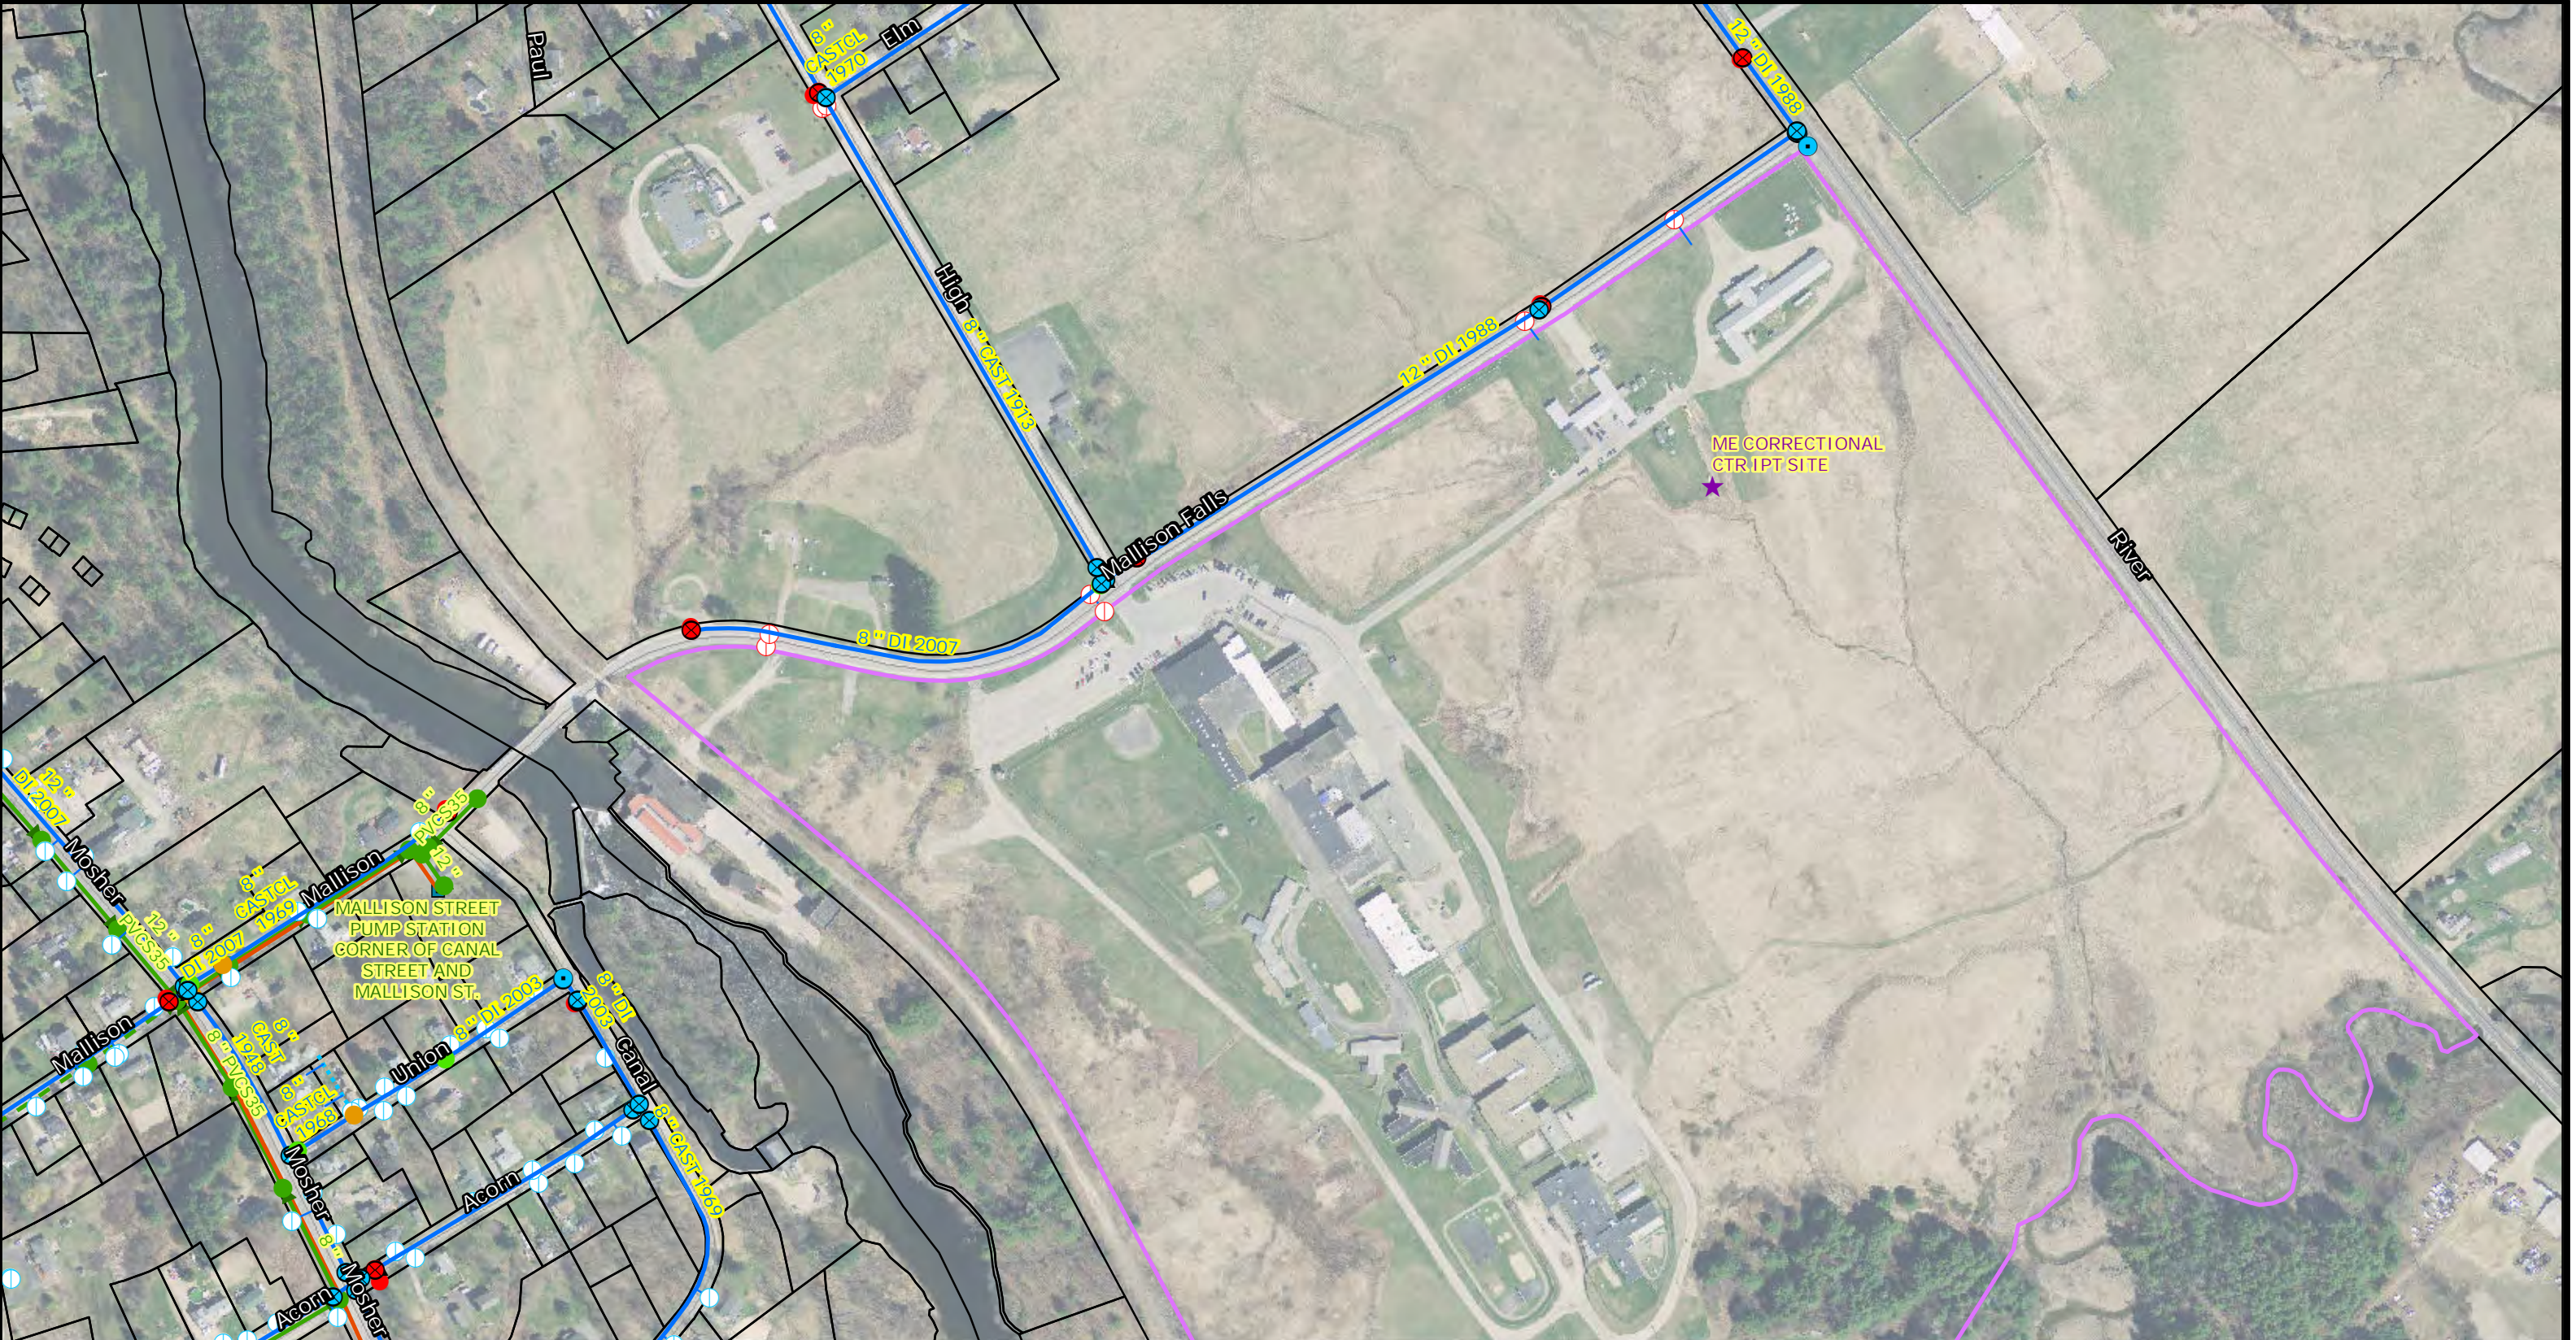
PORTLAND WATER DISTRICT

The ability to serve request indicated that the average daily water use and sewer discharge rate could be as much as 190,000 gallons per day. The data noted above indicates there should be adequate pressure and volume of water to serve the domestic water needs of the proposed correctional facility expansion. Based on the high water pressure in this area, we recommend that you consider the installation of pressure reducing devices that comply with state plumbing codes. A better understanding of this project's impact on the inter-municipal capacity allocation between Windham, Gorham and Westbrook, along with necessary system upgrades, are anticipated before the District has the ability to serve the wastewater needs of this project. Please see conditions of service below for more information.

It is anticipated that this project will require water service to provide private fire protection to the site. Please note that the District does not guarantee any quantity of water or pressure through a fire protection service. Please share these results with your sprinkler system designer so that they can design the fire protection system to best fit the noted conditions. If the data is out of date or insufficient for their needs, please contact the MEANS Division to request a hydrant flow test and we will work with you to get more complete data.

As a condition of allowing any new water services, any existing services that will no longer be used as a result of the development must be retired per PWD standards. This includes shutting the corporation valve and cutting the pipe from the water main (for service sizes 2-inch and smaller) or removing the gate valve and capping the tapping sleeve (for service sizes 4-inch and larger). The existing services at this site may be used by the proposed development as long as the project team determines that they will provide adequate flow and pressure for the proposed use.

- Inflow and Infiltration Mitigation
 - The District has reason to believe that there is a significant amount of inflow and infiltration entering the sewer system from the private sewer main east of Mallison Falls Bridge. This I&I will need to be quantified and ultimately mitigated prior to additional flows being accepted into the PWD system.

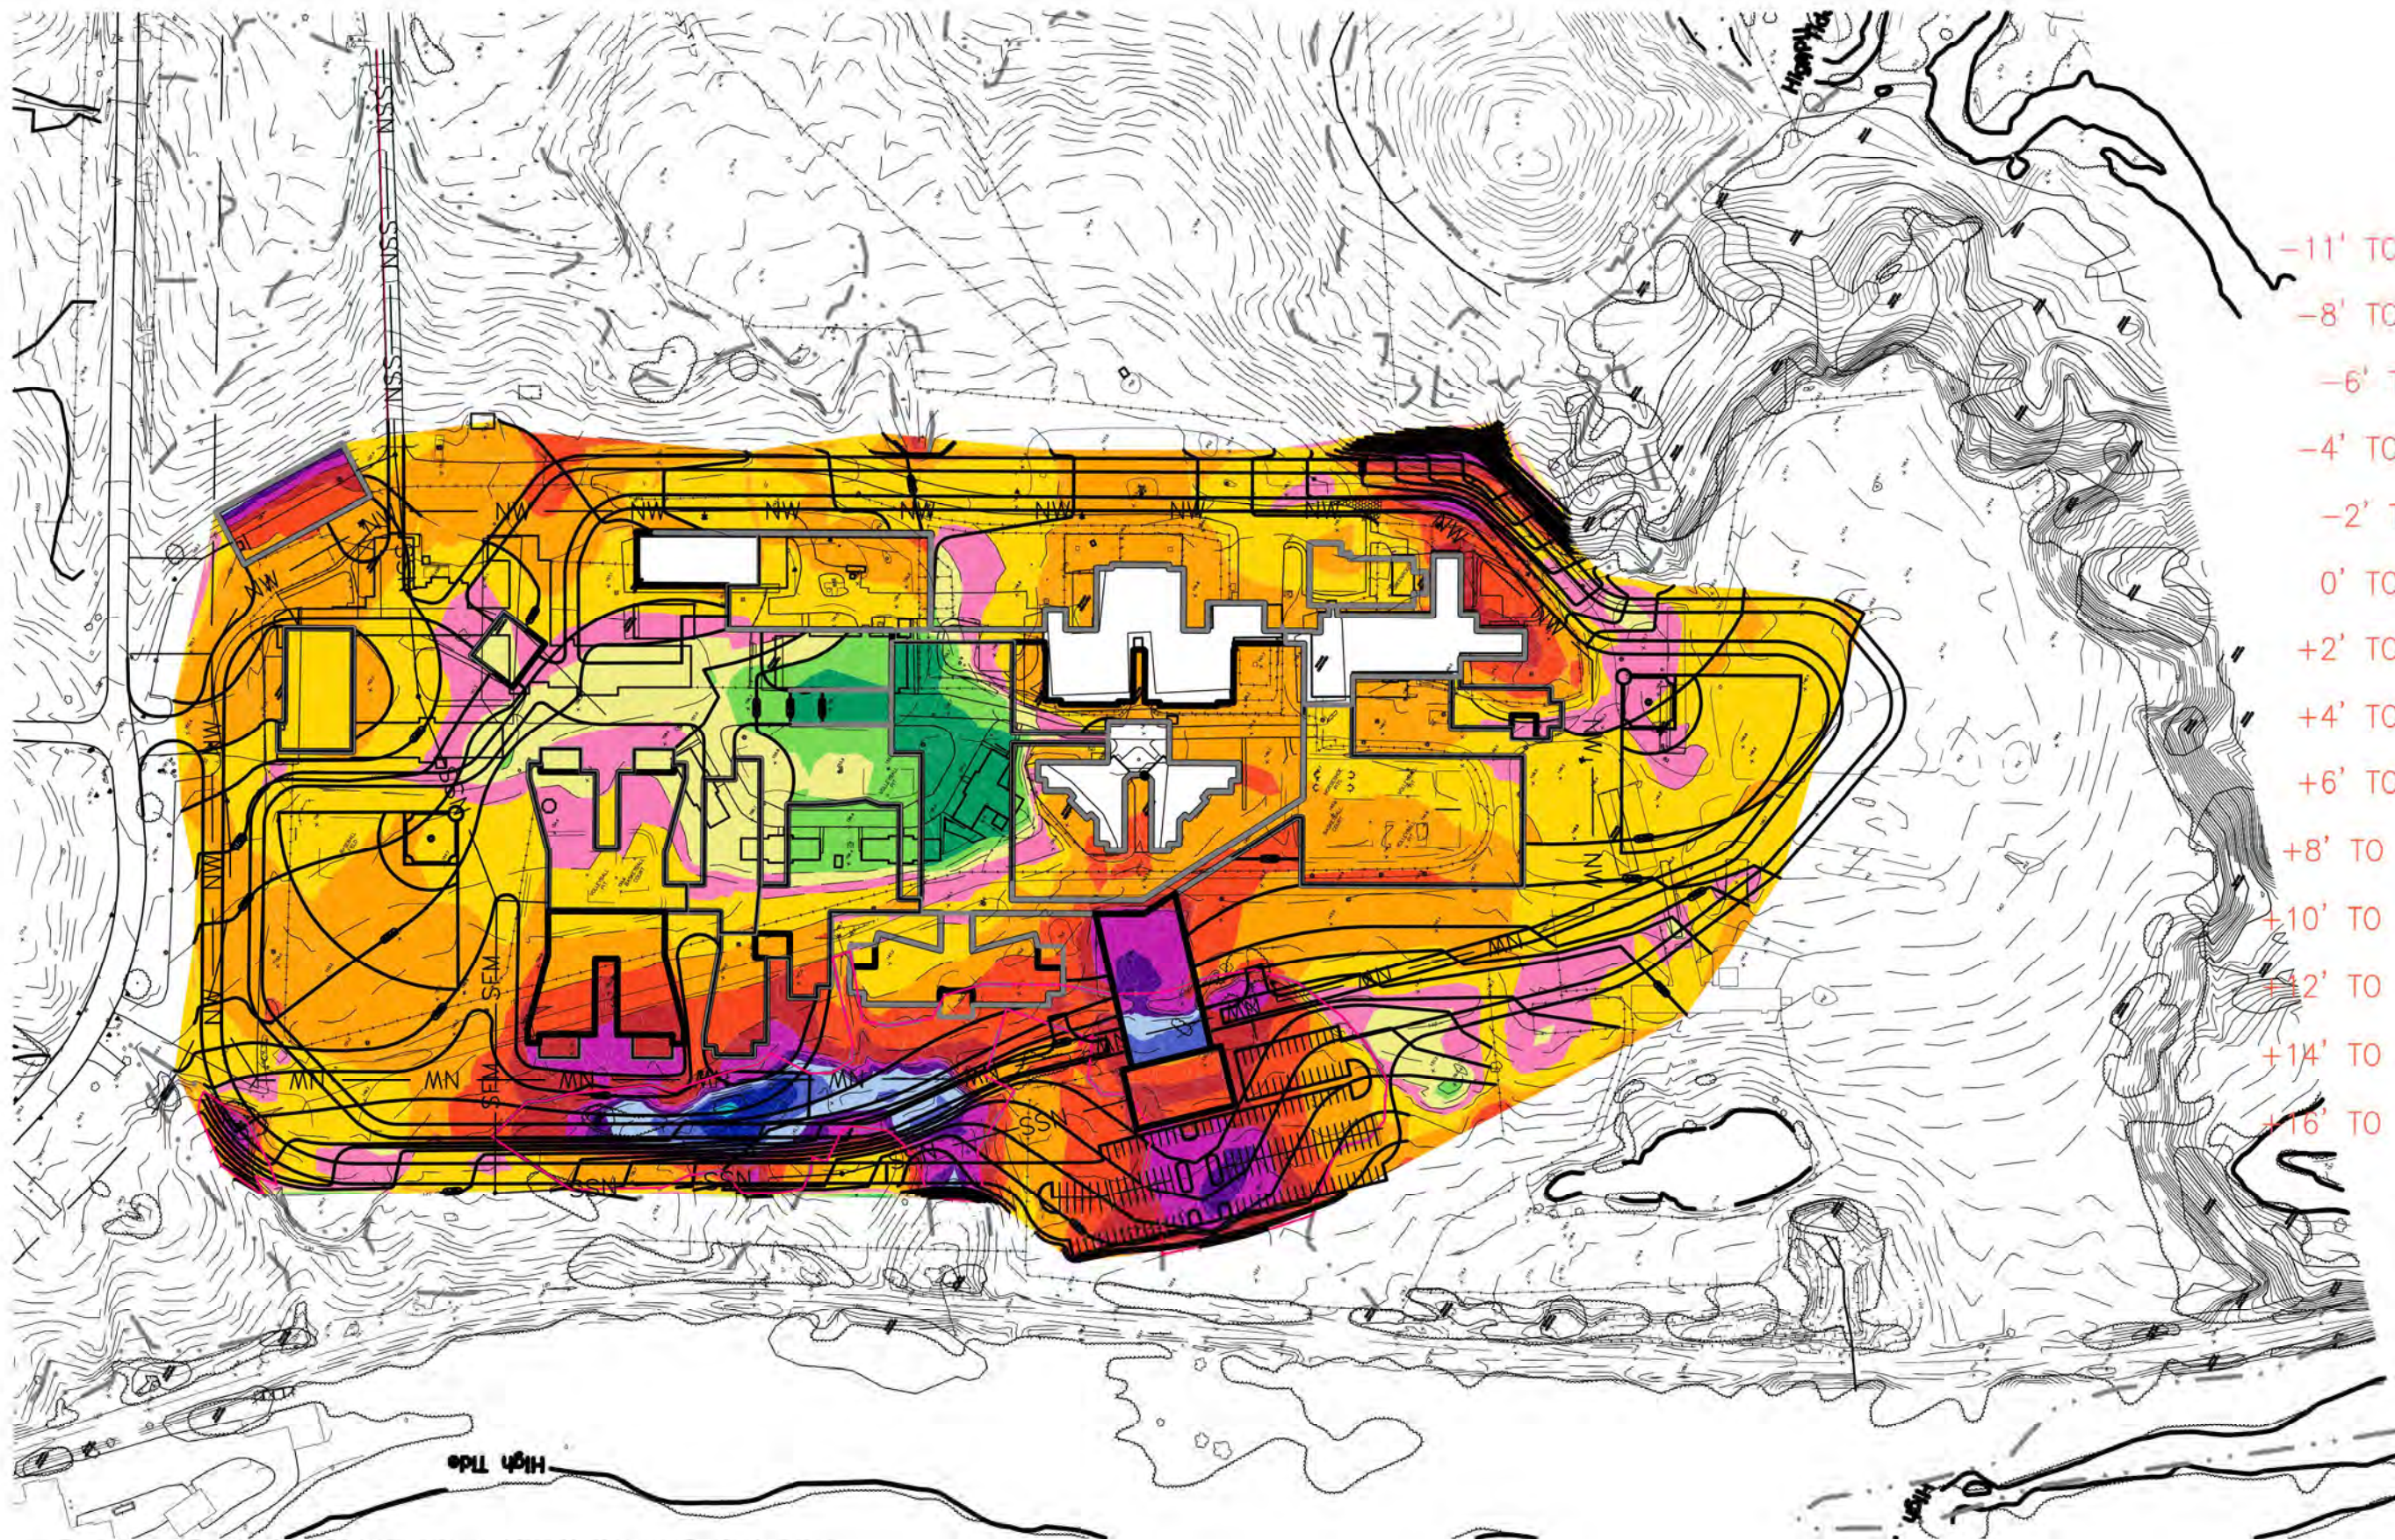
EARTHWORK CALCULATIONS

FEASIBILITY STUDY AND CONCEPT DESIGN
FOR THE MAINE CORRECTIONAL CENTER
MAINE DEPARTMENT OF CORRECTIONS
WINDHAM, MAINE

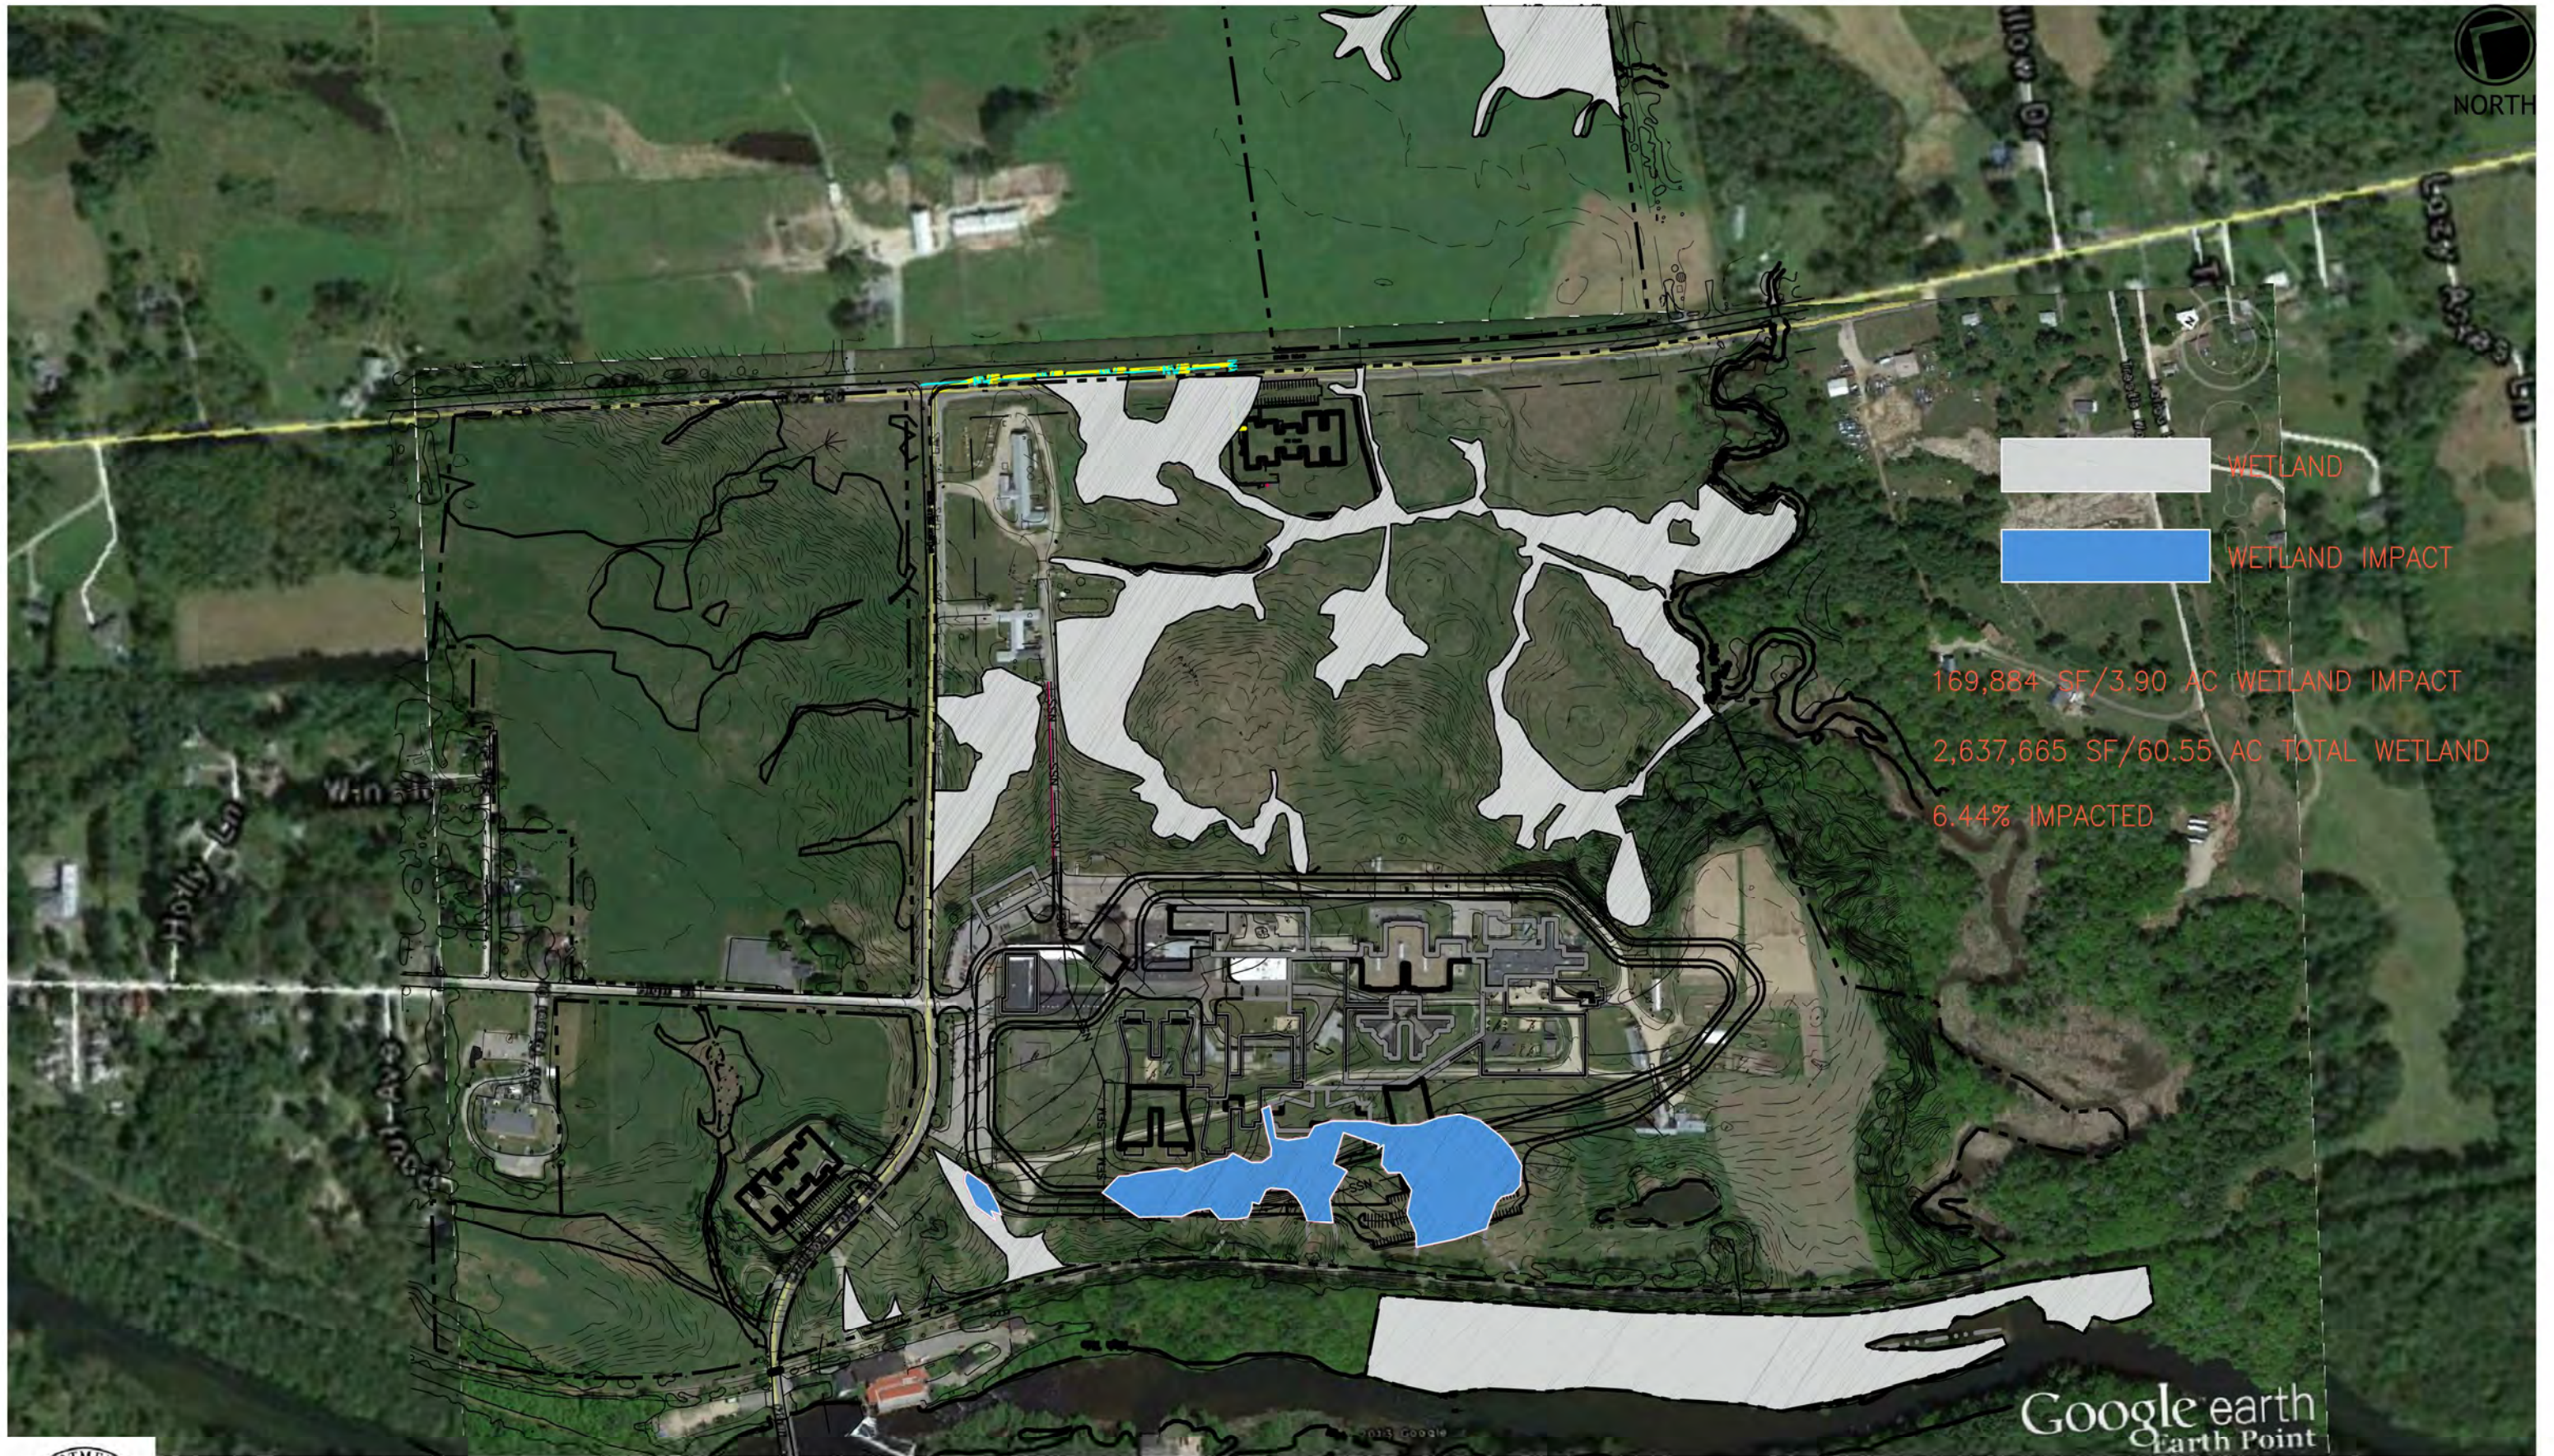
WETLAND IMPACT

MAINE DEPARTMENT OF CORRECTIONS
 MAINE CORRECTIONAL CENTER REUSE & RECONFIGURATION STUDY
 WINDHAM, MAINE

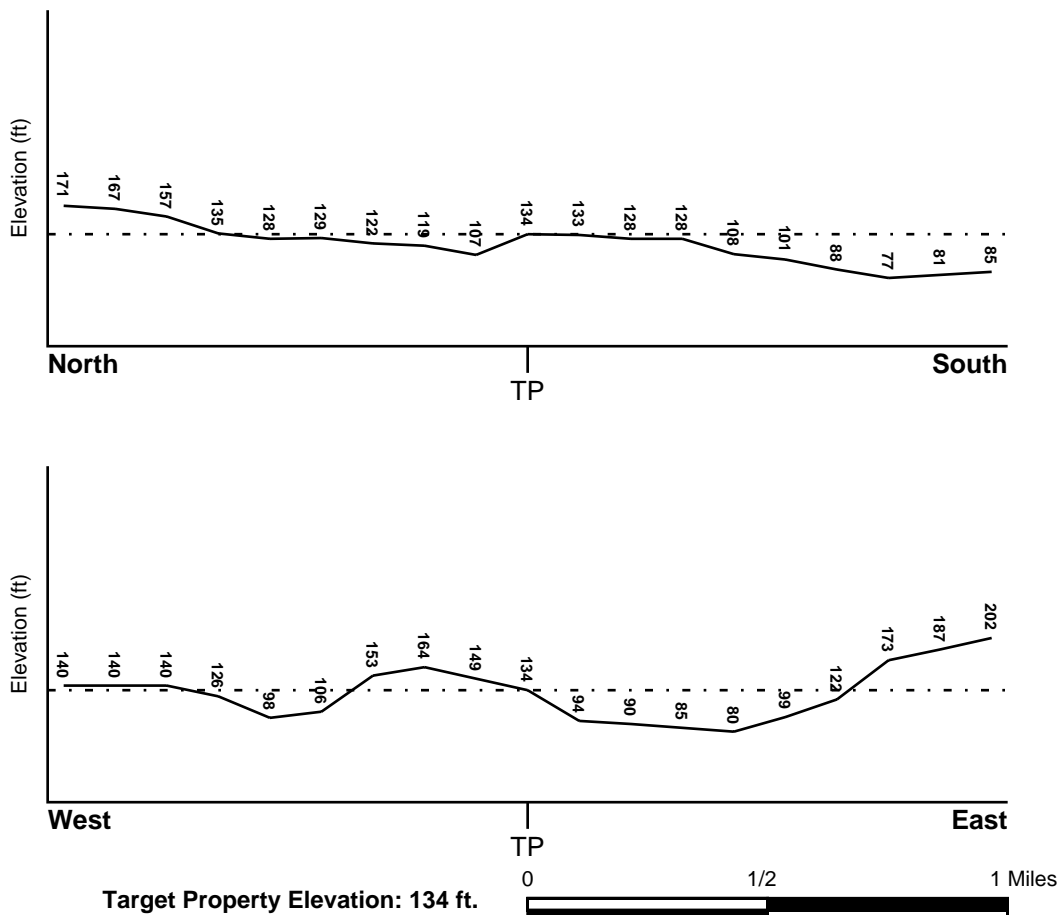
SURROUNDING TOPOGRAPHY: ELEVATION PROFILES

General Topographic Gradient: General East

Source: Topography has been determined from the USGS 7.5' Digital Elevation Model and should be evaluated on a relative (not an absolute) basis. Relative elevation information between sites of close proximity should be field verified.

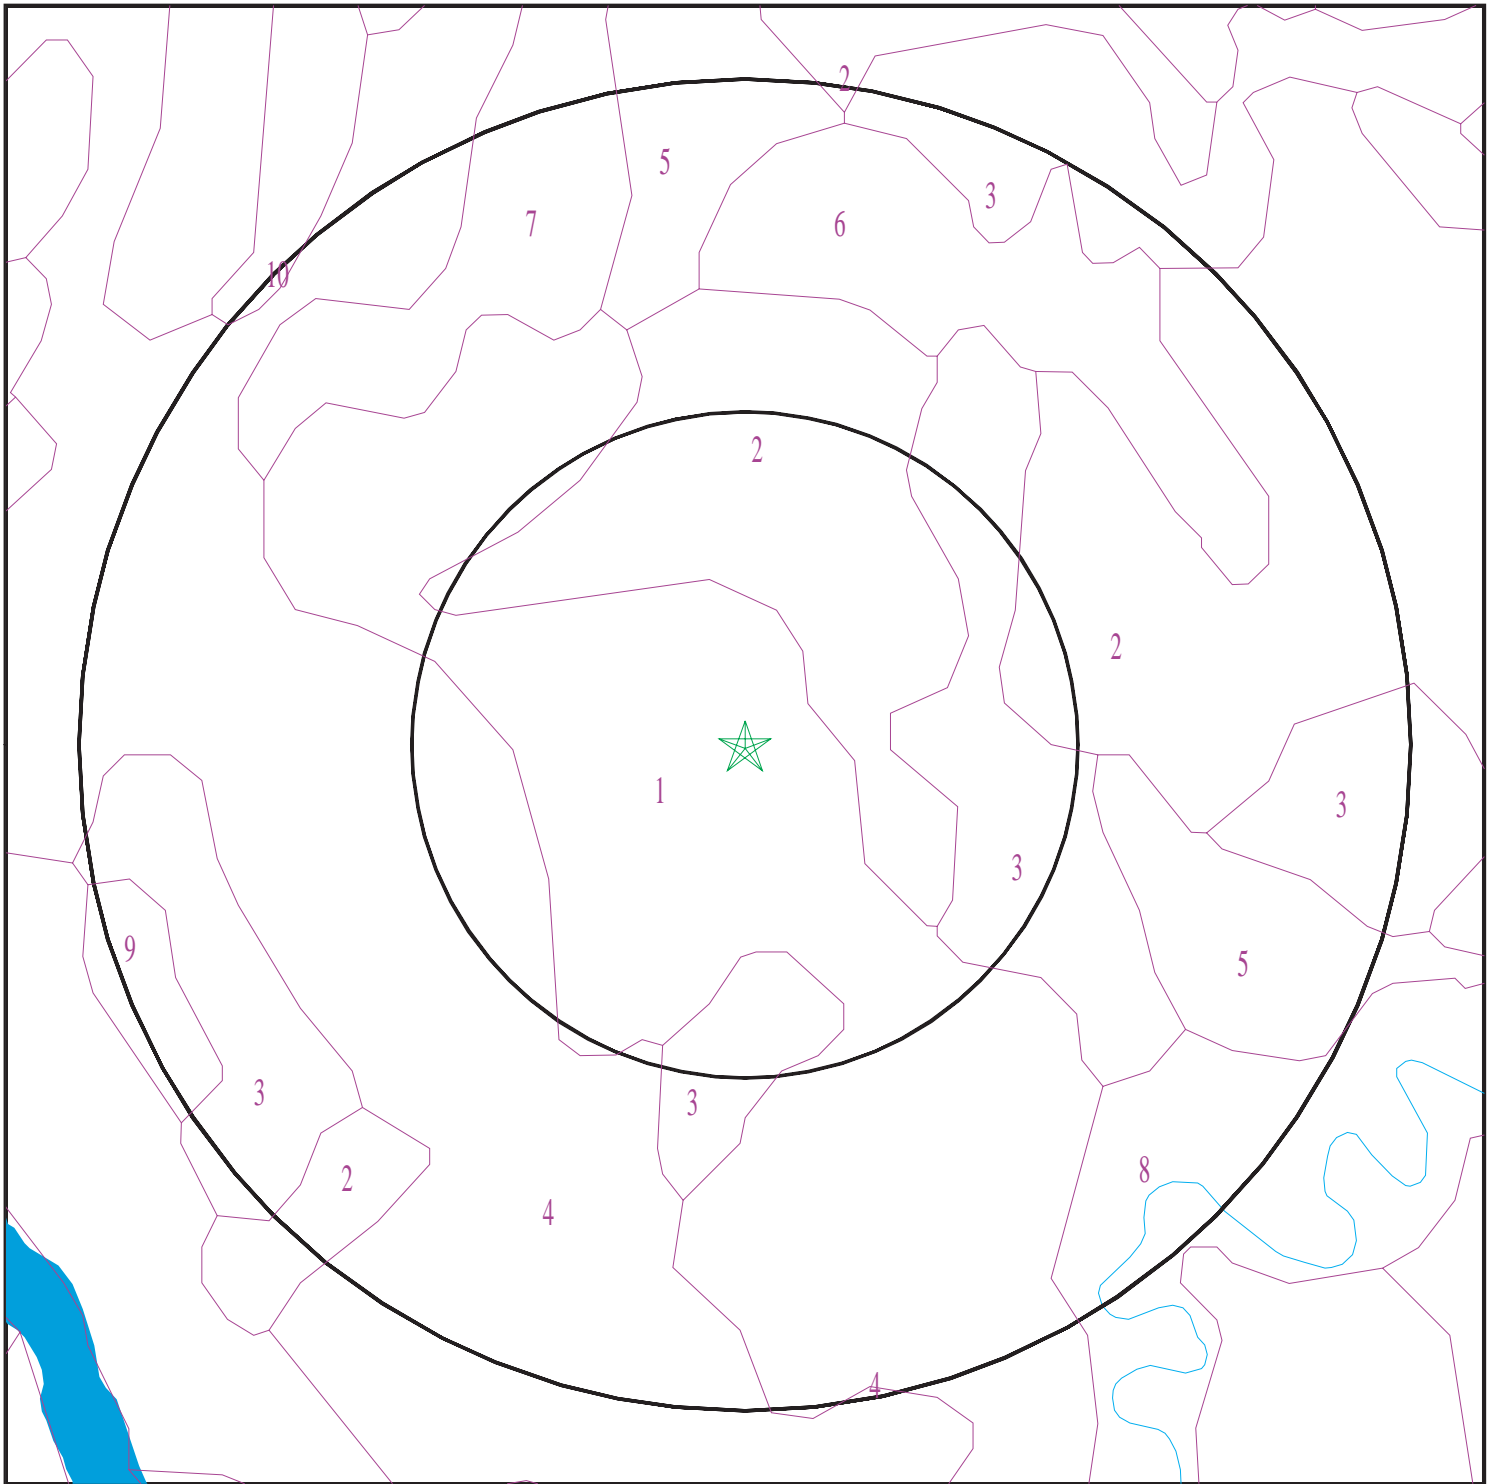
SSURGO SOIL MAP - 3797670.2s

- ★ Target Property
- SSURGO Soil
- Water
